Playdale Playgrounds

Annual Inspection Report For Millennium Green

Date of inspection: 27/07/2019

Main Street, Ainstable, Cumbria

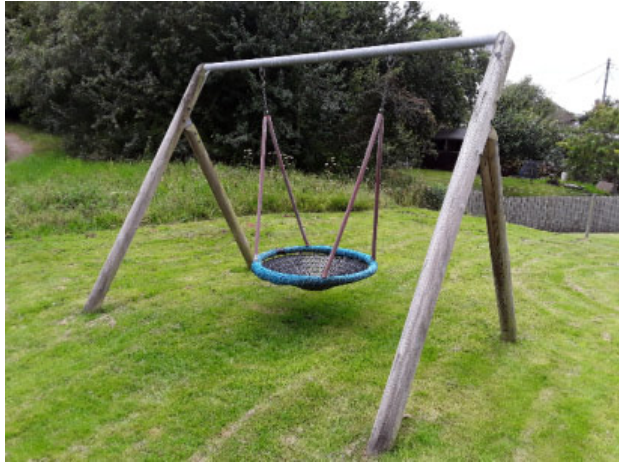
Item: Swings - Basket Swing - Type 1
Manufacturer: Playdale Playgrounds Ltd
Surface Type: Grass Matrix Tiles
Equipment Compliance: No
Surface Area Compliance: No
Ref/Part Number:
Total Findings: 5
Life Expectancy: >10 Years

The openings between the slots in the Basket Seat form finger entrapments, when the seat is in motion - Monitor Use

The mats have grassed over; this may have an effect on the impact absorbing properties of the surface - Monitor use

The shackles are showing wear - Grease the shackles (Done whilst on site)

The seat is starting to show its age - Monitor use

There is some chain wear - Monitor for any further deterioration

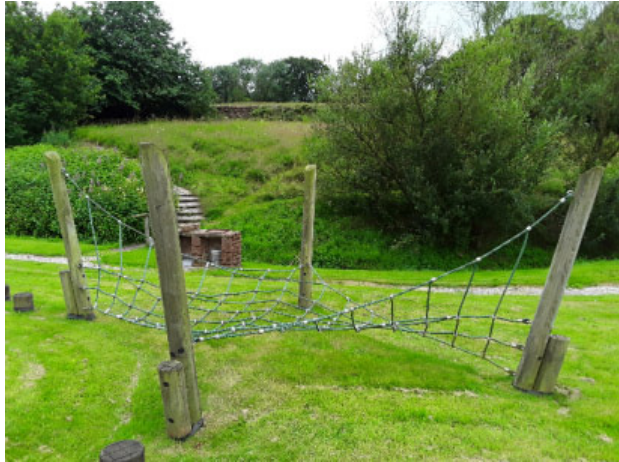
Item: Activity Equipment - Net Climber
Manufacturer: Playdale Playgrounds Ltd
Surface Type: Grass
Equipment Compliance: Yes
Surface Area Compliance: Yes
Ref/Part Number:
Total Findings: 1
Life Expectancy: >10 Years

The unit is in satisfactory condition - None required

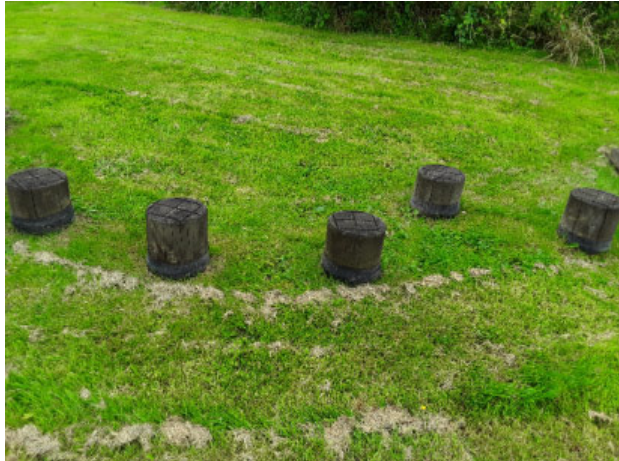
Item: Activity Equipment - Log Walk
Manufacturer: Playdale Playgrounds Ltd
Surface Type: Grass
Equipment Compliance: Yes
Surface Area Compliance: Yes
Ref/Part Number:
Total Findings: 2
Life Expectancy: >10 Years

A log is rotten - Replace the rotten log

3no log are rotting in the middle and will require replacement next year - Monitor or replace

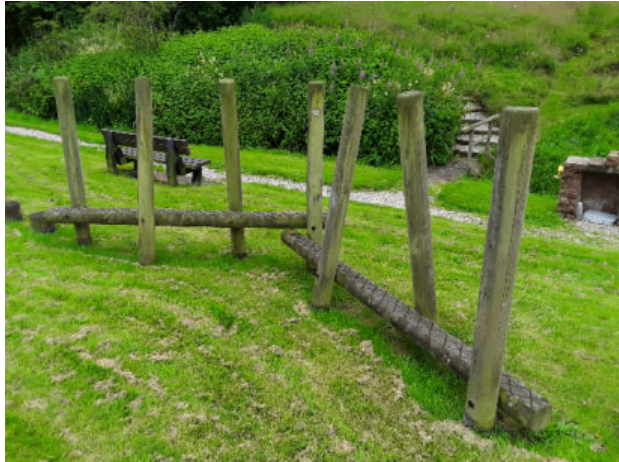
Item: Activity Equipment - Intertwine
Manufacturer: Playdale Playgrounds Ltd
Surface Type: Grass
Equipment Compliance: Yes
Surface Area Compliance: Yes
Ref/Part Number:
Total Findings: 1
Life Expectancy: >10 Years

The intertwine is in satisfactory condition - None required

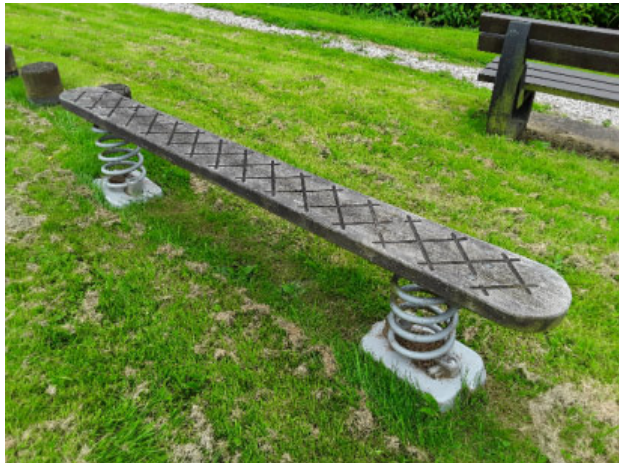
Item: Rocking Equipment - Wobble Board
Manufacturer: Playdale Playgrounds Ltd
Surface Type: Grass
Equipment Compliance: Yes
Surface Area Compliance: Yes
Ref/Part Number:
Total Findings: 1
Life Expectancy: >10 Years

The wobble board is in satisfactory condition - None required

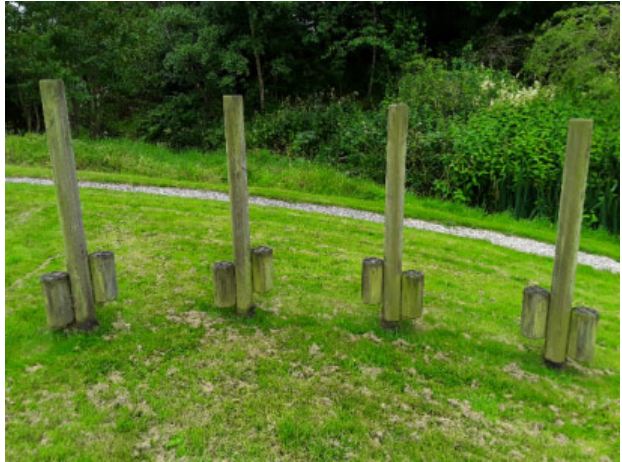
Item: Activity Equipment - Stilts
Manufacturer: Playdale Playgrounds Ltd
Surface Type: Grass
Equipment Compliance: Yes
Surface Area Compliance: Yes
Ref/Part Number:
Total Findings: 1
Life Expectancy: >10 Years

The stilts are in satisfactory condition - None required

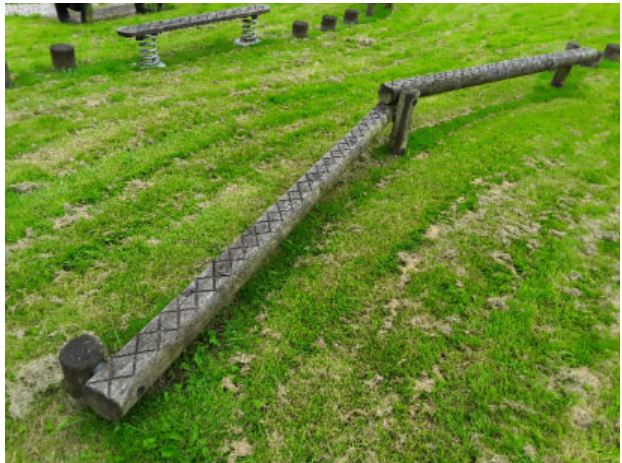
Item: Activity Equipment - Balance Beam
Manufacturer: Playdale Playgrounds Ltd
Surface Type: Grass
Equipment Compliance: Yes
Surface Area Compliance: Yes
Ref/Part Number:
Total Findings: 1

The twin balance beam unit in satisfactory condition - None required

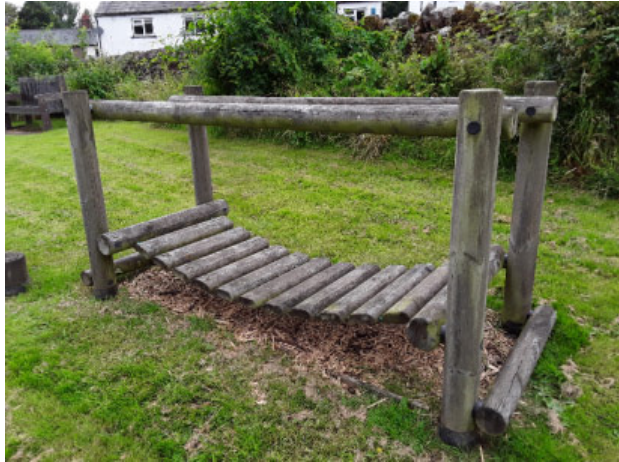
Item: Activity Equipment - Bridge
Manufacturer: Playdale Playgrounds Ltd
Surface Type: Grass
Equipment Compliance: Yes
Surface Area Compliance: Yes
Ref/Part Number:
Total Findings: 1
Life Expectancy: >10 Years

The mini-suspension bridge is in satisfactory condition - None required

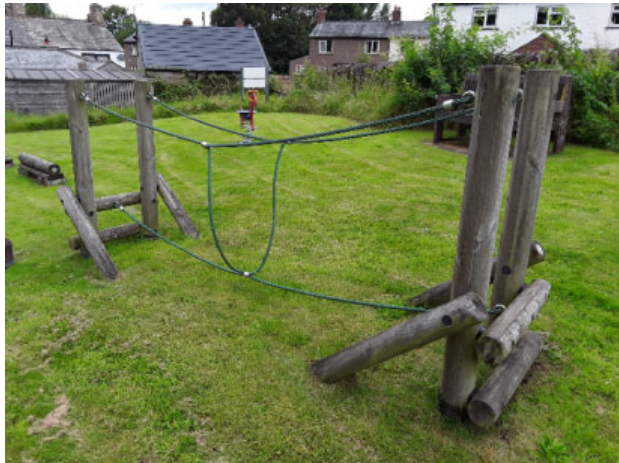
Item: Activity Equipment - Burma Bridge
Manufacturer: Playdale Playgrounds Ltd
Surface Type: Grass
Equipment Compliance: Yes
Surface Area Compliance: Yes
Ref/Part Number:
Total Findings: 2
Life Expectancy: >10 Years

There is some evidence of rot a strainer pole - Monitor for any further deterioration

The bottom rope is showing slight damage, and signs of wear - None required

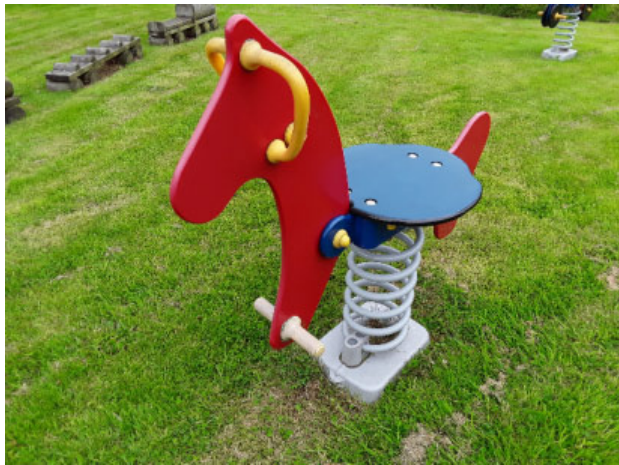
Item: Rocking Equipment - Spring Horse
Manufacturer: Ledon
Surface Type: Grass
Equipment Compliance: No
Surface Area Compliance: Yes
Ref/Part Number:
Total Findings: 2
Life Expectancy: >10 Years

The ends of the footrests have a cross section of less than 15cm² and fail to meet the requirements of BS EN 1176 - Monitor use

The spring horse is in satisfactory condition - None required

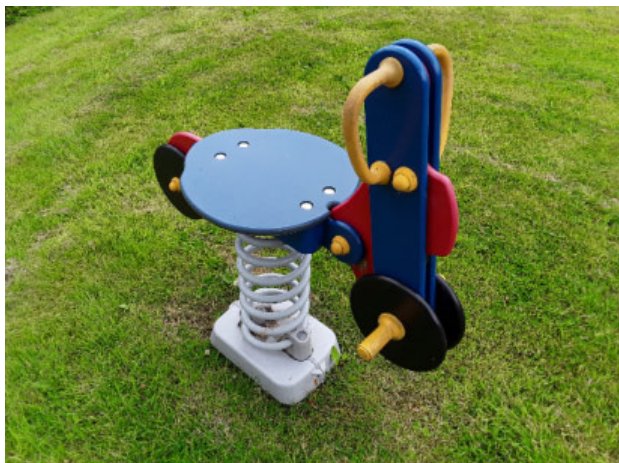
Item: Rocking Equipment - Spring Motorbike
Manufacturer: Ledon
Surface Type: Grass
Equipment Compliance: No
Surface Area Compliance: Yes
Ref/Part Number:
Total Findings: 2
Life Expectancy: >10 Years

The footrests fail dimension requirements - Monitor use

The Spring is in satisfactory condition - None required

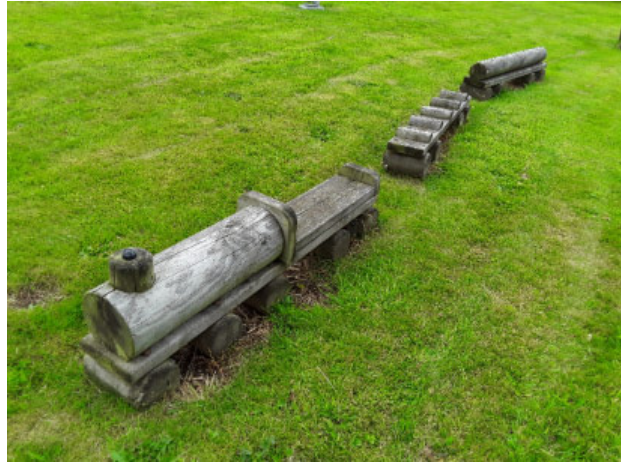
Item: Activity Equipment - Train
Manufacturer: Playdale Playgrounds Ltd
Surface Type: Grass
Equipment Compliance: Yes
Surface Area Compliance: Yes
Ref/Part Number:
Total Findings: 1
Life Expectancy: >10 Years

The train is in satisfactory condition - None required

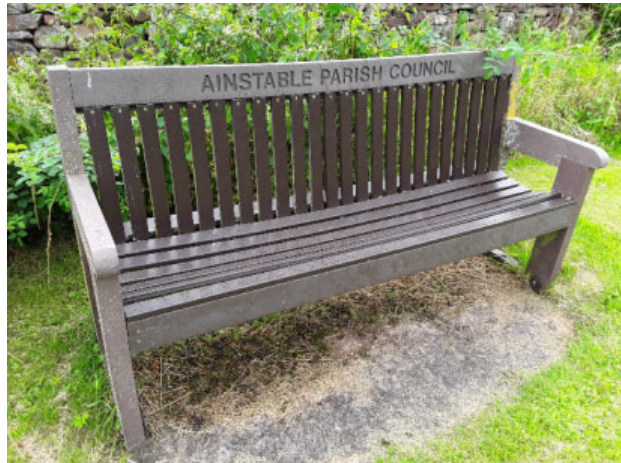
Item: Ancillary Items - Seating Area
Manufacturer: Unknown
Surface Type: Concrete
Equipment Compliance: N/A
Surface Area Compliance: N/A
Ref/Part Number:
Total Findings: 3
Life Expectancy: 3 - 5 Years

The seats are in good condition - See below

A rose bush is growing over a seat - Cut back the bush

There is an unused bracket is below a seat - Remove or knock the bracket flat

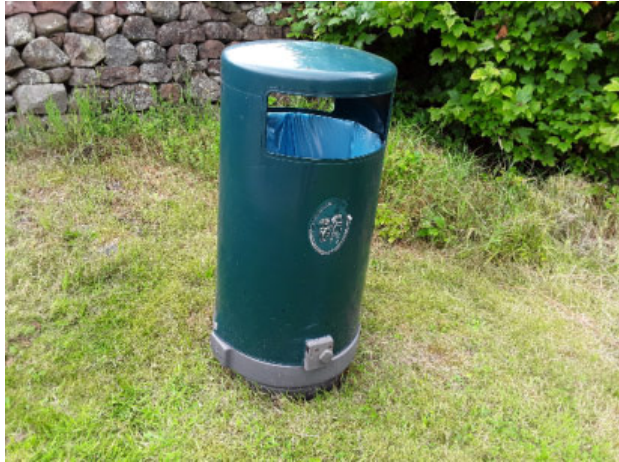
Item: Ancillary Items - Litter Bin
Manufacturer: Unknown
Surface Type: Concrete
Equipment Compliance: N/A
Surface Area Compliance: N/A
Ref/Part Number:
Total Findings: 1
Life Expectancy: 5 -10 Years

The bin is in satisfactory condition - None required

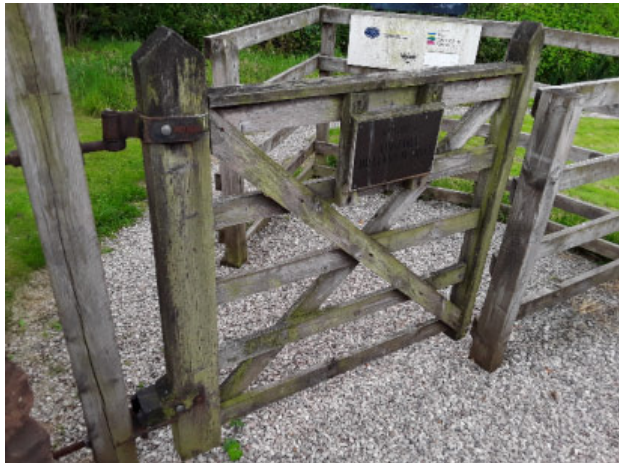
Item: Ancillary Items - Gate
Manufacturer: Unknown
Surface Type: Crushed Stone
Equipment Compliance: N/A
Surface Area Compliance: N/A
Ref/Part Number:
Total Findings: 1
Life Expectancy: 5 -10 Years

The gate is in satisfactory condition - None required

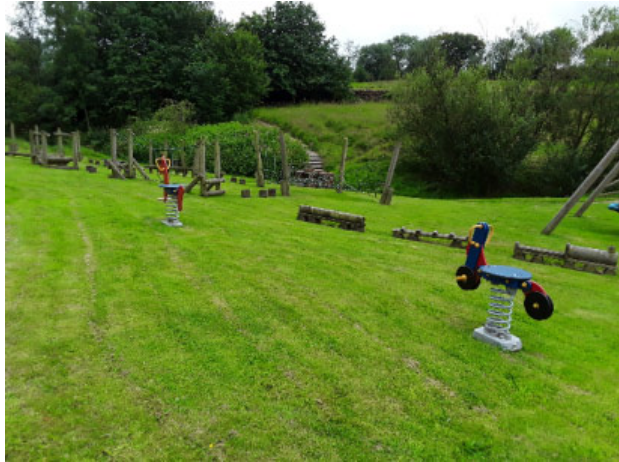
Item: Ancillary Items - Site General
Manufacturer: Unknown
Surface Type: N/A
Equipment Compliance: N/A
Surface Area Compliance: N/A
Ref/Part Number:
Total Findings: 2

The play area entrance is not obvious from the road - Consider a warning signage

The beck could be hazardous to smaller children, especially when in flood - Consider warning signage

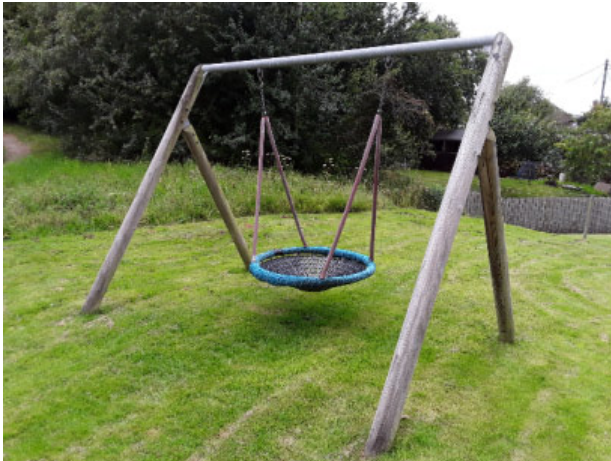
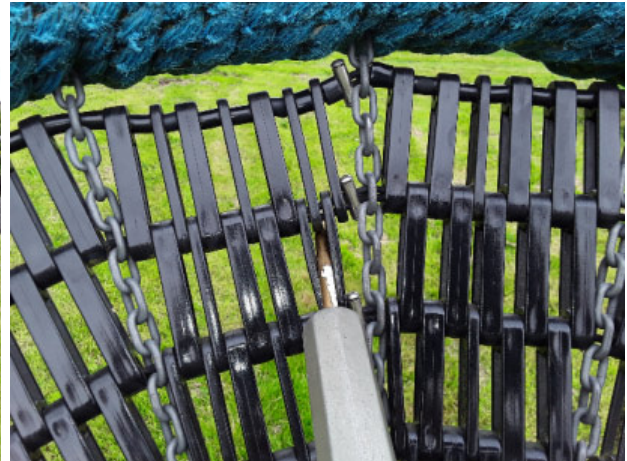
5 - Very Low Risk (Finding 1)

Finding: The openings between the slots in the Basket Seat form finger entrapments, when the seat is in motion

Action: Monitor Use

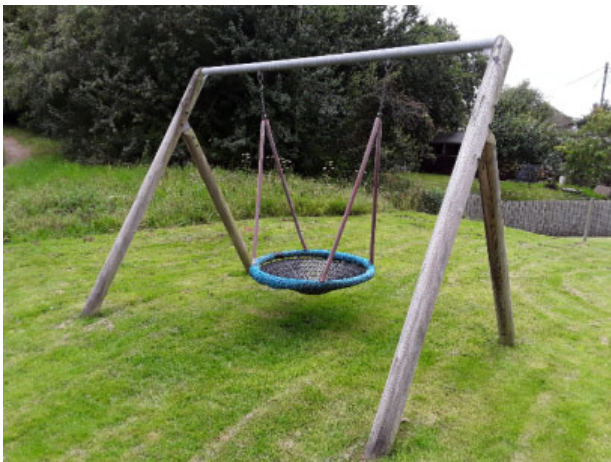
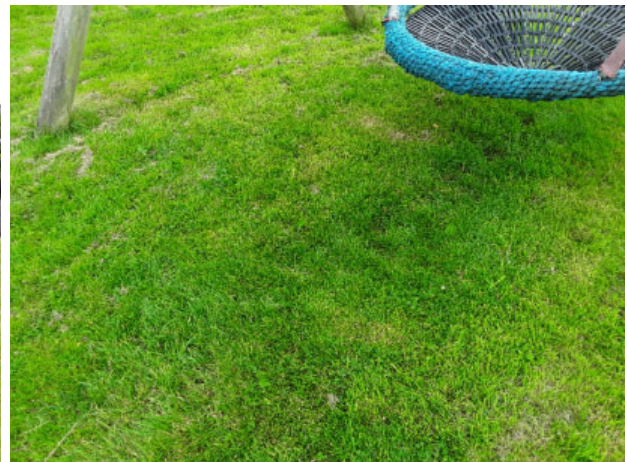
6 - Low Risk (Finding 2)

Finding: The mats have grassed over; this may have an effect on the impact absorbing properties of the surface

Action: Monitor use

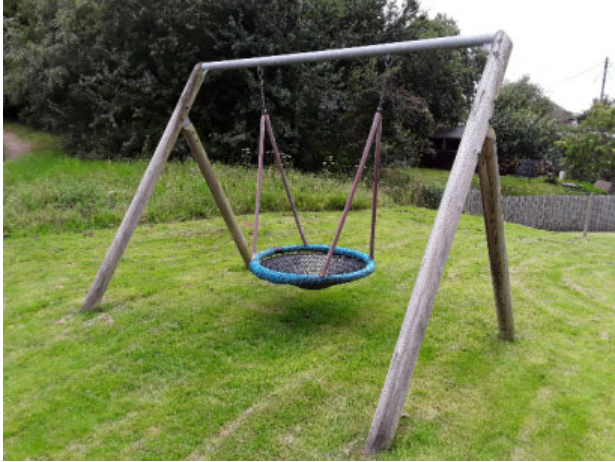
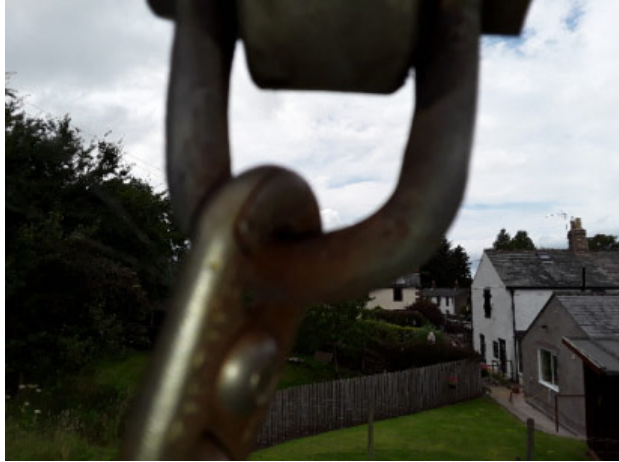
5 - Very Low Risk (Finding 3)

Finding: The shackles are showing wear

Action: Grease the shackles (Done whilst on site)

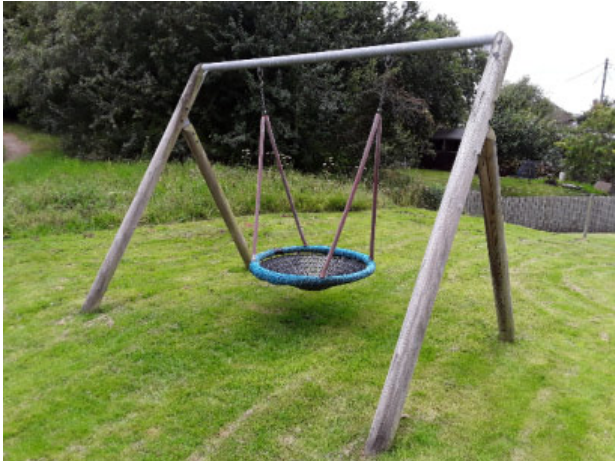
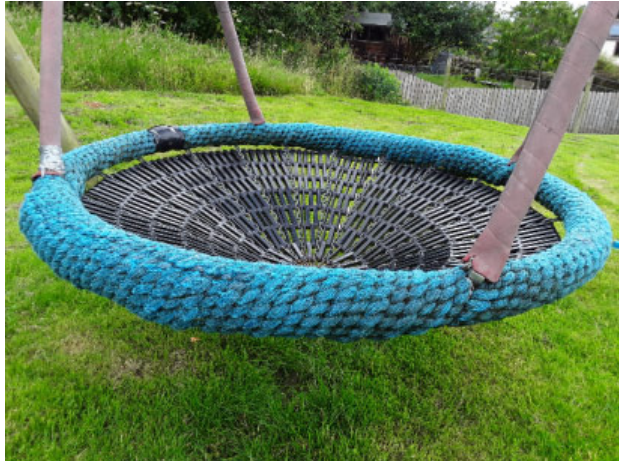
4 - Very Low Risk (Finding 4)

Finding: The seat is starting to show its age

Action: Monitor use

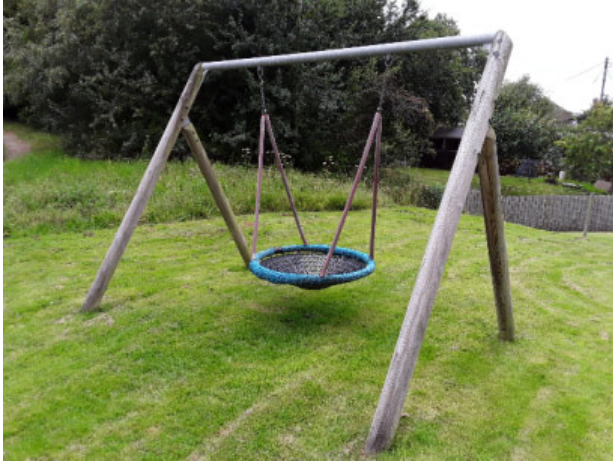
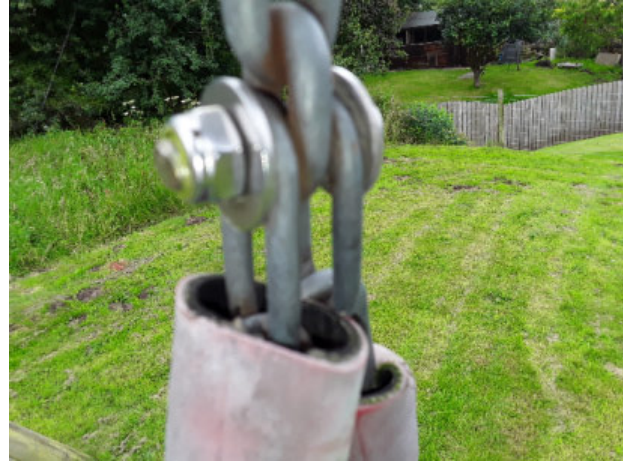
5 - Very Low Risk (Finding 5)

Finding: There is some chain wear

Action: Monitor for any further deterioration

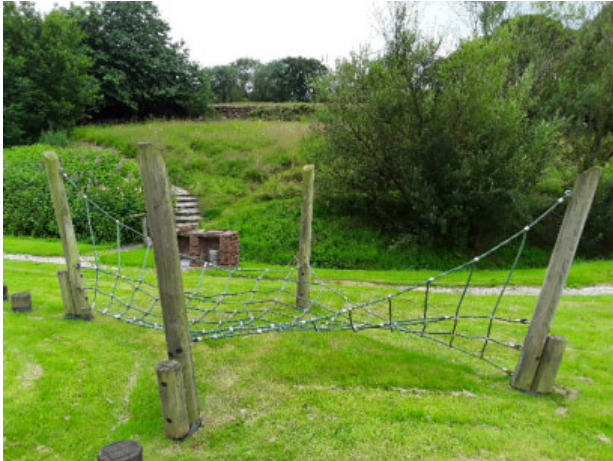
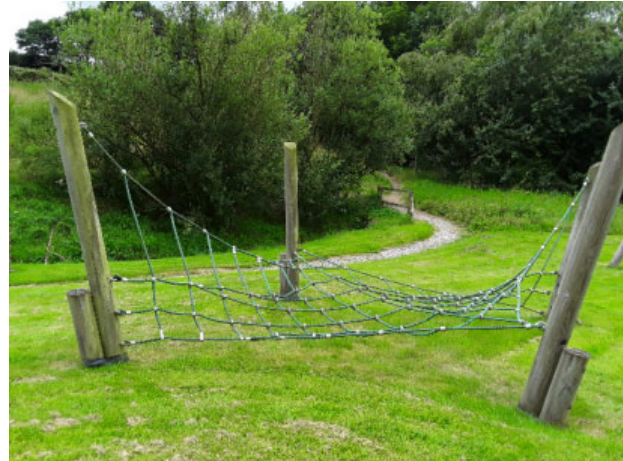
Finding: The unit is in satisfactory condition

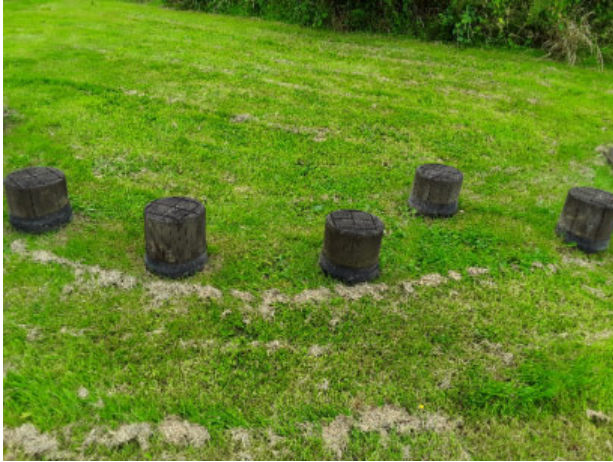
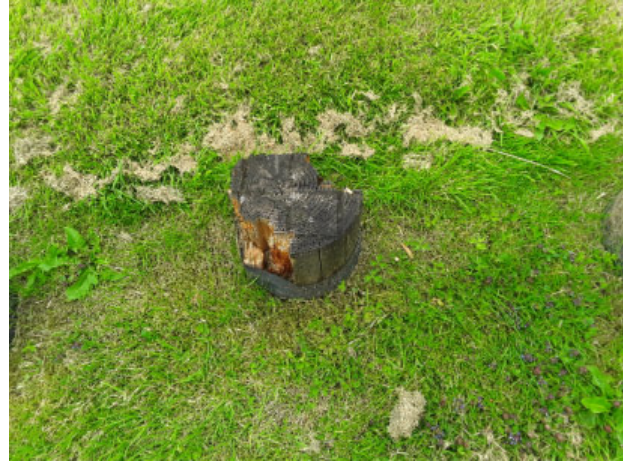
8 - Low Risk (Finding 1)

Finding: A log is rotten

Action: Replace the rotten log

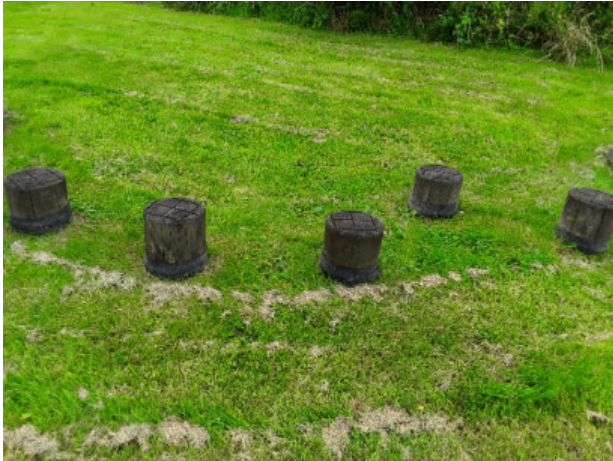
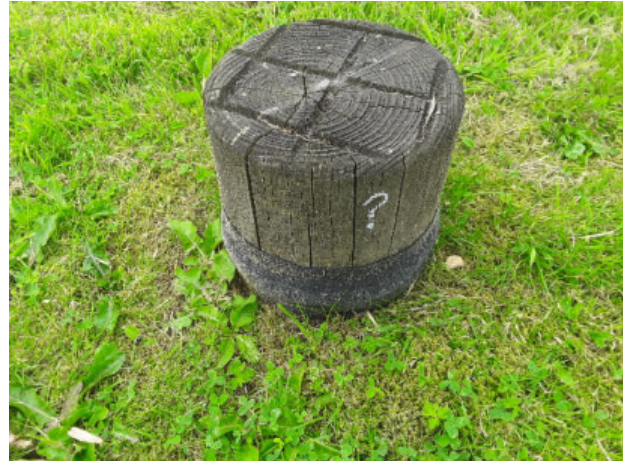
5 - Very Low Risk (Finding 2)

Finding: 3no log are rotting in the middle and will require replacement next year

Action: Monitor or replace

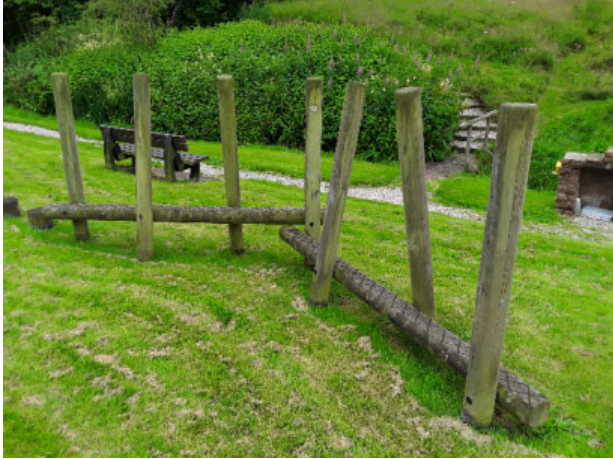
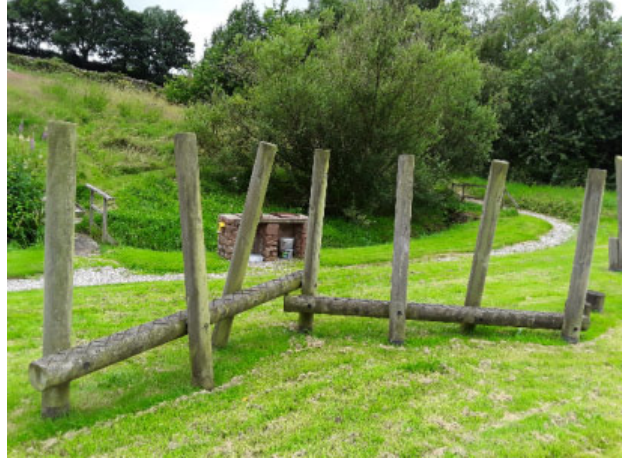
Finding: The intertwine is in satisfactory condition

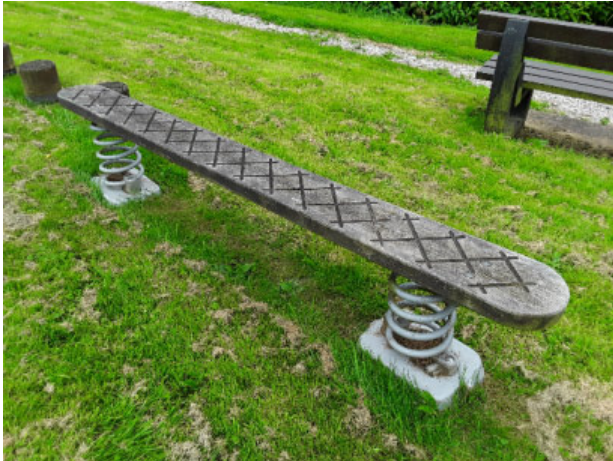
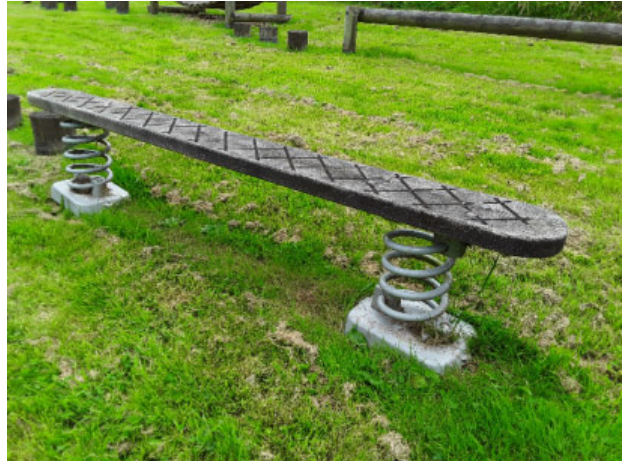
Finding: The wobble board is in satisfactory condition

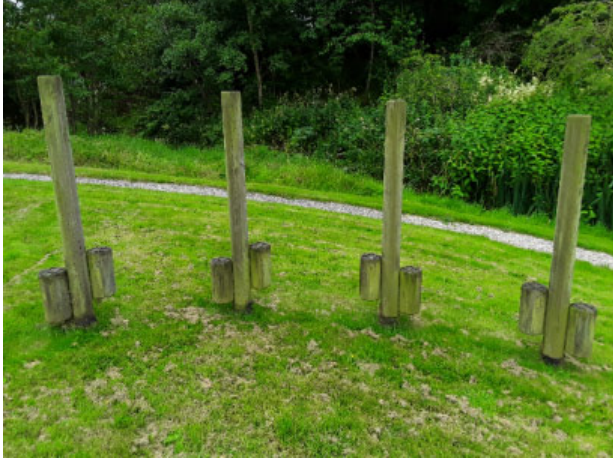
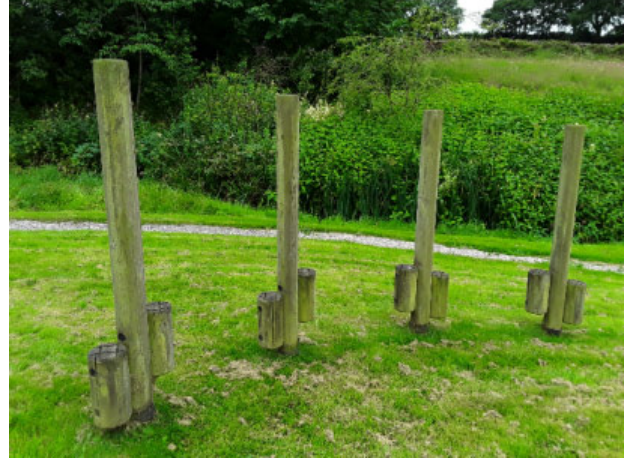
Finding: The stilts are in satisfactory condition

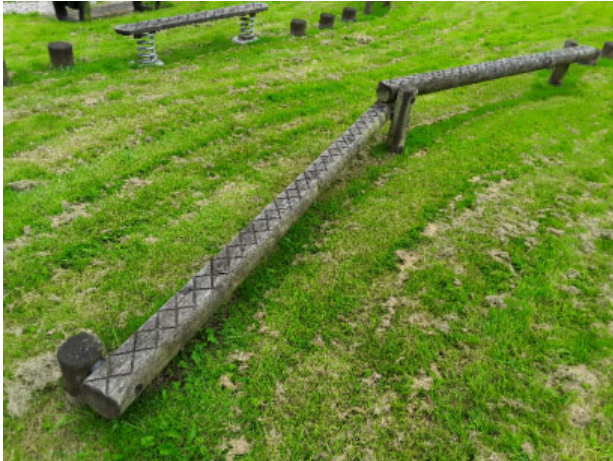
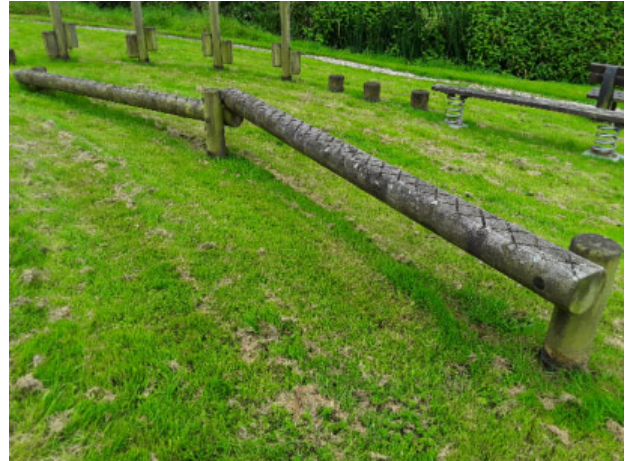
Finding: The twin balance beam unit in satisfactory condition

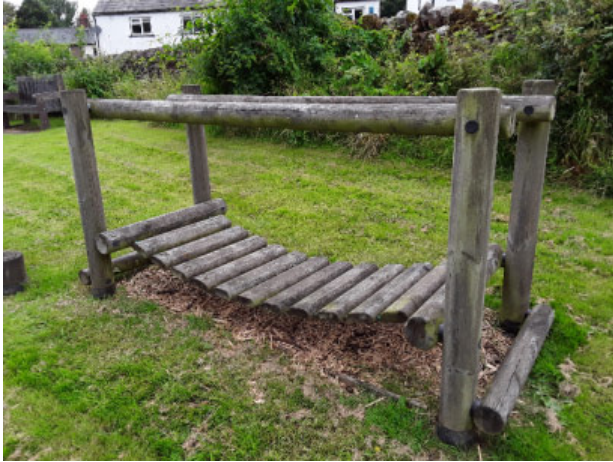
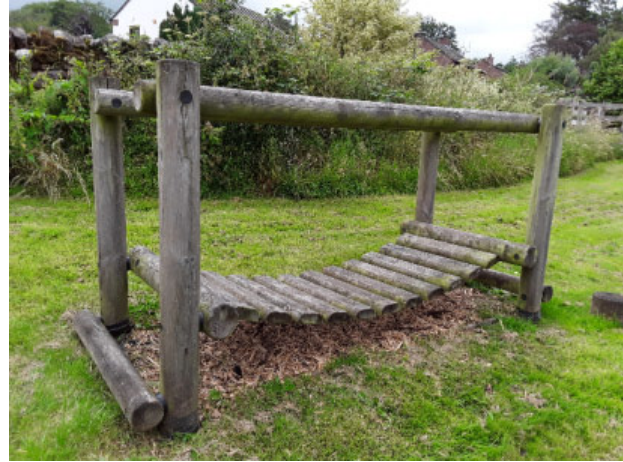
Finding: The mini-suspension bridge is in satisfactory condition

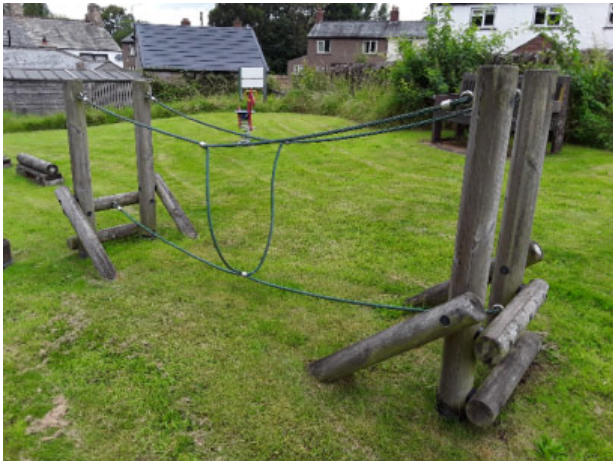
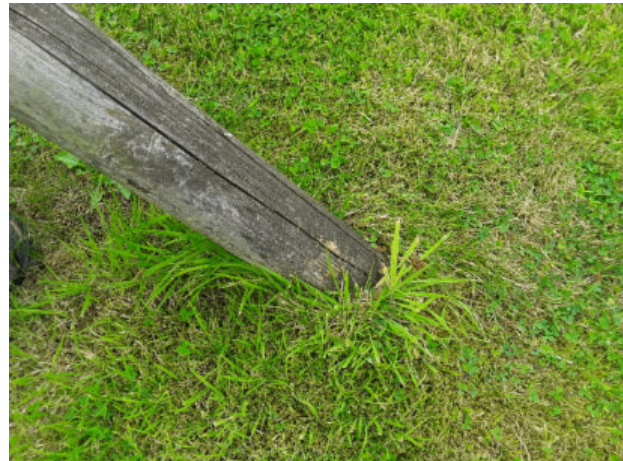
4 - Very Low Risk (Finding 1)

Finding: There is some evidence of rot a strainer pole

Action: Monitor for any further deterioration

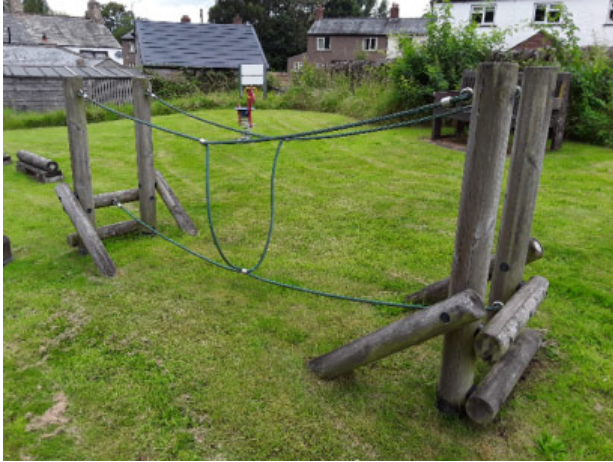
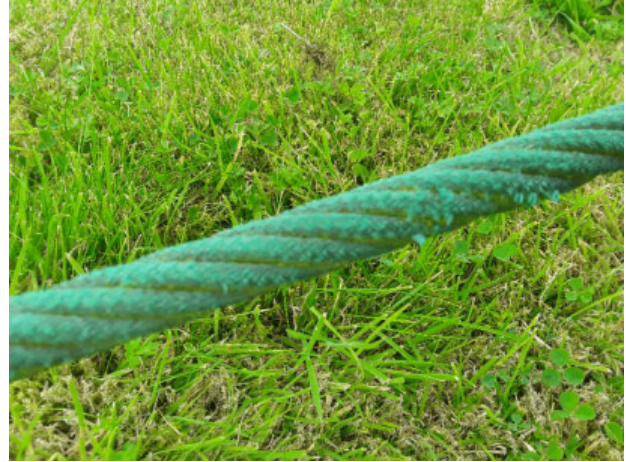
Finding: The bottom rope is showing slight damage, and signs of wear

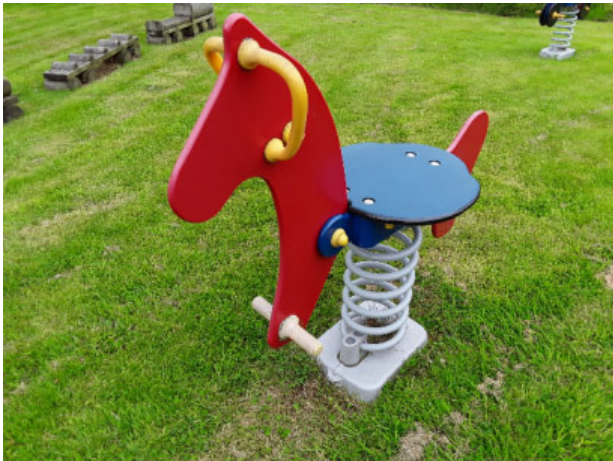
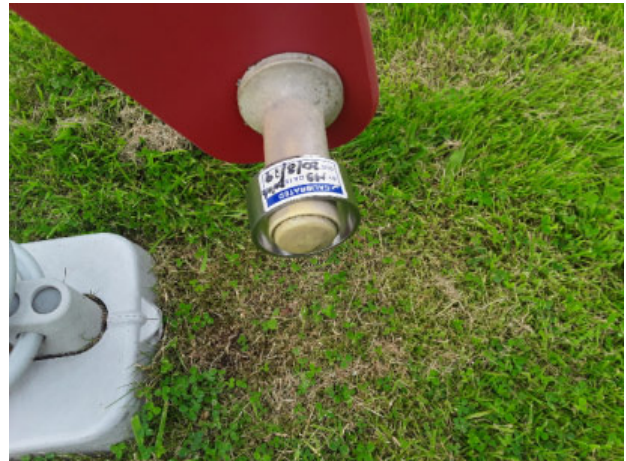
5 - Very Low Risk (Finding 1)

Finding: The ends of the footrests have a cross section of less than 15cm² and fail to meet the requirements of BS EN 1176

Action: Monitor use

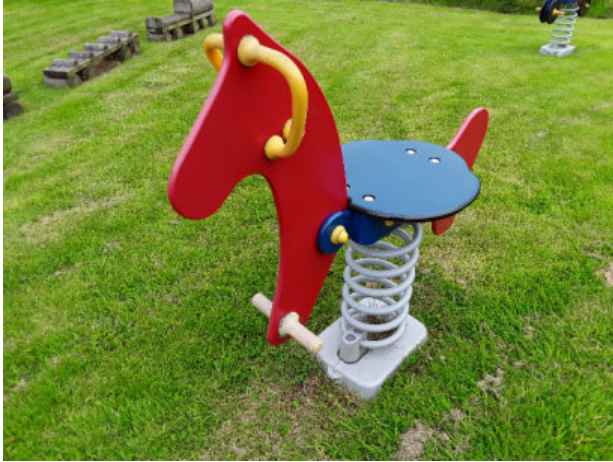
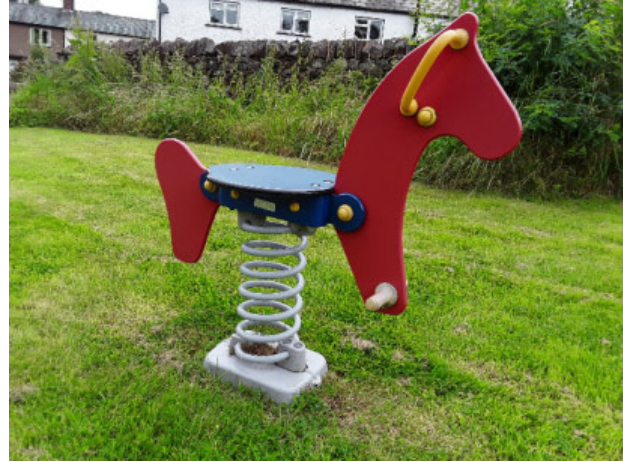
Finding: The spring horse is in satisfactory condition

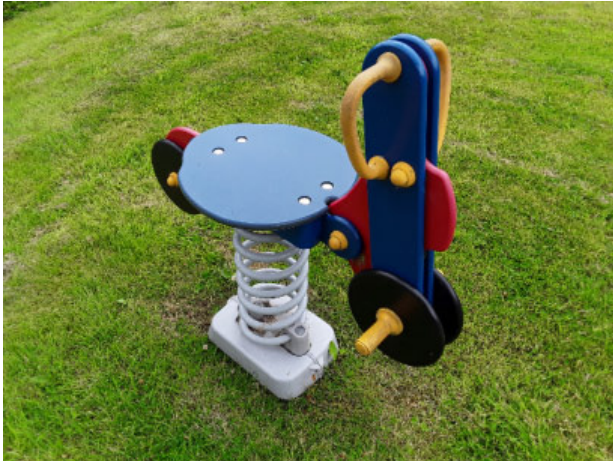
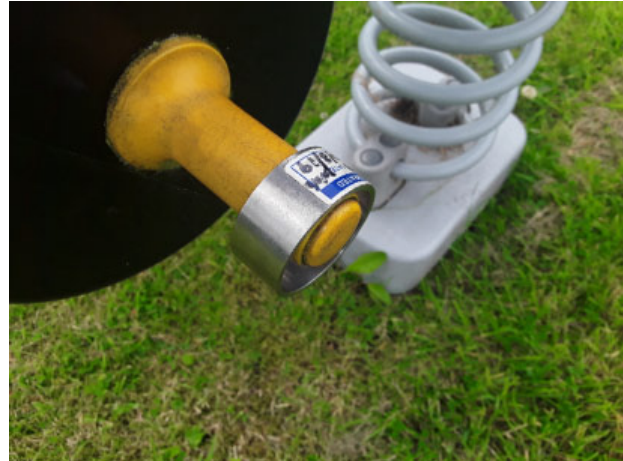
5 - Very Low Risk (Finding 1)

Finding: The footrests fail dimension requirements

Action: Monitor use

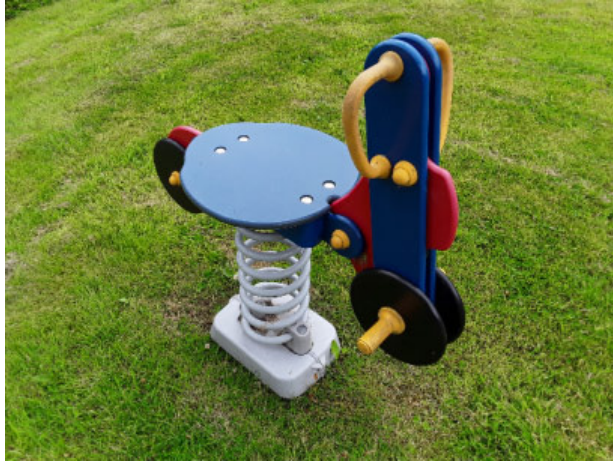
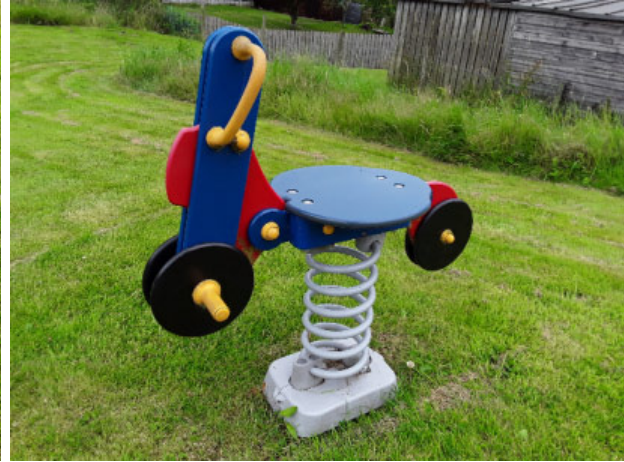
Finding: The Springer is in satisfactory condition

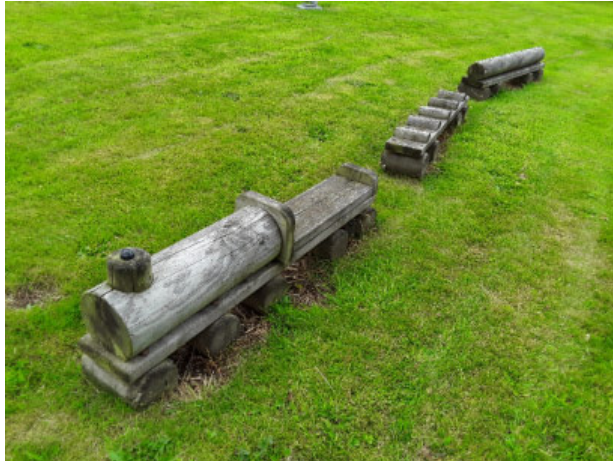
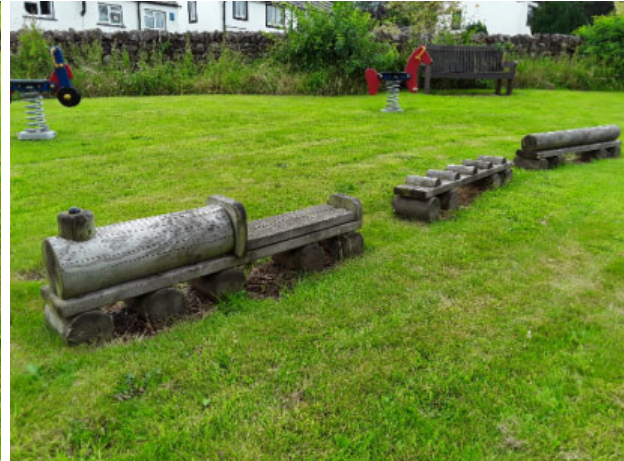
Finding: The train is in satisfactory condition

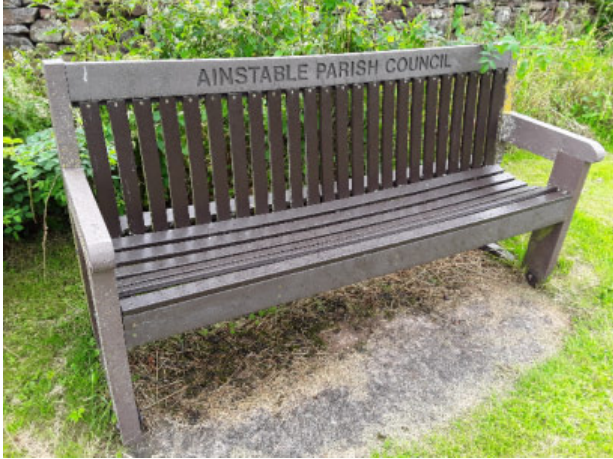
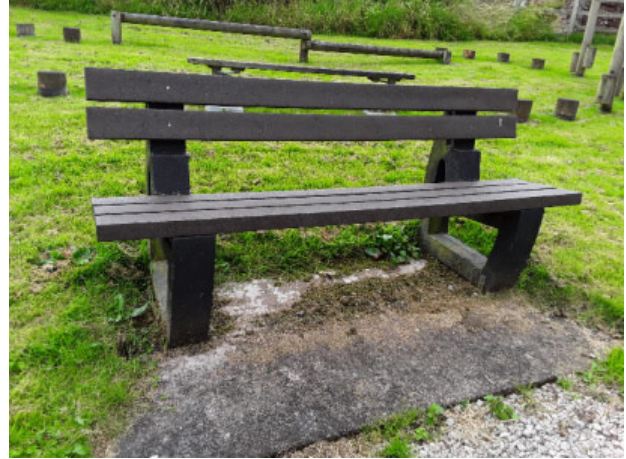
Finding: The seats are in good condition

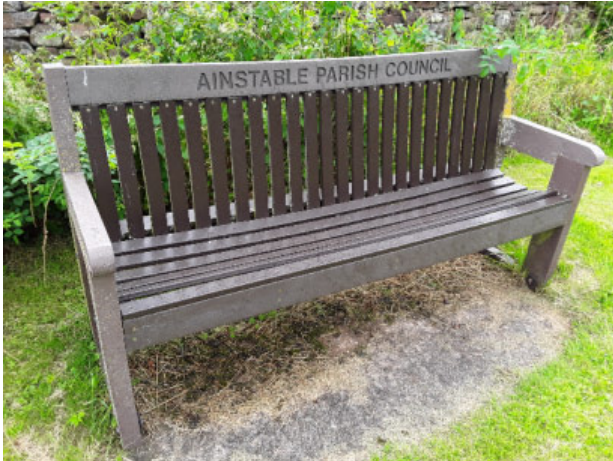
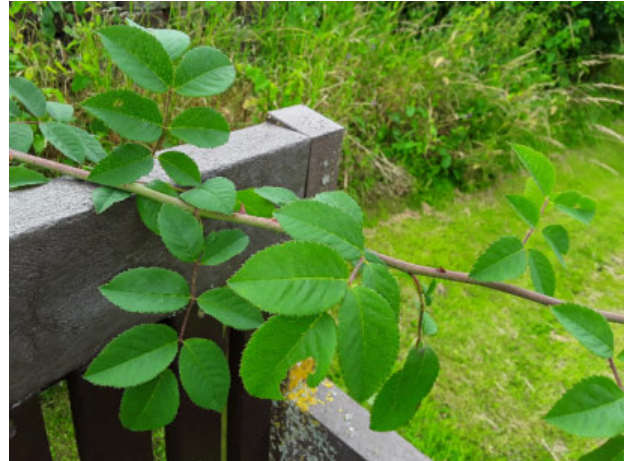
Finding: A rose bush is growing over a seat

Action: Cut back the bush

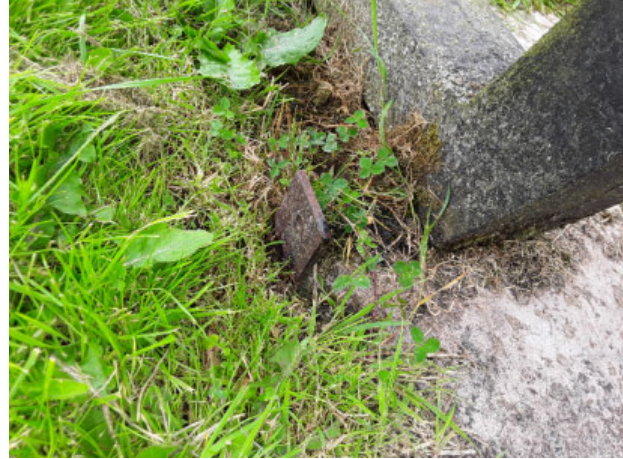
5 - Very Low Risk (Finding 3)

Finding: There is an unused bracket is below a seat

Action: Remove or knock the bracket flat

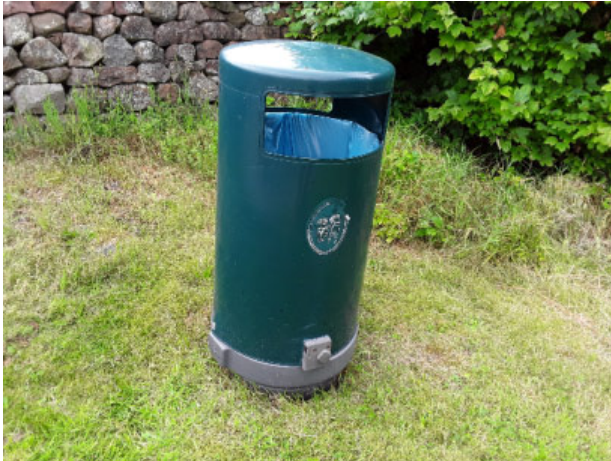
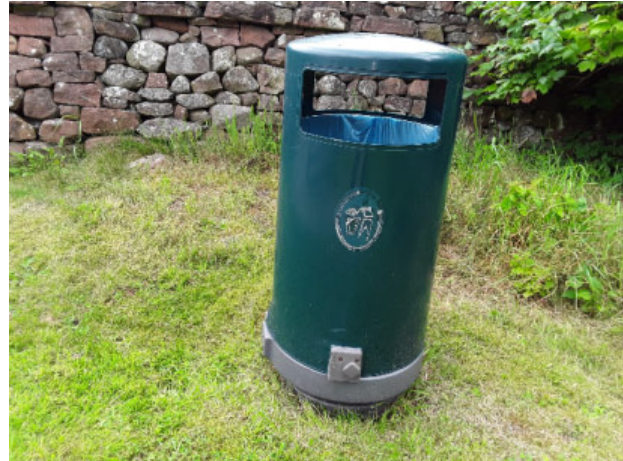
Finding: The bin is in satisfactory condition

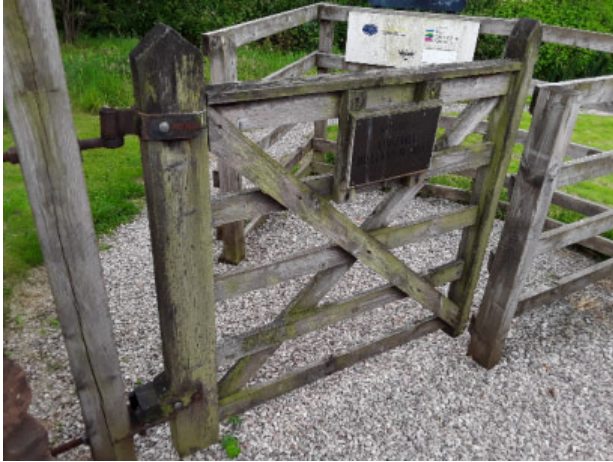
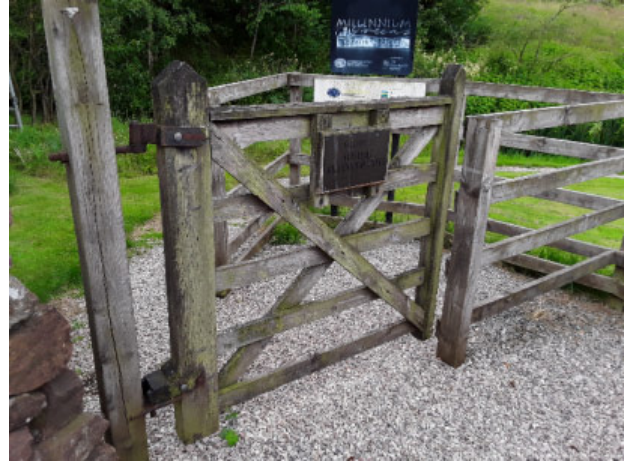
Finding: The gate is in satisfactory condition

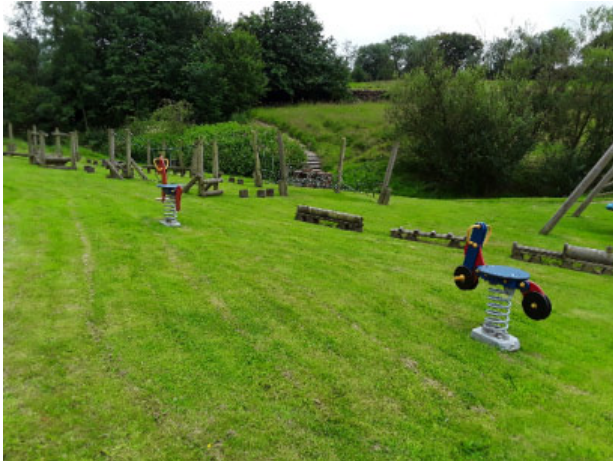
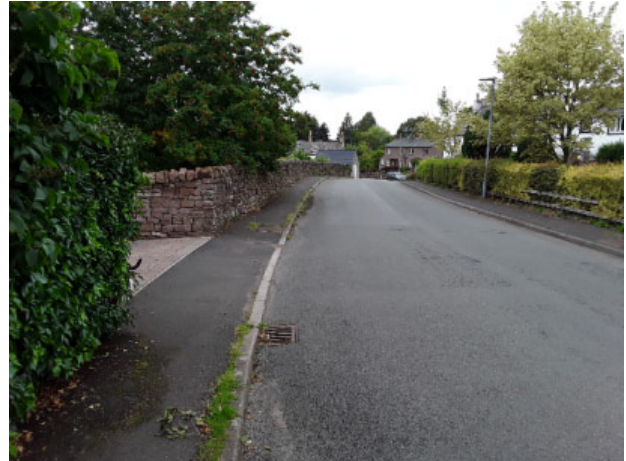
8 - Low Risk (Finding 1)

Finding: The play area entrance is not obvious from the road

Action: Consider a warning signage

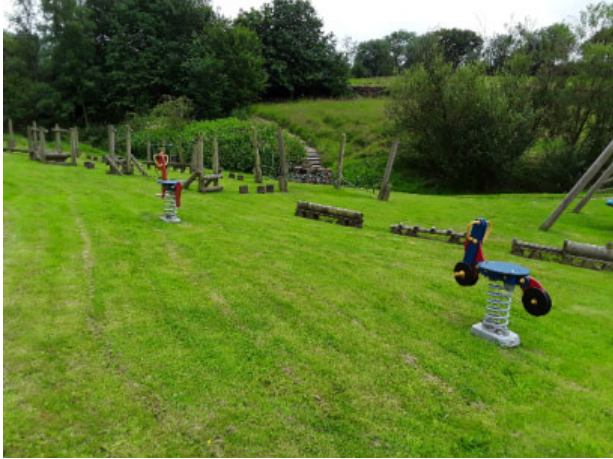
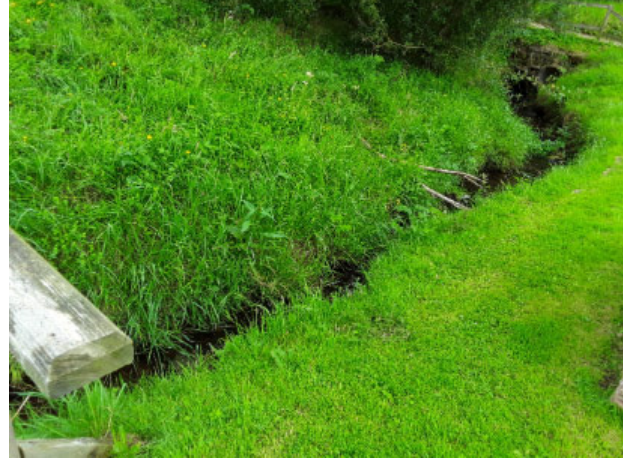
8 - Low Risk (Finding 2)

Finding: The beck could be hazardous to smaller children, especially when in flood

Action: Consider warning signage
