# Playdale Playgrounds

## Annual Inspection

Ainstable Parish Council

## Millennium Green

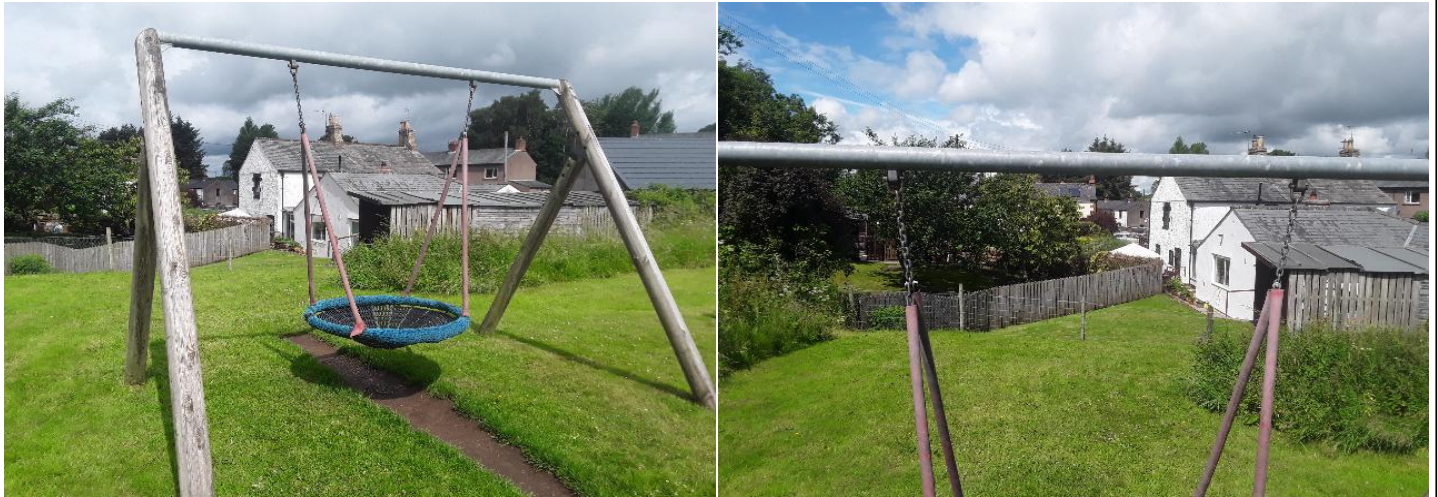
Swings of this design are recommended to have a secondary safety mechanism fitted to prevent collapse of the seat - Consider providing a secondary safety mechanism

**Finding:** Swings of this design are recommended to have a secondary safety mechanism fitted to prevent collapse of the seat  
**Action:** Consider providing a secondary safety mechanism

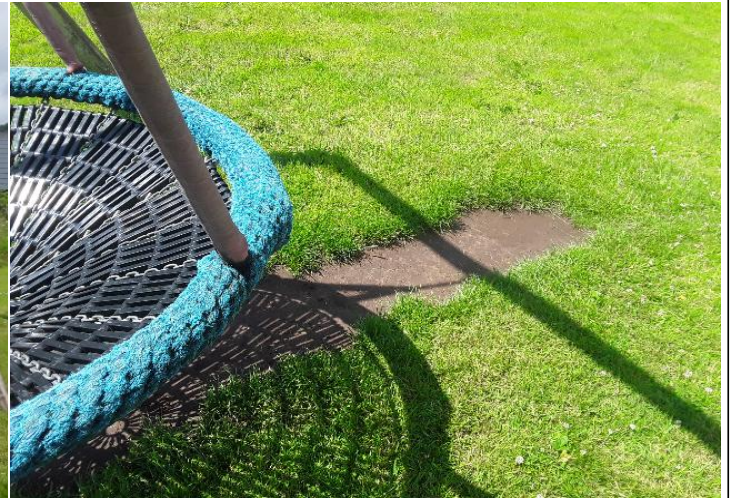
The openings between the slots in the Basket Seat form finger entrapments; whilst the swing is in motion - Monitor Use

**Finding:** The openings between the slots in the Basket Seat form finger entrapments; whilst the swing is in motion  
**Action:** Monitor Use

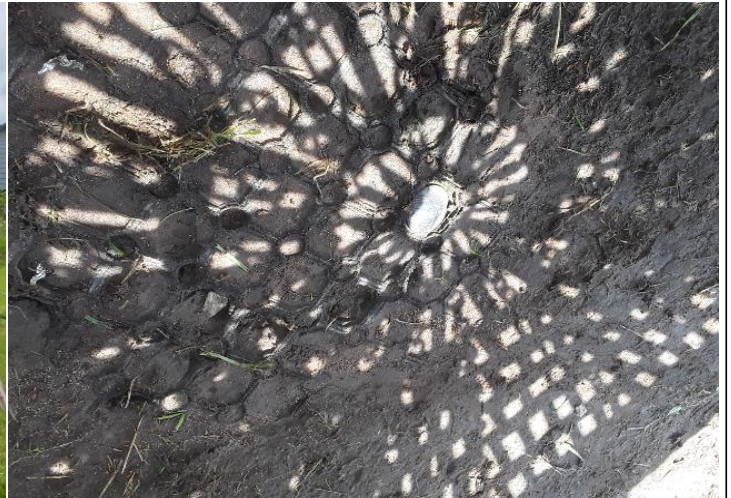
Fixing Pins have been installed in the impact area - Remove pins from impact area

**Finding:** Fixing Pins have been installed in the impact area **Action:** Remove pins from impact area

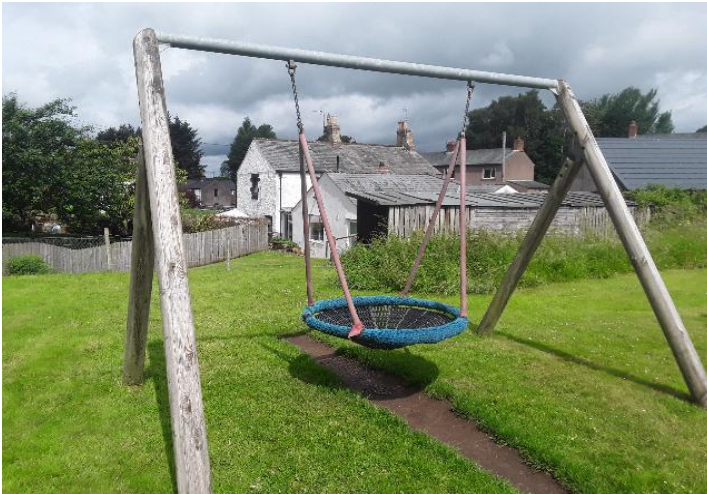
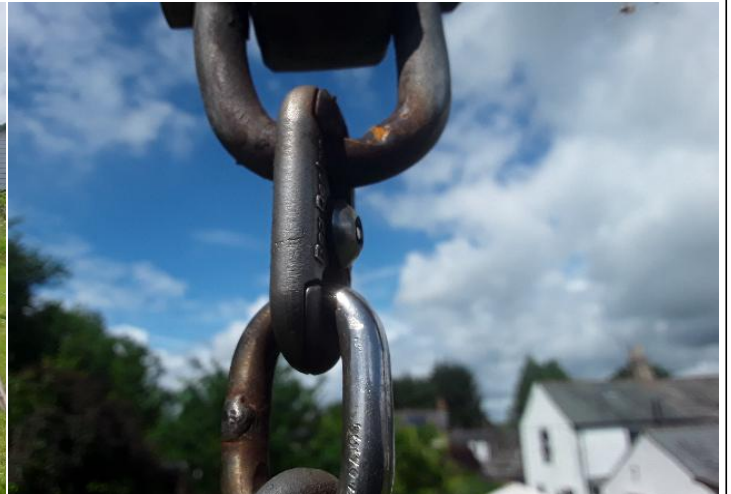
The shackles are showing wear - Grease the shackles (Done) and monitor for further deterioration

**Finding:** The shackles are showing wear **Action:** Grease the shackles (Done) and monitor for further deterioration

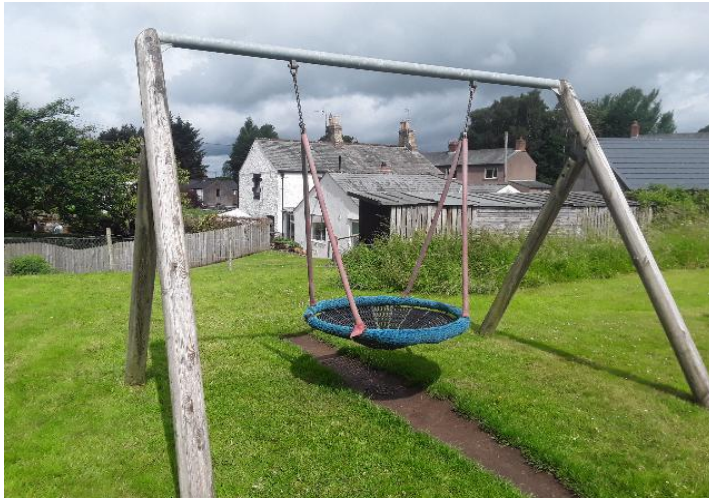
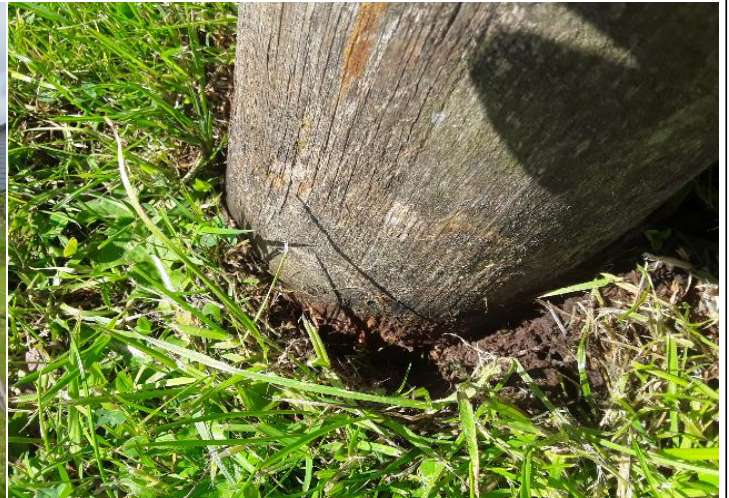
There is some evidence of rot in a leg - Monitor use

**Finding:** There is some evidence of rot in a leg

**Action:** Monitor use

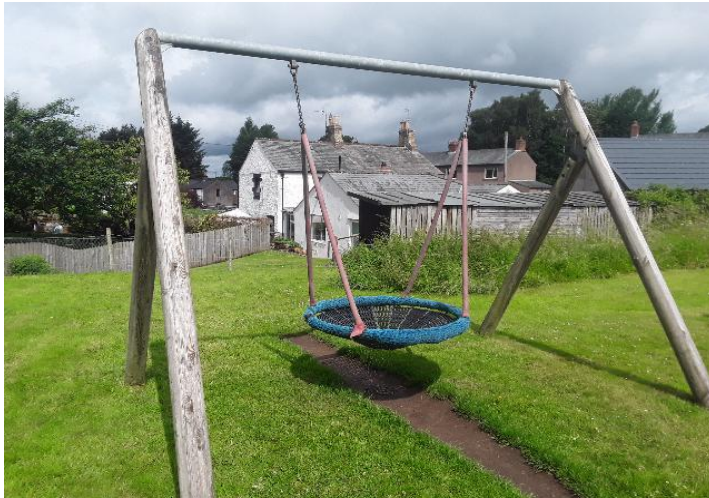
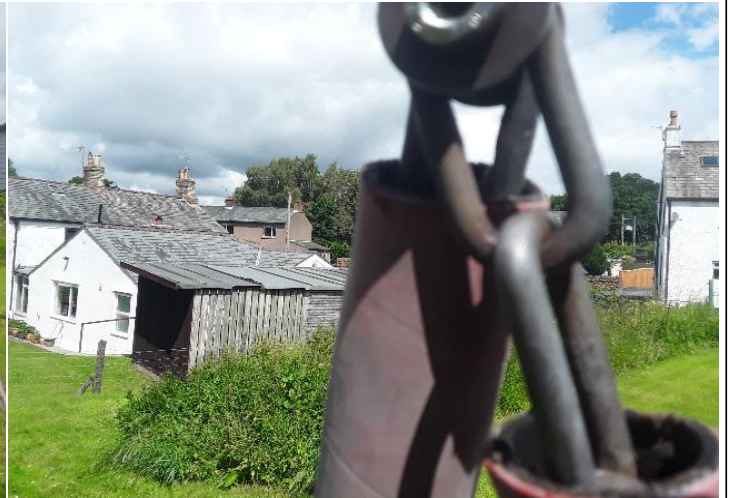
The large chain links are wearing, which may require attention next year - Monitor for any further deterioration

**Finding:** The large chain links are wearing, which may require attention next year

**Action:** Monitor for any further deterioration

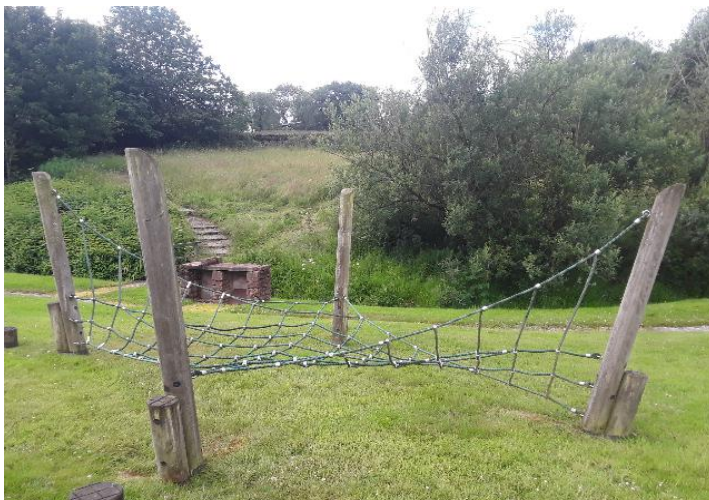
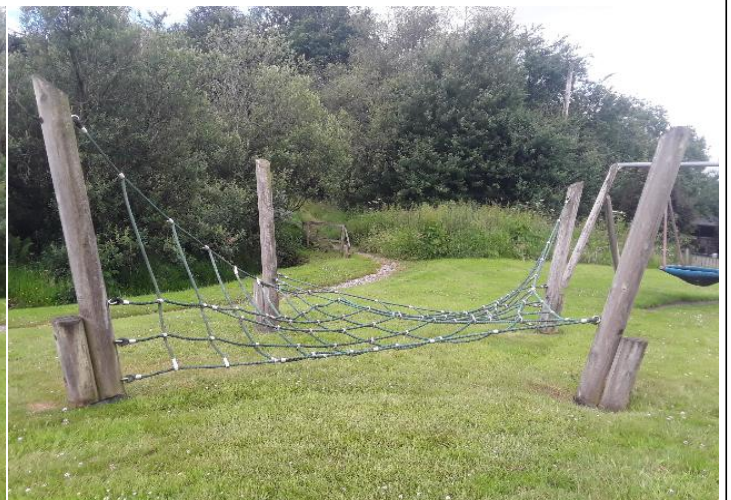
**Finding:** The web net is in satisfactory condition

**Action:** See below

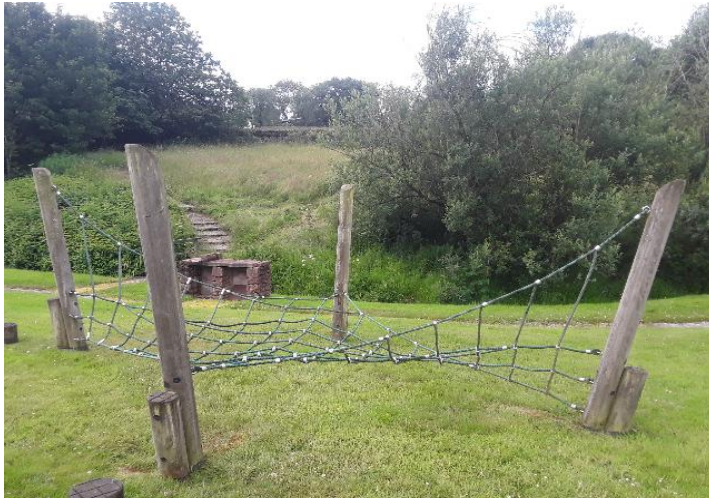
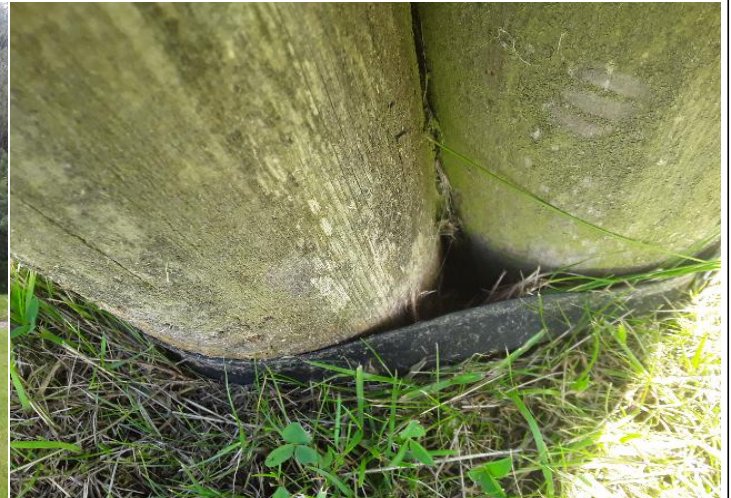
The step-up logs are starting to show rot - Monitor use

**Finding:** The step-up logs are starting to show rot

**Action:** Monitor use

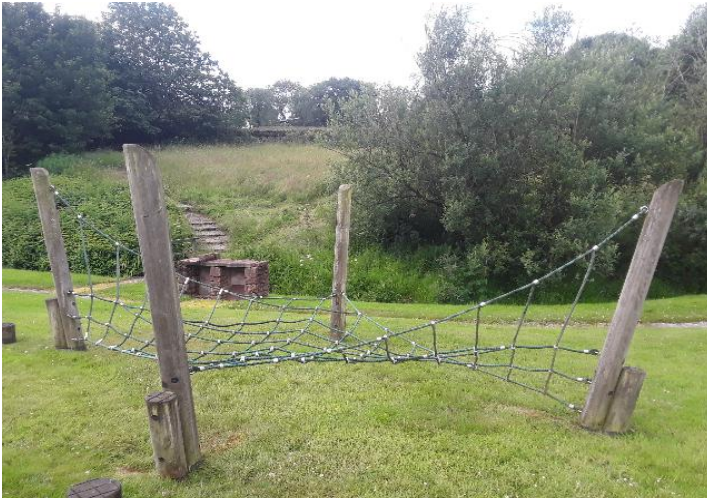
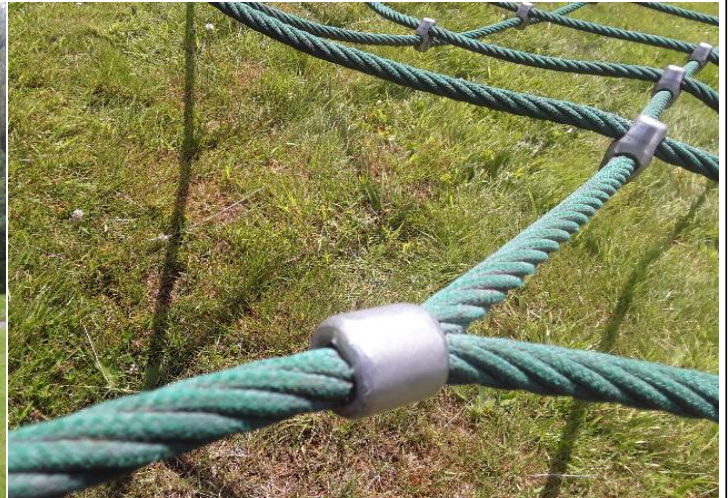
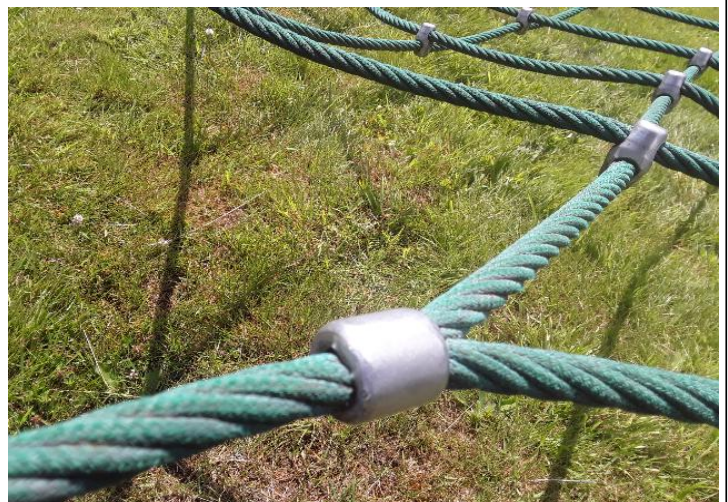
The net is starting to showing signs of wear and slight damage - Monitor for further deterioration

**Finding:** The net is starting to showing signs of wear and slight damage

**Action:** Monitor for further deterioration

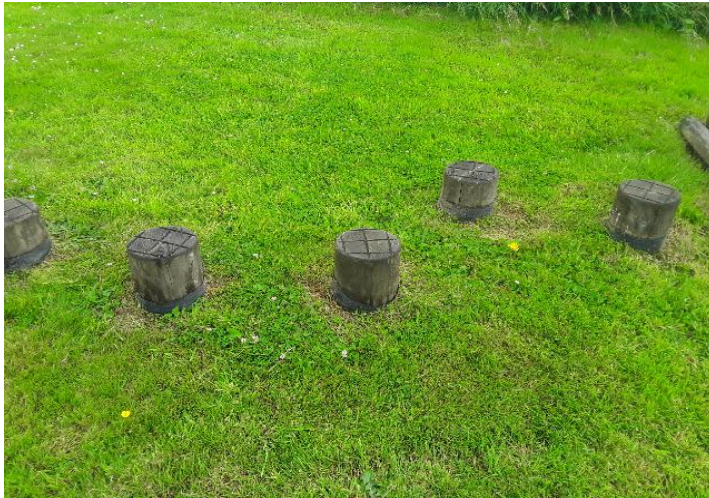
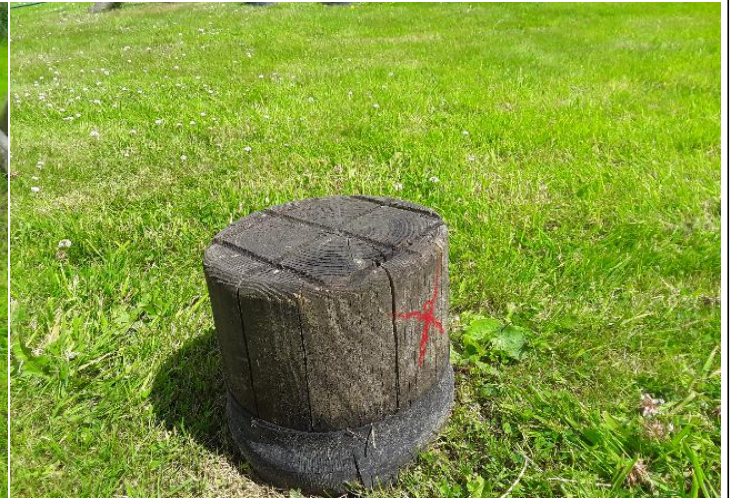
3no logs are rotten in the middle - Replace the rotten logs

**Finding:** 3no logs are rotten in the middle

**Action:** Replace the rotten logs

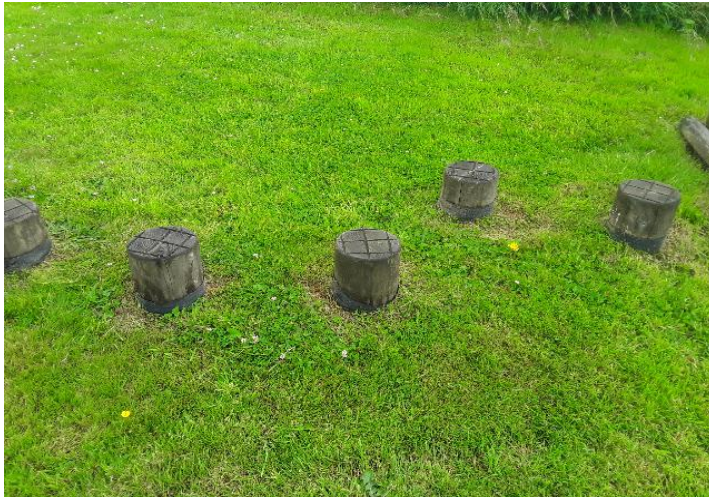
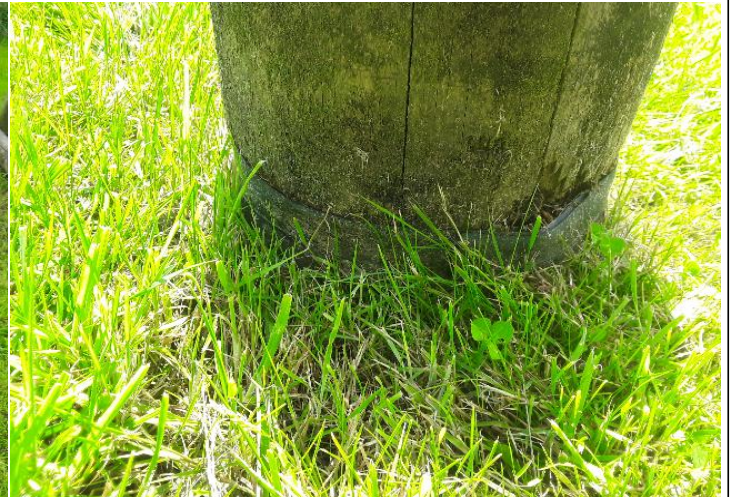
Some logs are showing slight rot - Monitor for any further deterioration

**Finding:** Some logs are showing slight rot

**Action:** Monitor for any further deterioration

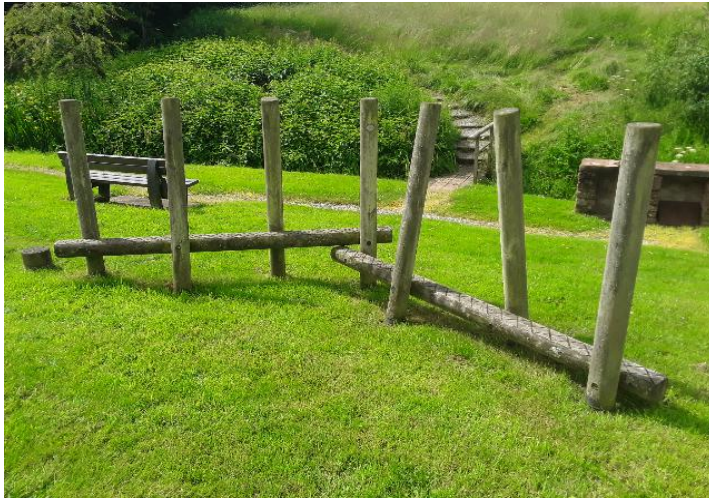
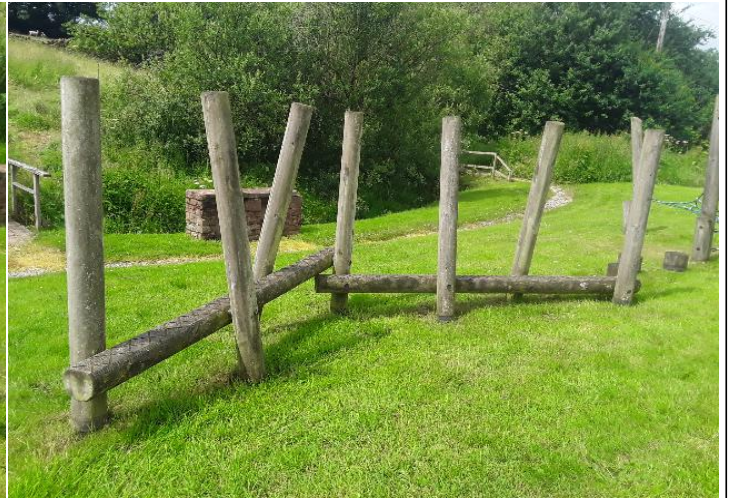
**Finding:** The intertwine is in satisfactory condition

**Action:** See below

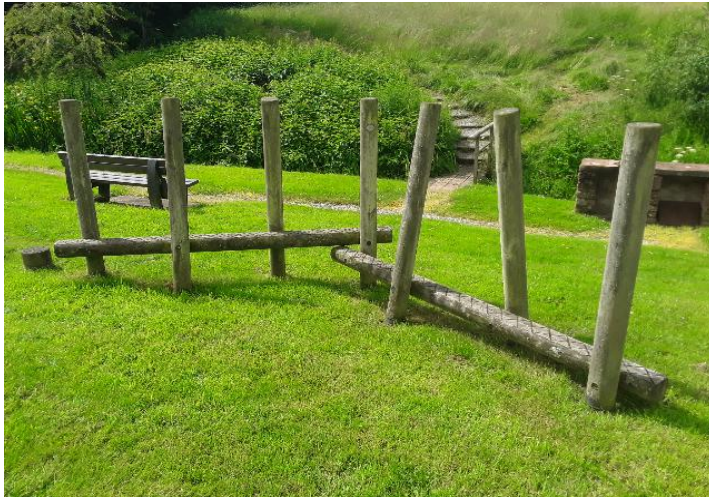
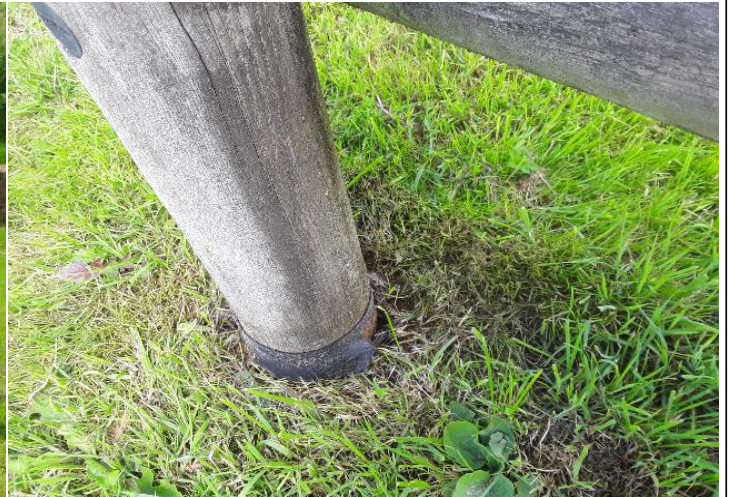
There is some evidence of rot in the timber - Monitor use

**Finding:** There is some evidence of rot in the timber

**Action:** Monitor use

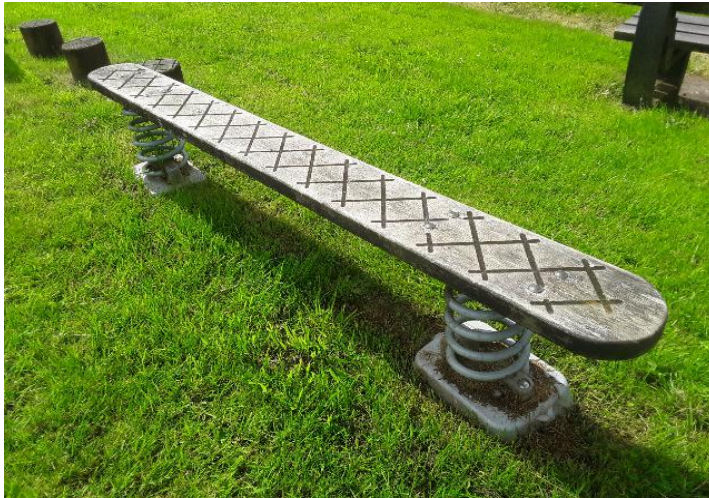
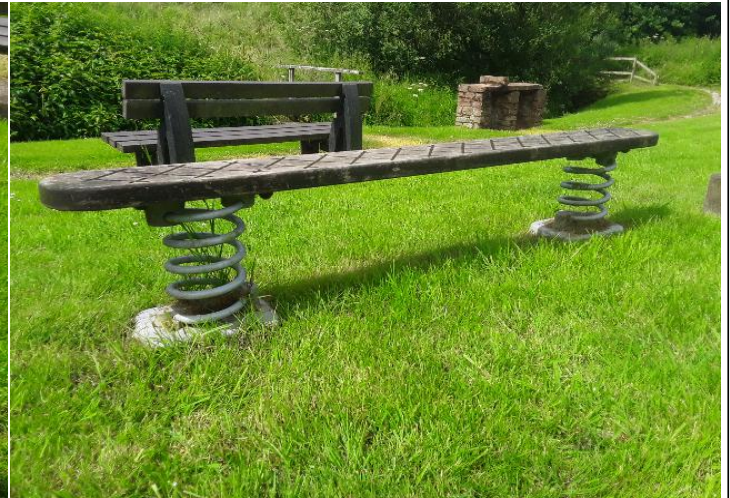
**Finding:** The wobble board is in satisfactory condition

**Action:** None required

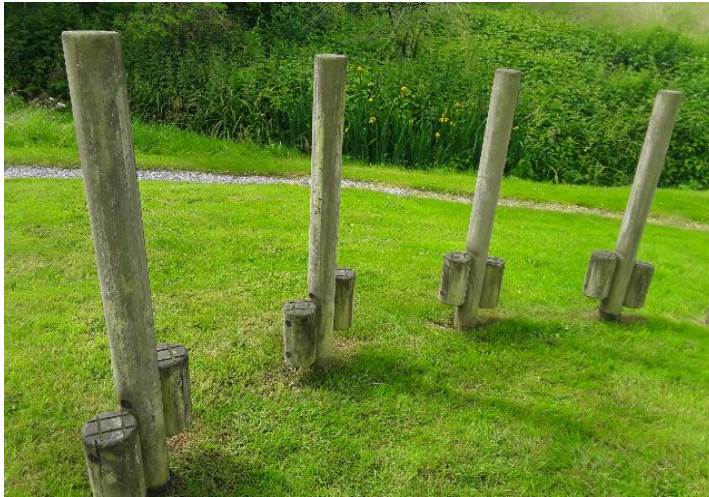
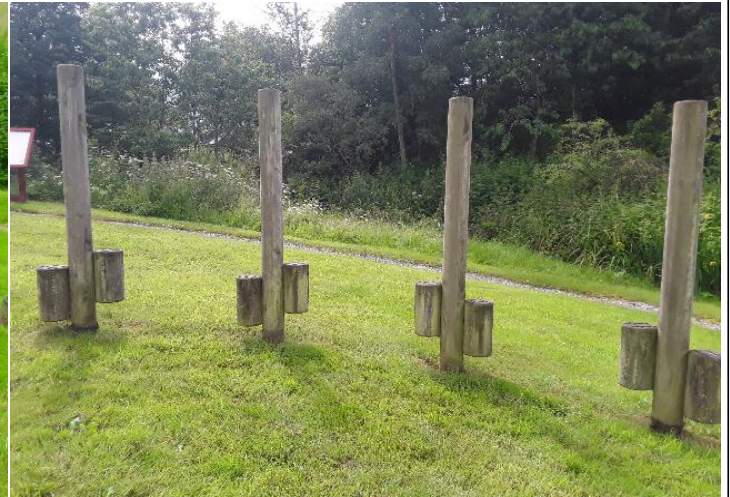
**Finding:** The stilts are in satisfactory condition

**Action:** See below

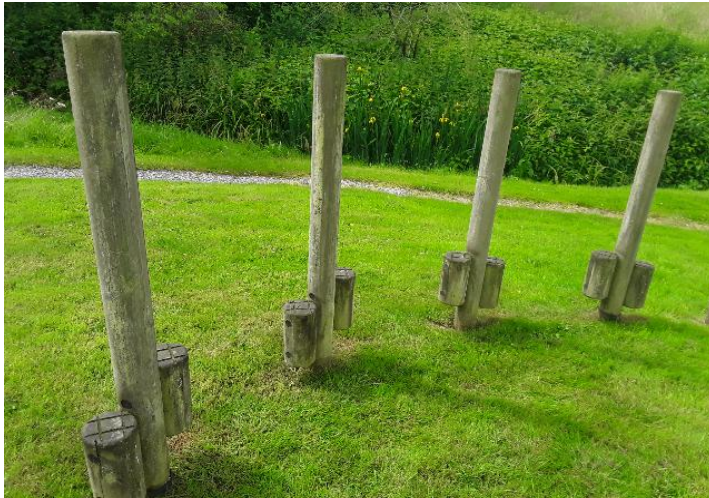
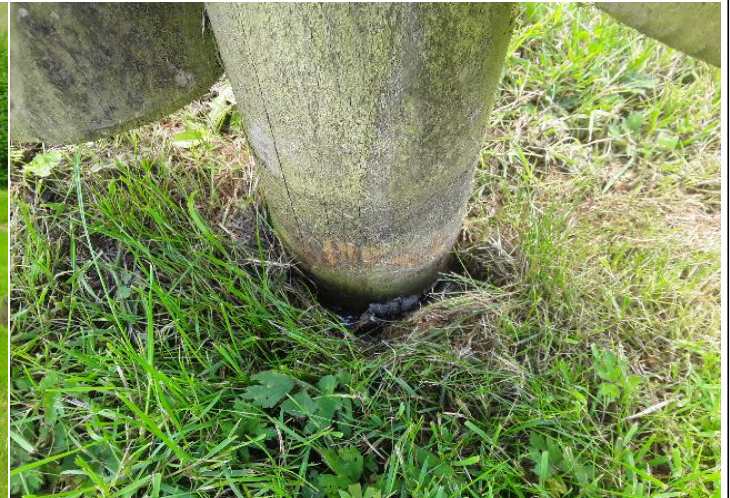
A stilt is showing rot - Monitor use

**Finding:** A stilt is showing rot

**Action:** Monitor use

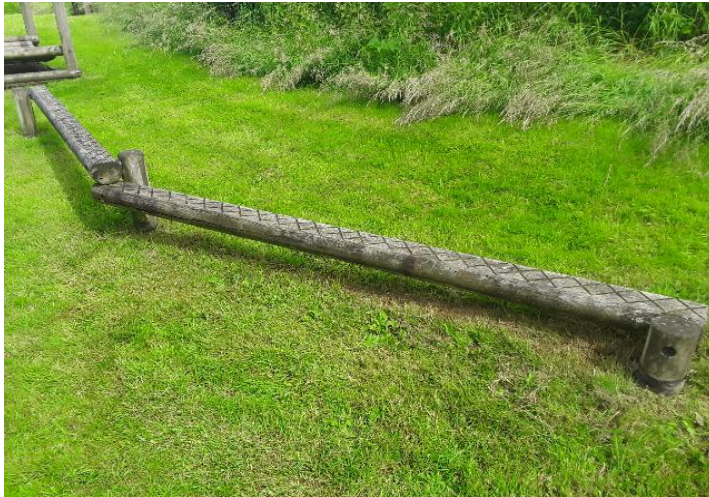
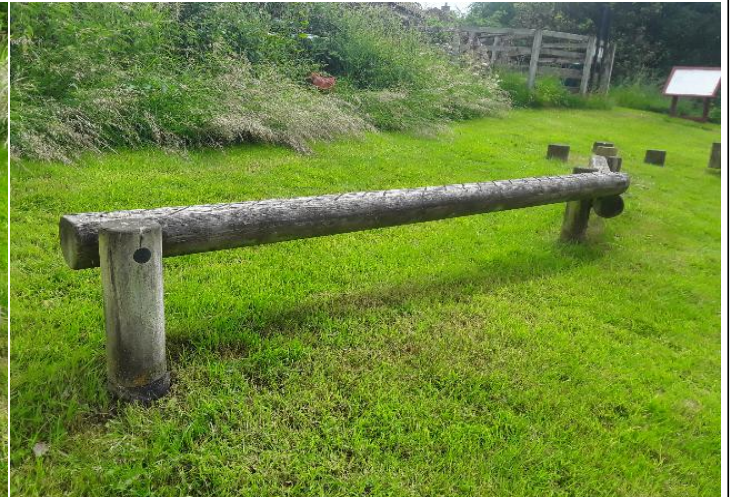
**Finding:** The twin balance beam is in satisfactory condition **Action:** None required

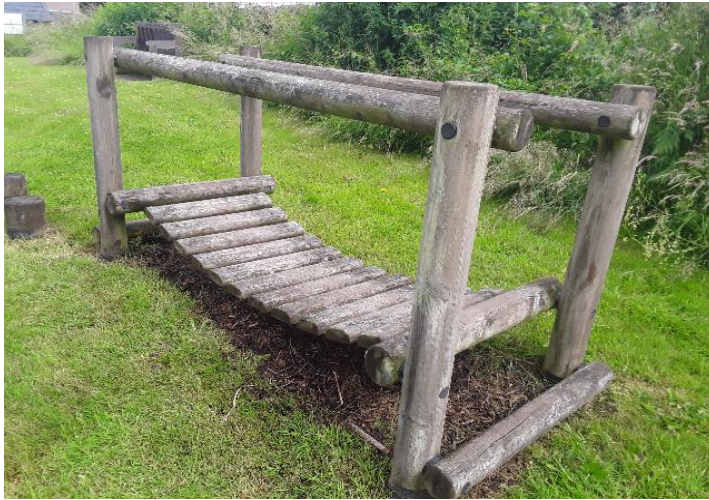
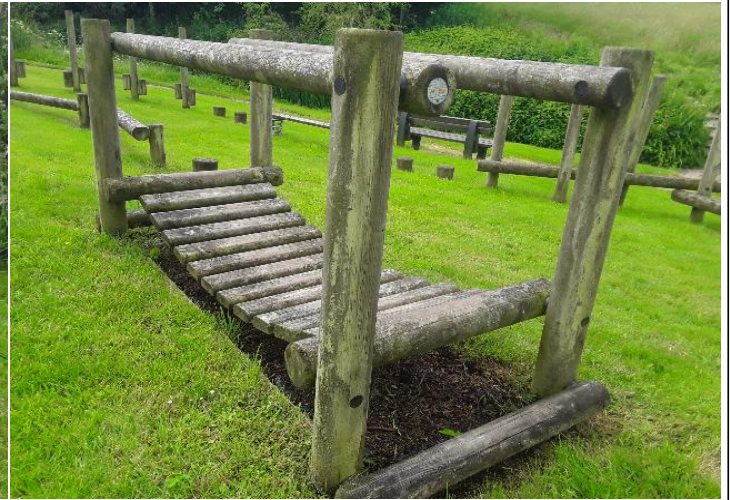
**Finding:** The mini-suspension bridge is in satisfactory condition

**Action:** None required

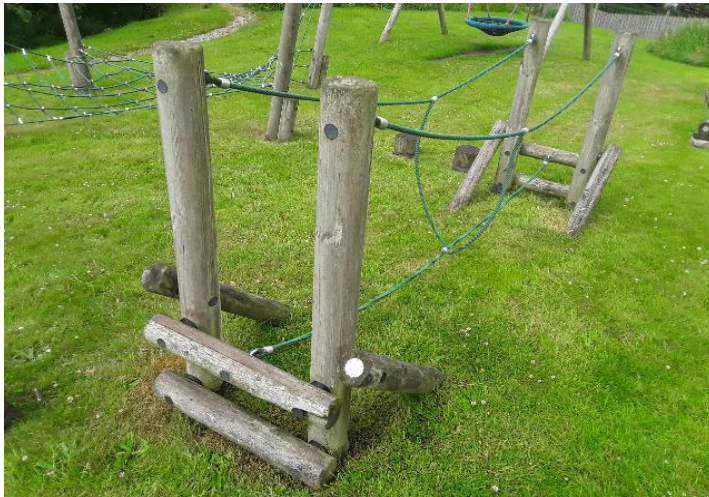
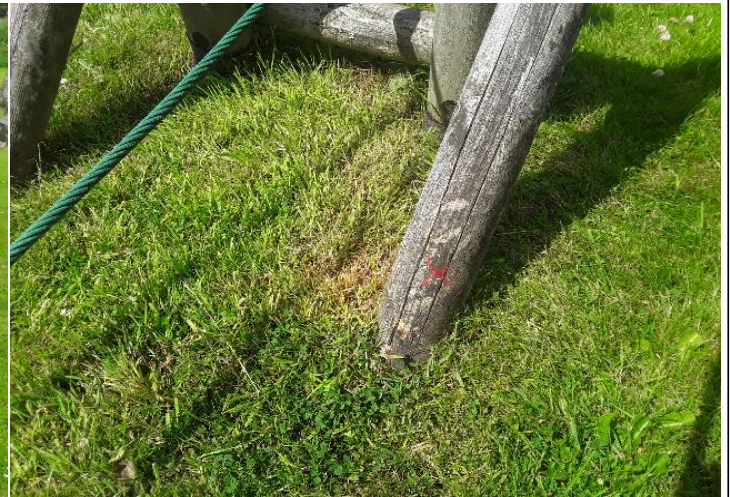
A strainer pole is rotten - Replace the rotten pole

**Finding:** A strainer pole is rotten

**Action:** Replace the rotten pole

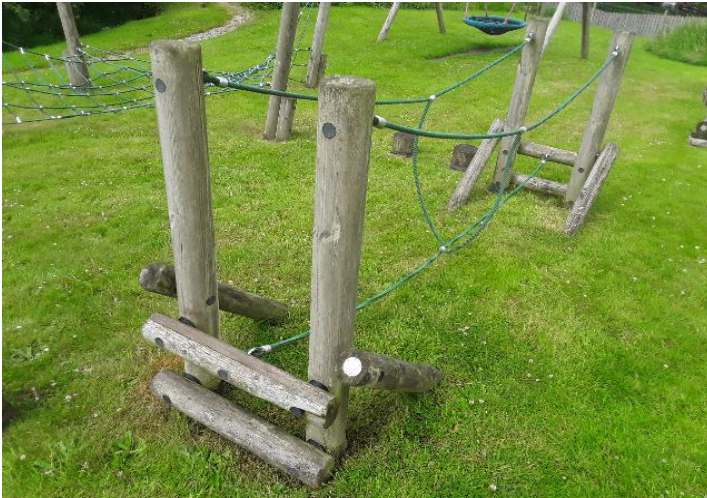
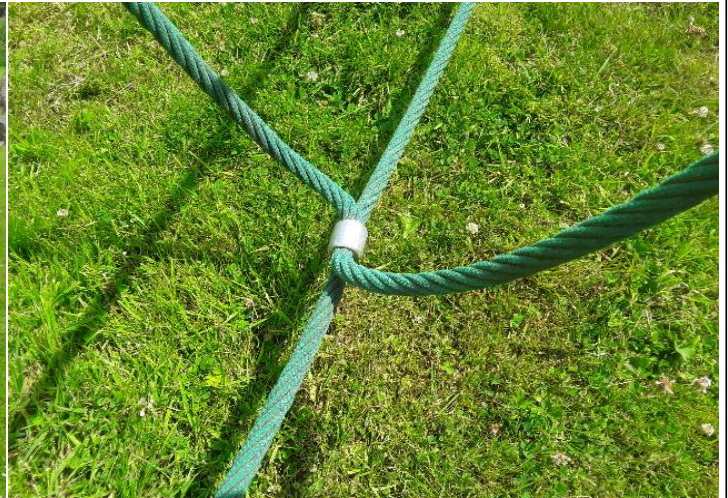
The bottom rope is showing slight damage, and signs of wear - None required

**Finding:** The bottom rope is showing slight damage, and signs of wear

**Action:** None required

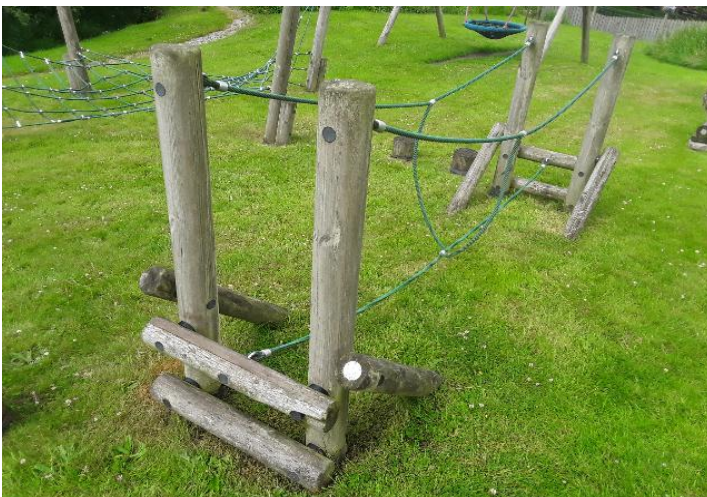
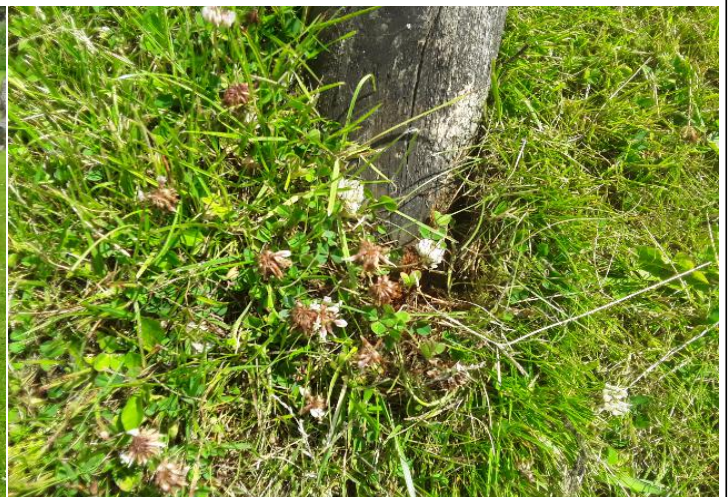
There is some evidence of rot in the timber - Monitor use

**Finding:** There is some evidence of rot in the timber

**Action:** Monitor use

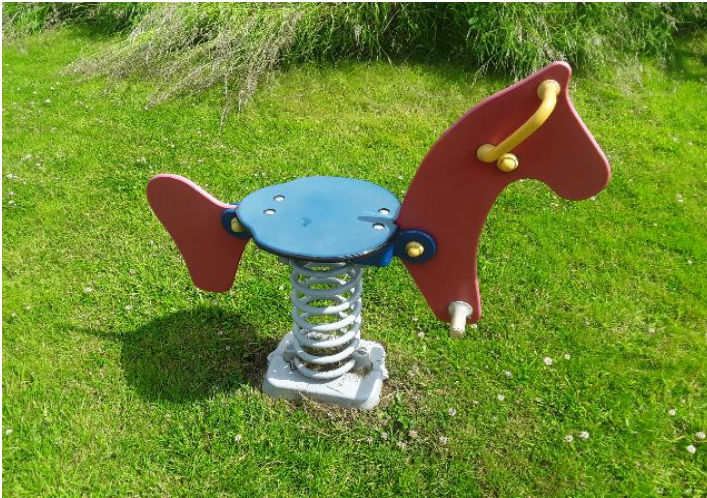
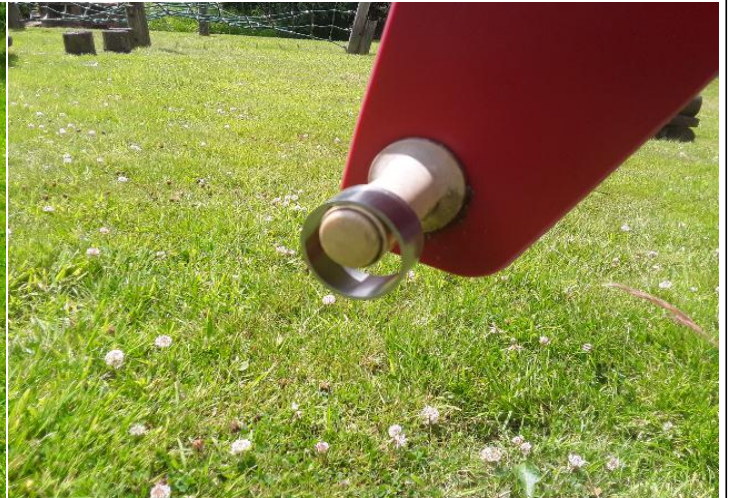
The ends of the footrests fail to meet the dimension requirements of BS EN 1176 - Monitor use

**Finding:** The ends of the footrests fail to meet the dimension requirements of BS EN 1176

**Action:** Monitor use

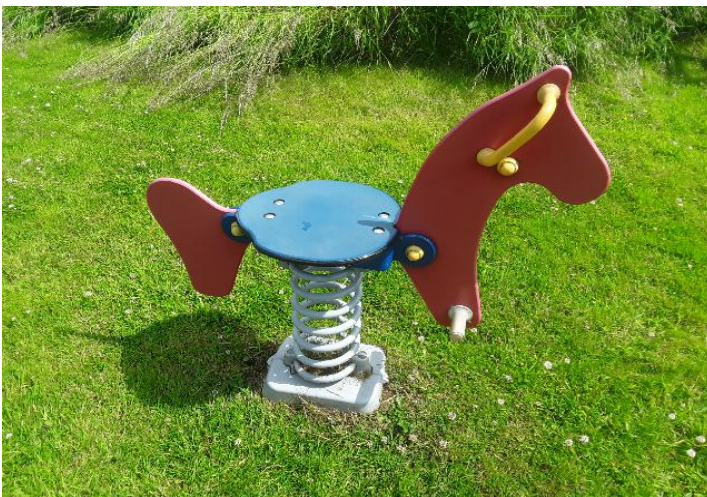
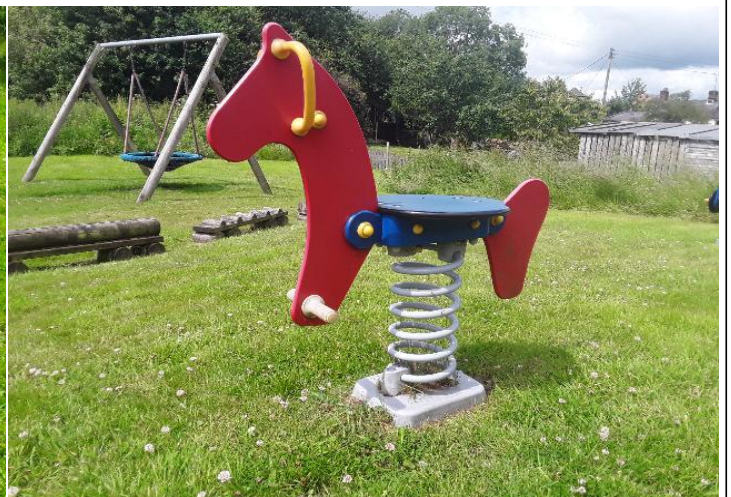
**Finding:** The spring horse is in satisfactory condition

**Action:** None required

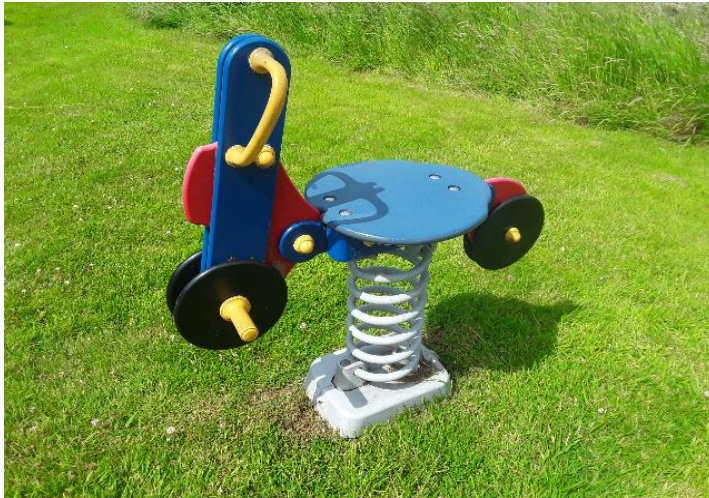
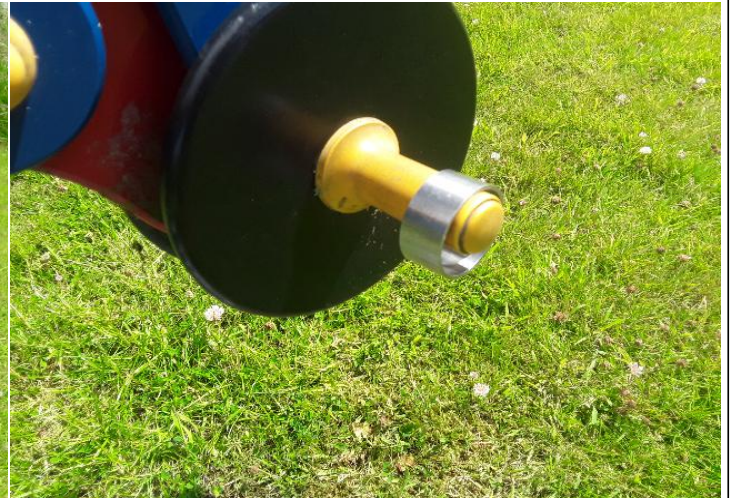
The footrests fail dimension requirements - Monitor use

**Finding:** The footrests fail dimension requirements

**Action:** Monitor use

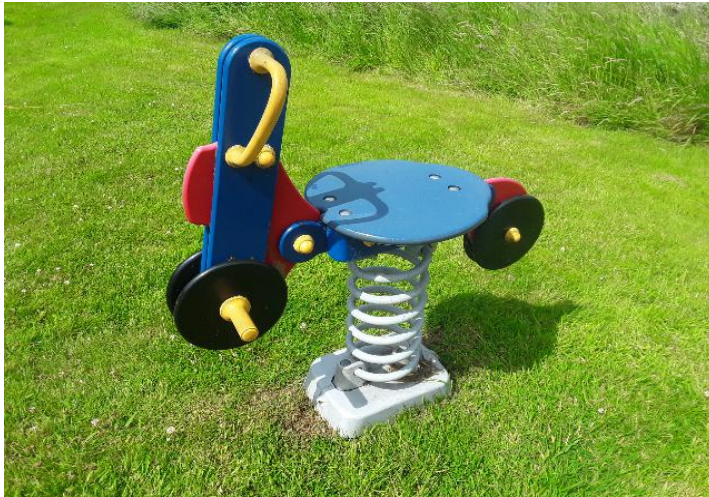
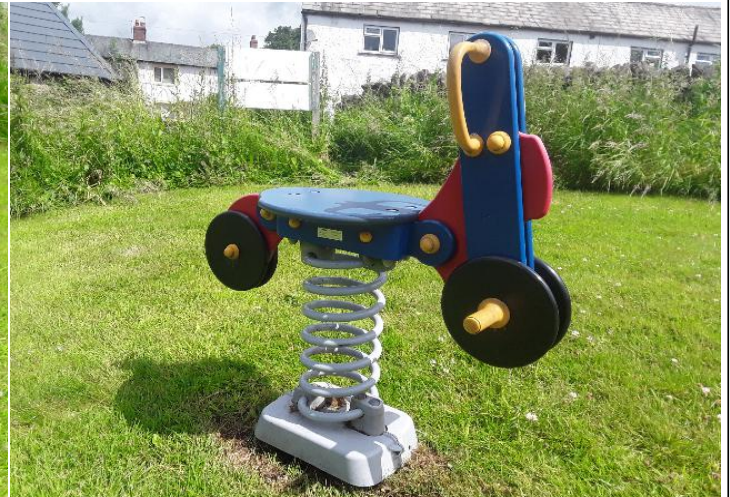
**Finding:** The Springer is in satisfactory condition

**Action:** None required

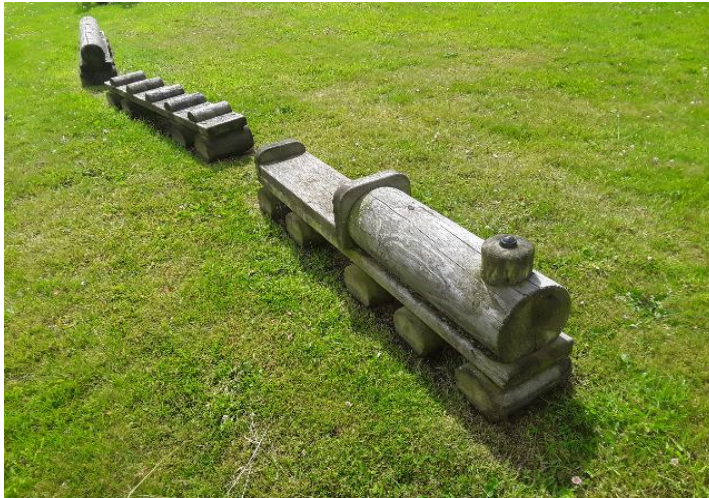
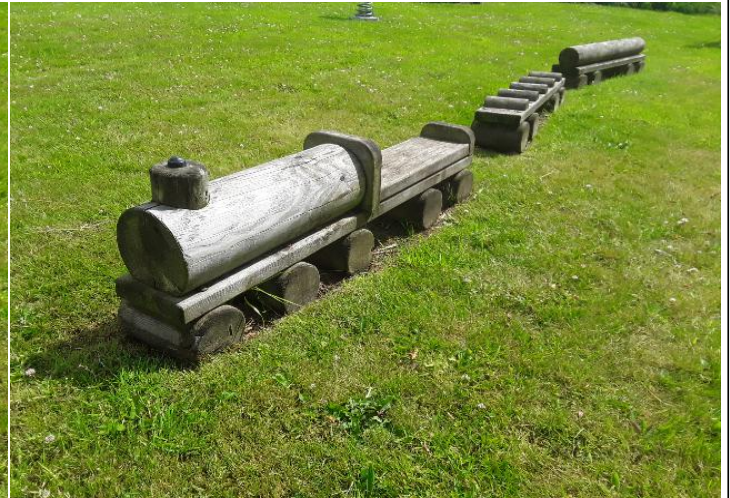
**Finding:** The train is in satisfactory condition

**Action:** None required

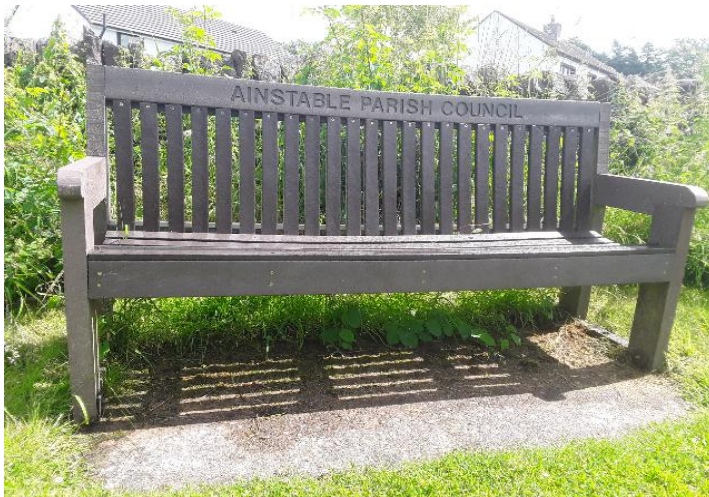
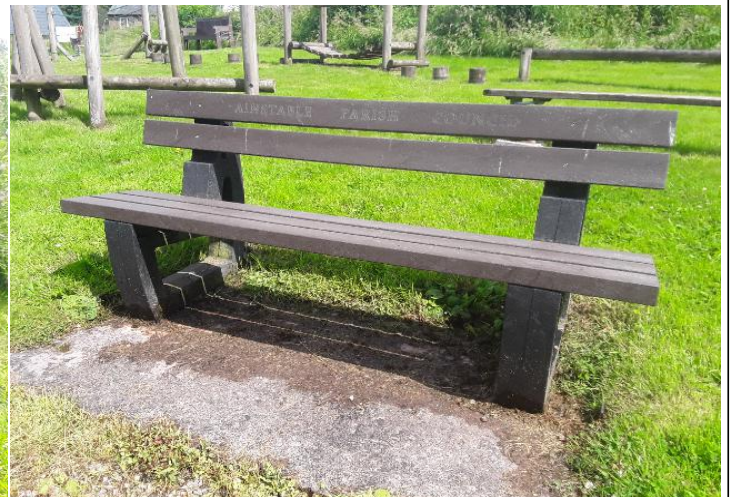
**Finding:** The seats are in good condition

**Action:** See below

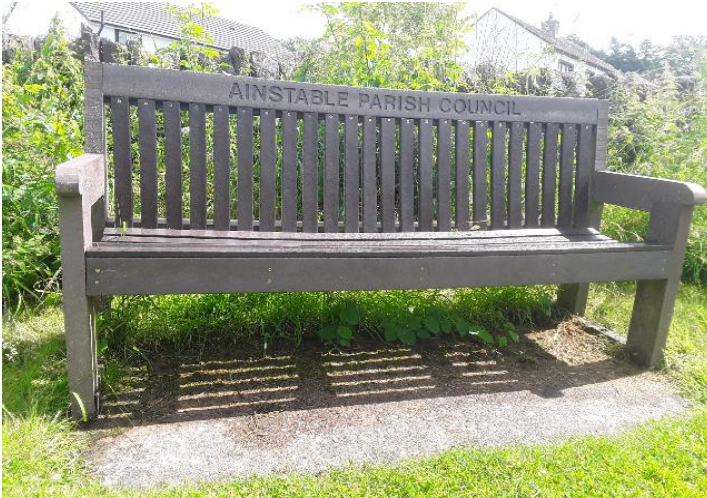
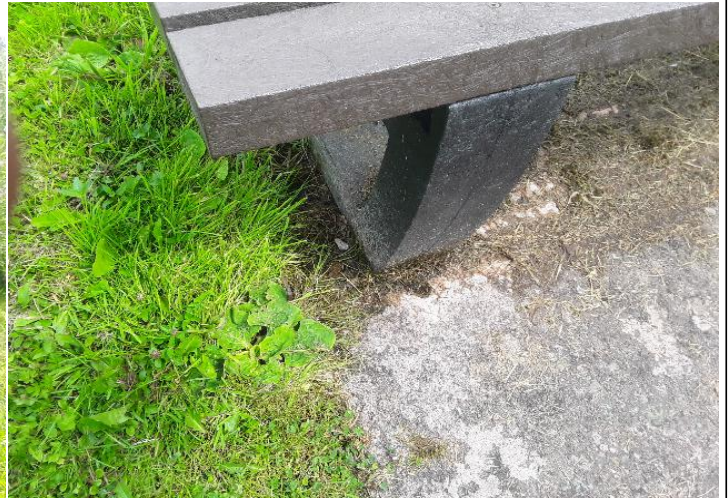
A seat is slightly loose on its ground fixings - Monitor for further deterioration

**Finding:** A seat is slightly loose on its ground fixings

**Action:** Monitor for further deterioration

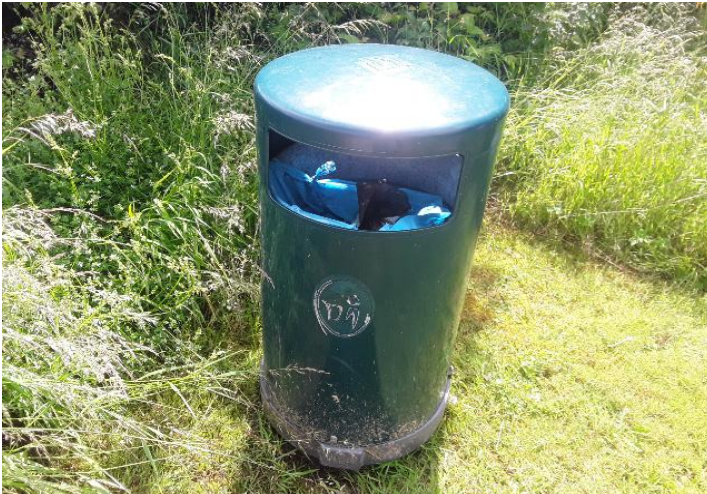
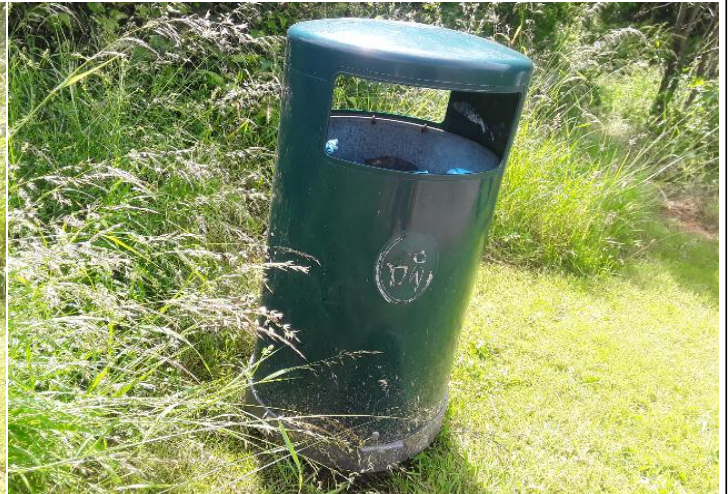
**Finding:** The bin is in satisfactory condition

**Action:** See below

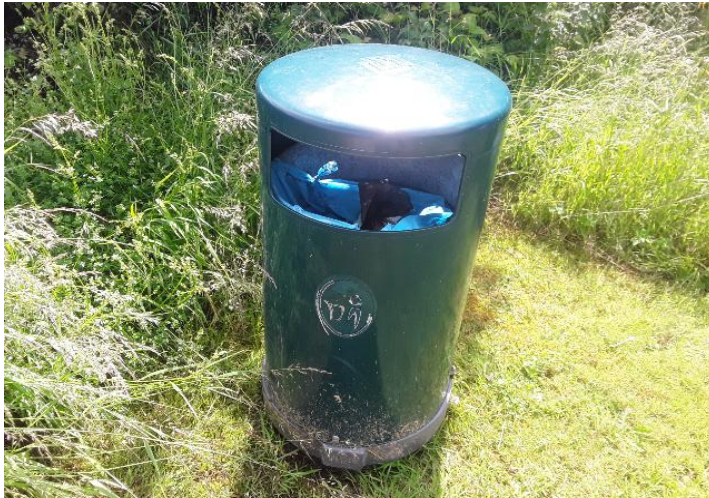
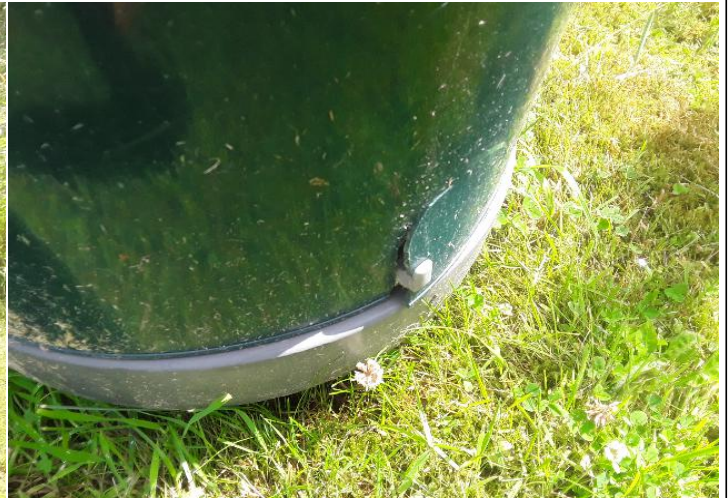
The bin is showing slight damage - Monitor

**Finding:** The bin is showing slight damage

**Action:** Monitor

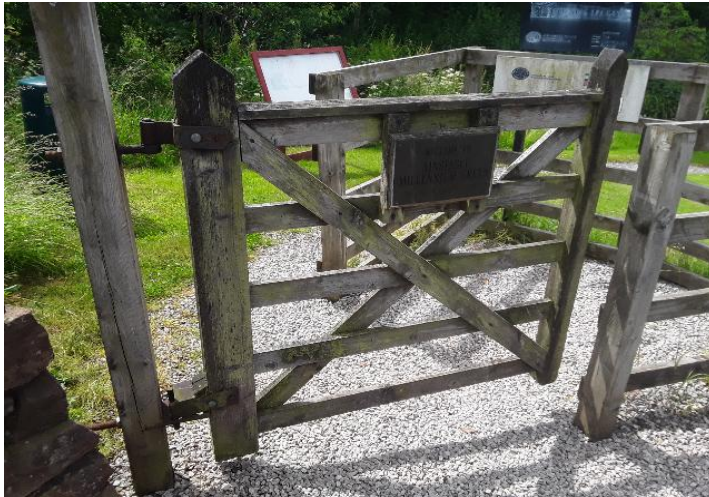
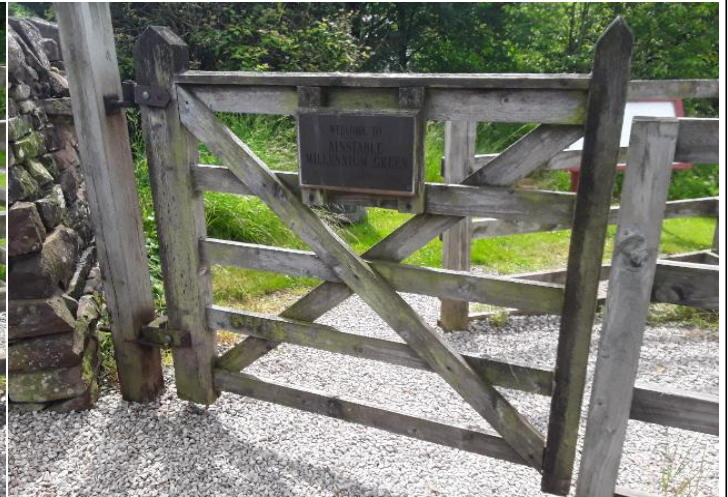
**Finding:** The gate is in satisfactory condition

**Action:** None required
