# Playdale Playgrounds

## Annual Inspection

Ainstable Parish Council

## Millennium Green

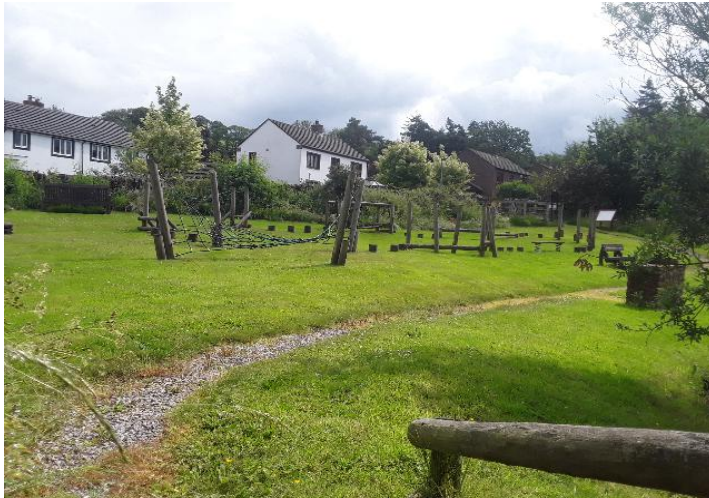
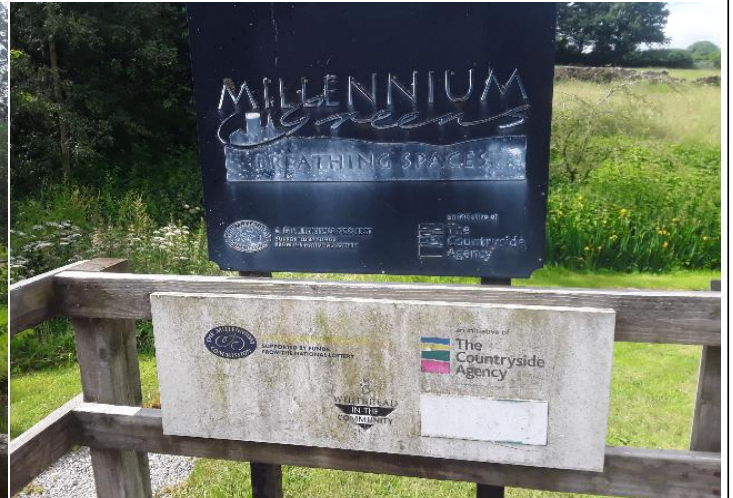
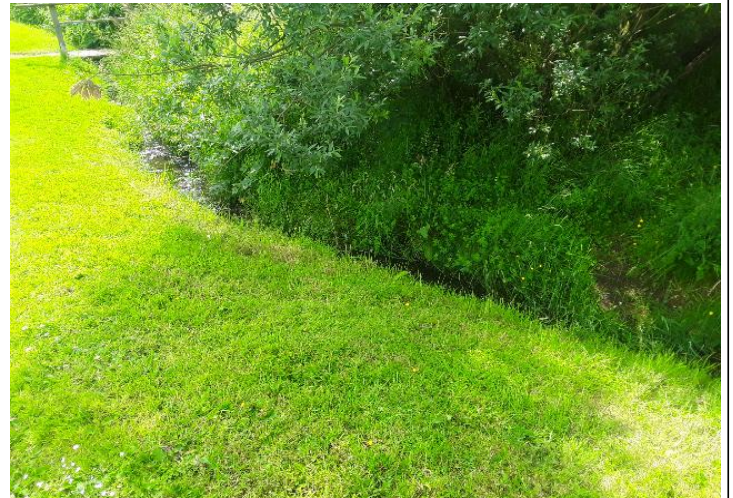
It is recommended that information signs with emergency contact details are installed at each entrance/exit point to the playground - Provide in accordance with the recommendations set out in BS EN 1176, also mentioning the beck as a water hazard

**Finding:** It is recommended that information signs with emergency contact details are installed at each entrance/exit set out in BS EN 1176, also mentioning the beck as a water hazard

**Action:** Provide in accordance with the recommendations set out in BS EN 1176, also mentioning the beck as a water hazard

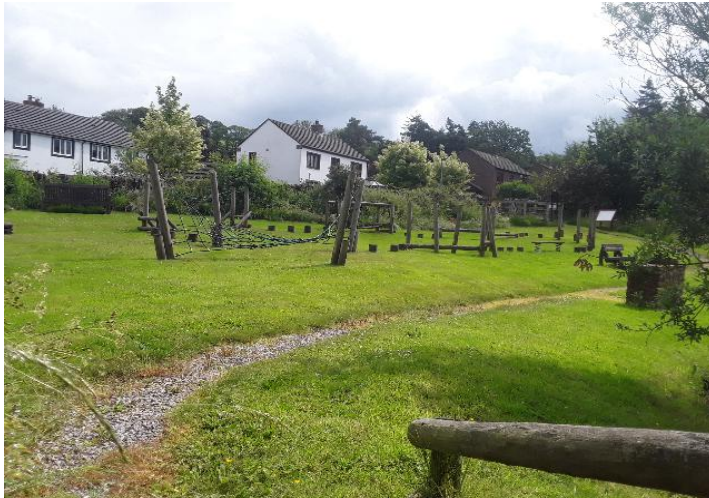
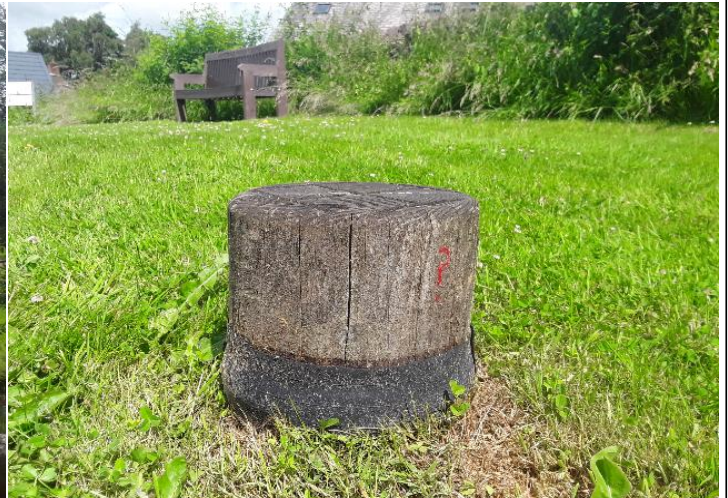
The covering on the bottom of the poles may cause rot, due to been damp. N.B Stimmer damage can also lead to rot - Monitor for deterioration of the poles

**Finding:** The covering on the bottom of the poles may cause rot, due to been damp. N.B Stimmer damage can also lead to rot

**Action:** Monitor for deterioration of the poles

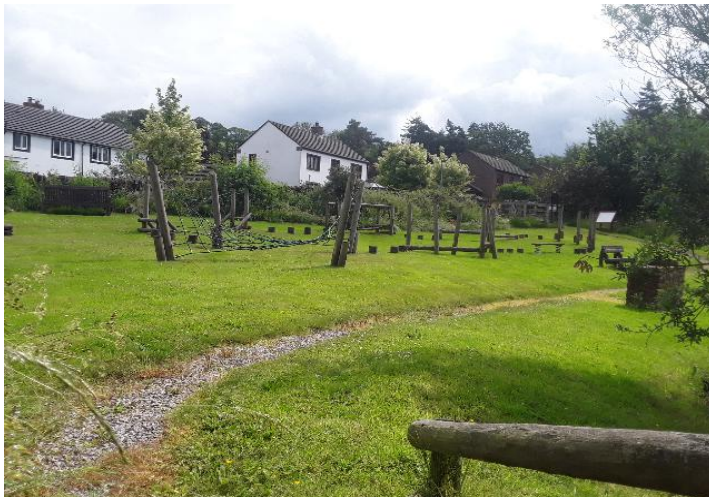
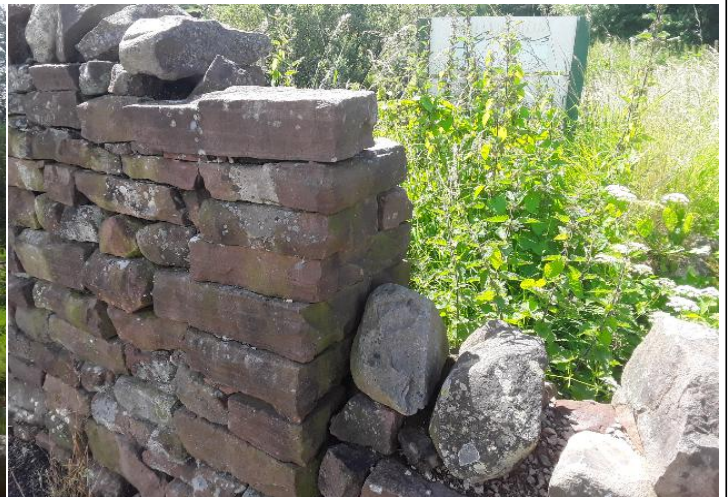
Part of the wall is becoming unstable - Repair as required

**Finding:** Part of the wall is becoming unstable

**Action:** Repair as required
