# Playdale Playgrounds

## Annual Inspection

Ainstable Parish Council

Millennium Green  
Main Street, Ainstable, Cumbria,

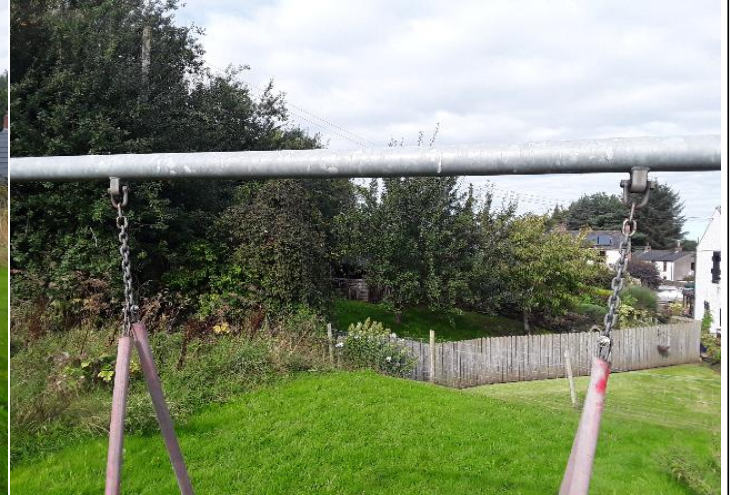
**Item:** Swings - Basket Swing - Type 1  
**Manufacturer:** Playdale Playgrounds Ltd

Basket swings are recommended to have a secondary safety mechanism fitted to prevent collapse of the seat - Consider providing a secondary safety mechanism

**Finding:** Basket swings are recommended to have a secondary safety mechanism fitted to prevent collapse of the seat

**Action:** Consider providing a secondary safety mechanism

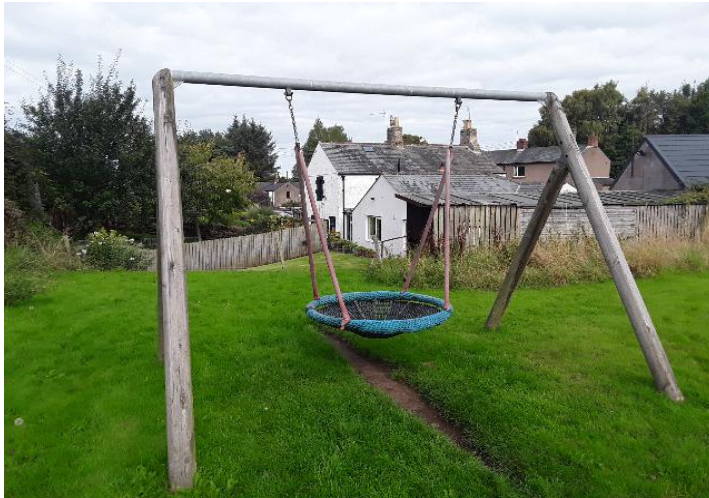
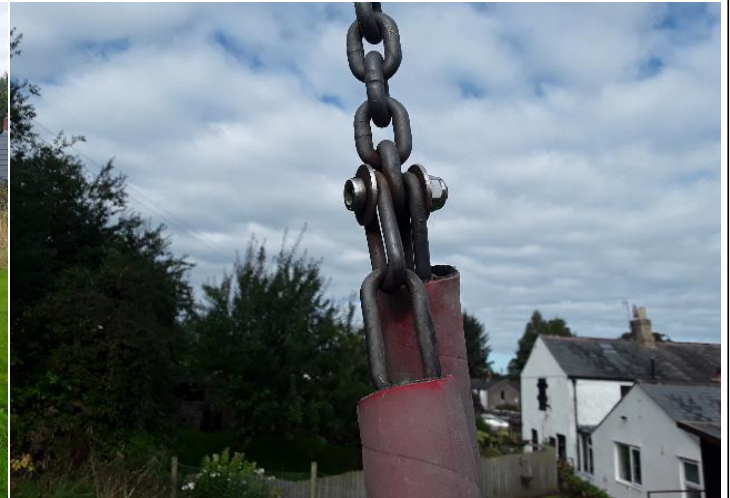
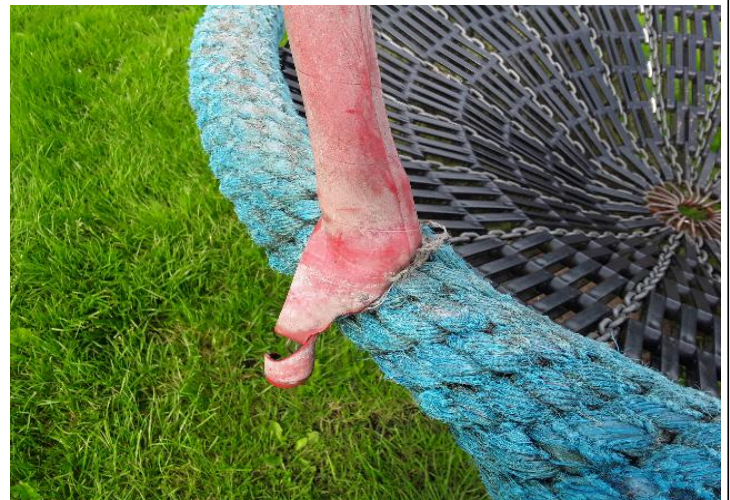
**Item:** Swings - Basket Swing - Type 1  
**Manufacturer:** Playdale Playgrounds Ltd

The exposed chain openings are in excess of 8.6mm - Refit and tape the damaged hose (Done whilst on site)

**Finding:** The exposed chain openings are in excess of 8.6mm

**Action:** Refit and tape the damaged hose (Done whilst on site)

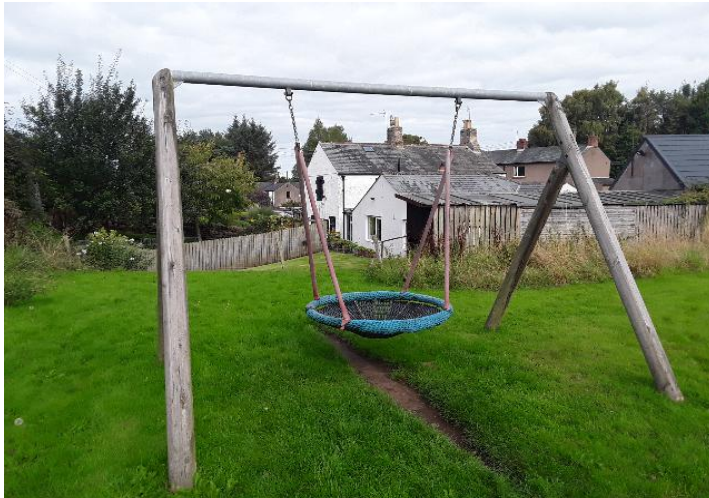
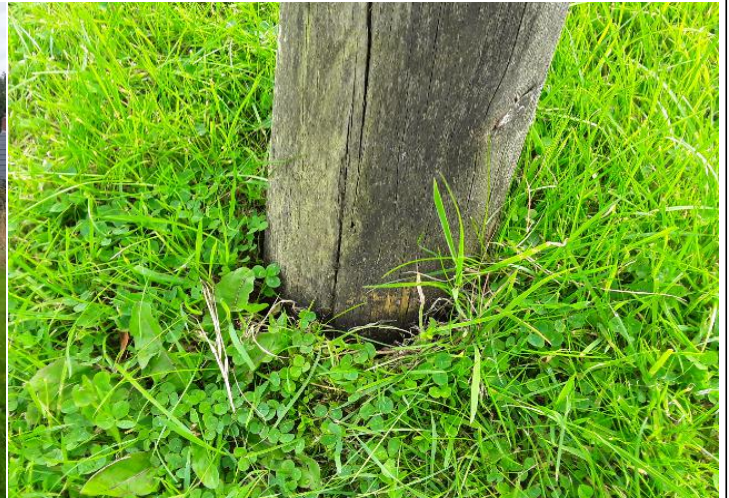
**Item:** Swings - Basket Swing - Type 1  
**Manufacturer:** Playdale Playgrounds Ltd

There is some evidence of rot in a leg - Monitor use

**Finding:** There is some evidence of rot in a leg

**Action:** Monitor use

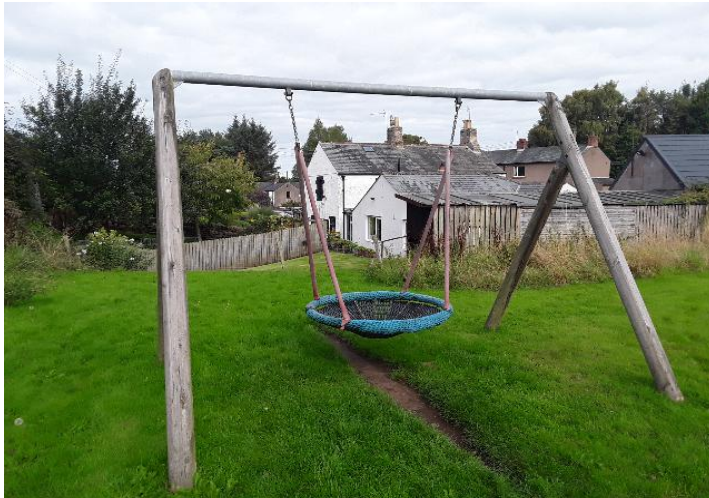
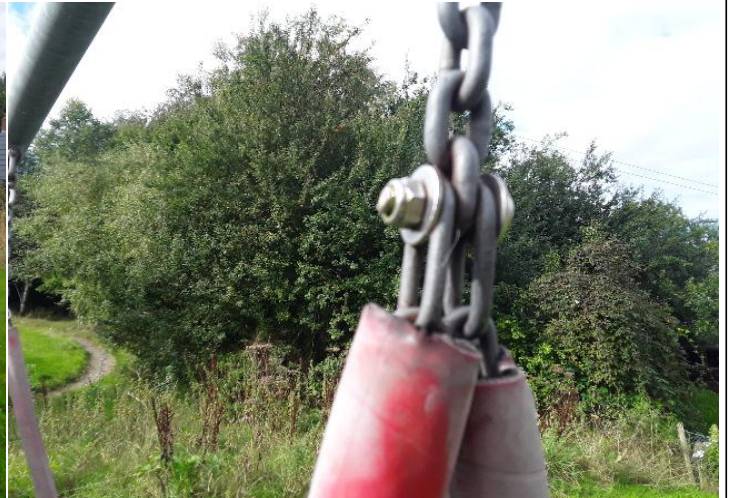
**Item:** Swings - Basket Swing - Type 1  
**Manufacturer:** Playdale Playgrounds Ltd

The large chain links are wearing, which may require attention next year - Monitor for any further deterioration and replace as required

**Finding:** The large chain links are wearing, which may require attention next year

**Action:** Monitor for any further deterioration and replace as required

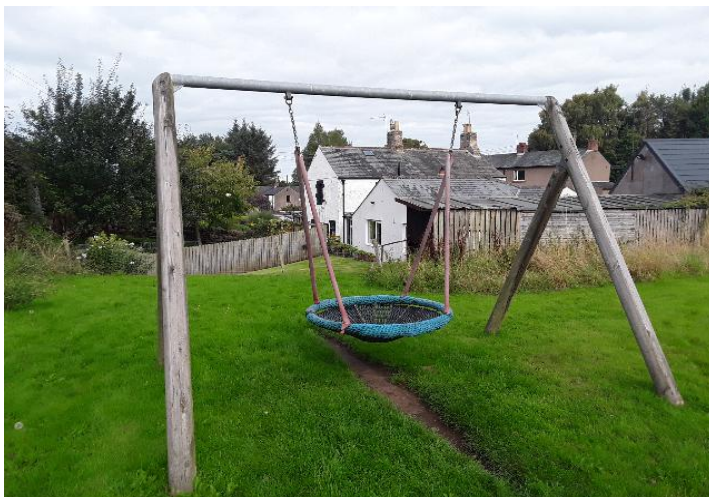
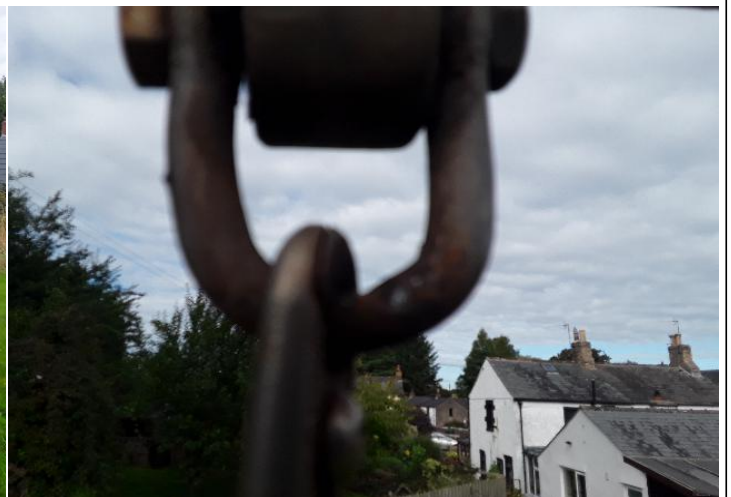
**Item:** Swings - Basket Swing - Type 1  
**Manufacturer:** Playdale Playgrounds Ltd

The shackles are showing wear - Monitor for further deterioration

**Finding:** The shackles are showing wear

**Action:** Monitor for further deterioration

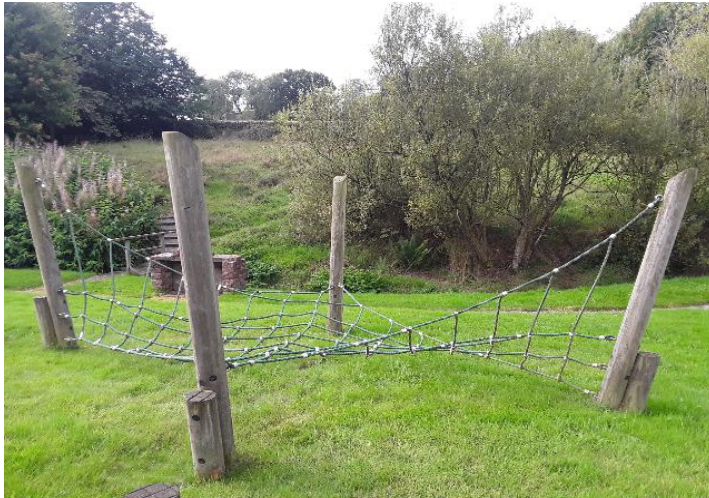
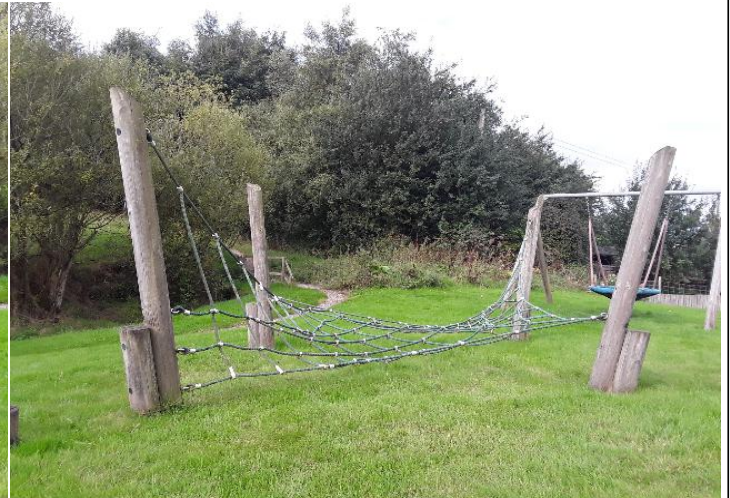
**Item:** Activity Equipment - Net Climber  
**Manufacturer:** Playdale Playgrounds Ltd

**Finding:** The web net is in satisfactory condition

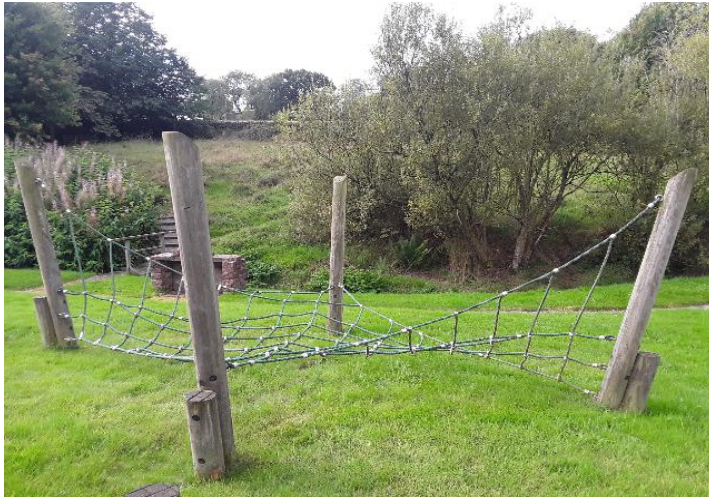
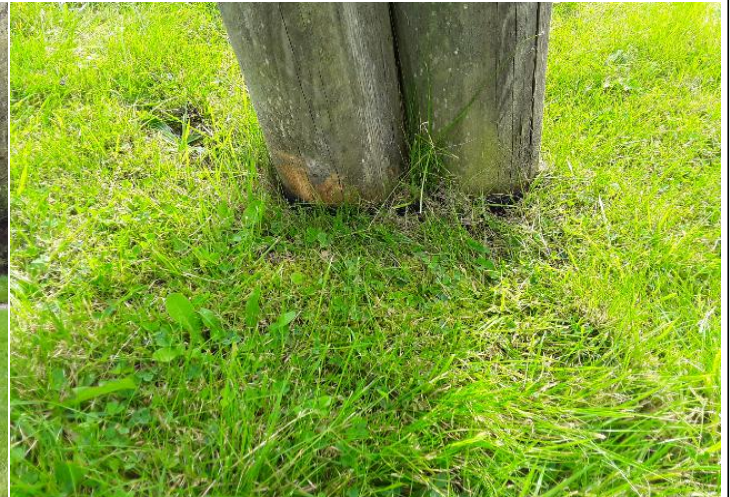
**Item:** Activity Equipment - Net Climber  
**Manufacturer:** Playdale Playgrounds Ltd

There is rot are starting in places - Monitor for any deterioration

**Finding:** There is rot are starting in places

**Action:** Monitor for any deterioration

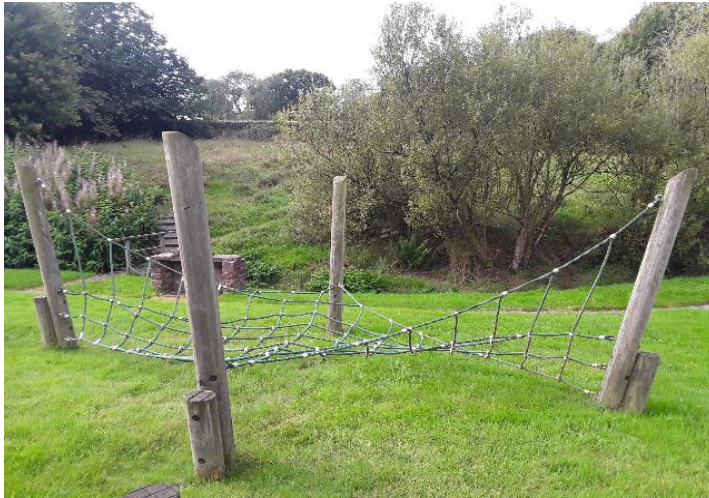
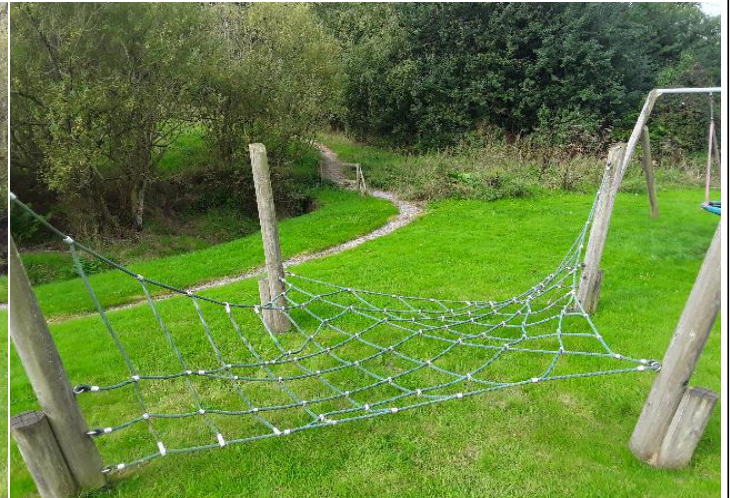
**Item:** Activity Equipment - Net Climber  
**Manufacturer:** Playdale Playgrounds Ltd

The net is starting to showing signs of wear and slight damage - Monitor for further deterioration

**Finding:** The net is starting to showing signs of wear and slight damage

**Action:** Monitor for further deterioration

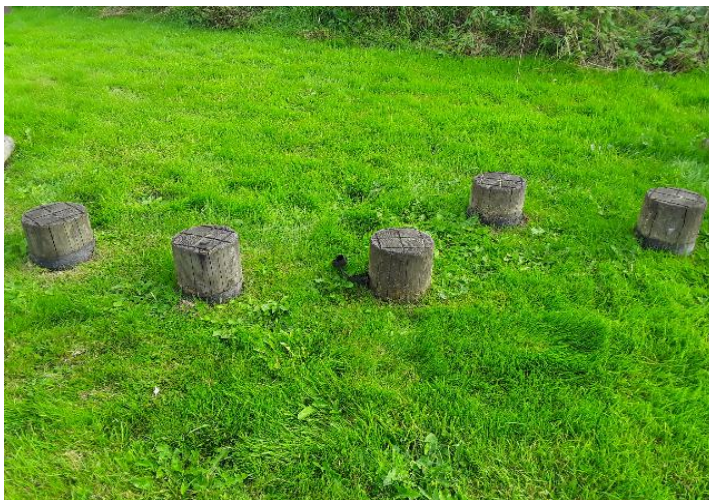
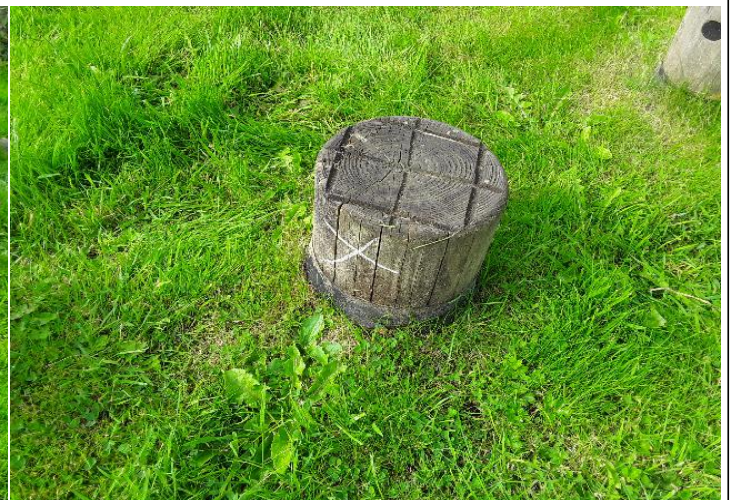
**Item:** Activity Equipment - Log Walk  
**Manufacturer:** Playdale Playgrounds Ltd

6no logs are rotten in the middle - Replace the rotten logs

**Finding:** 6no logs are rotten in the middle

**Action:** Replace the rotten logs

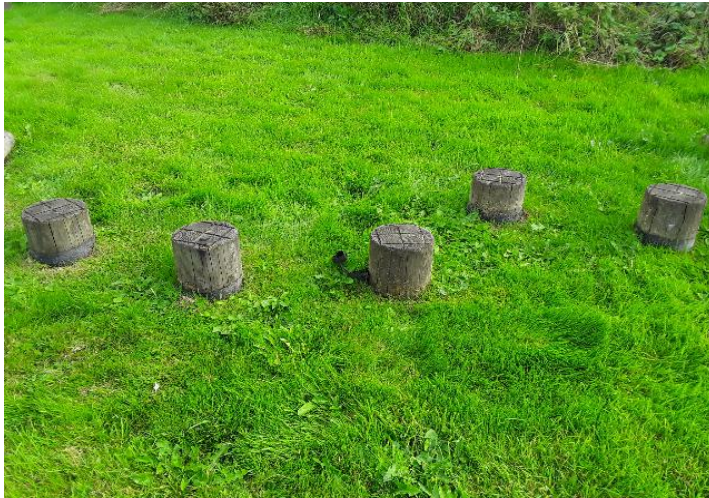
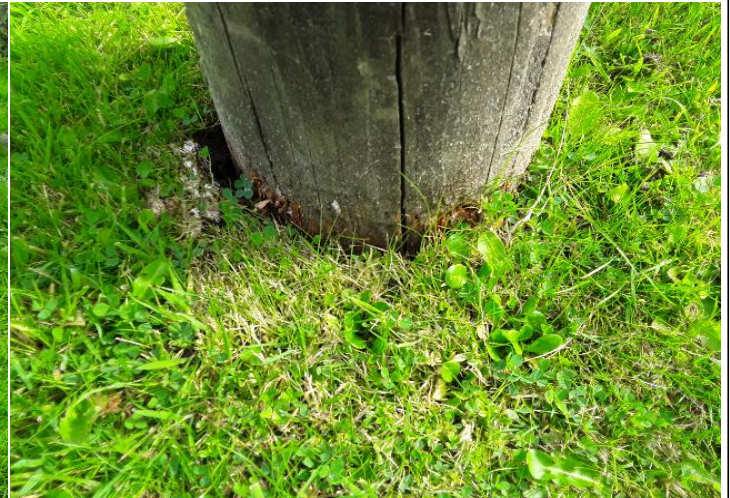
**Item:** Activity Equipment - Log Walk  
**Manufacturer:** Playdale Playgrounds Ltd

Some logs are showing rot - Monitor for any further deterioration

**Finding:** Some logs are showing rot

**Action:** Monitor for any further deterioration

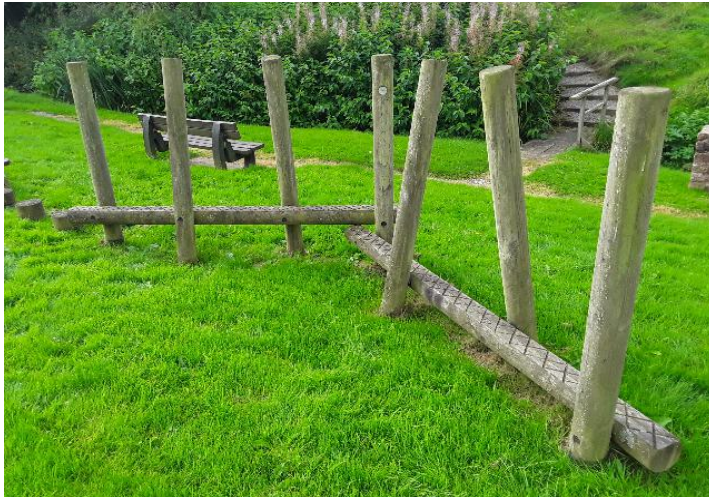
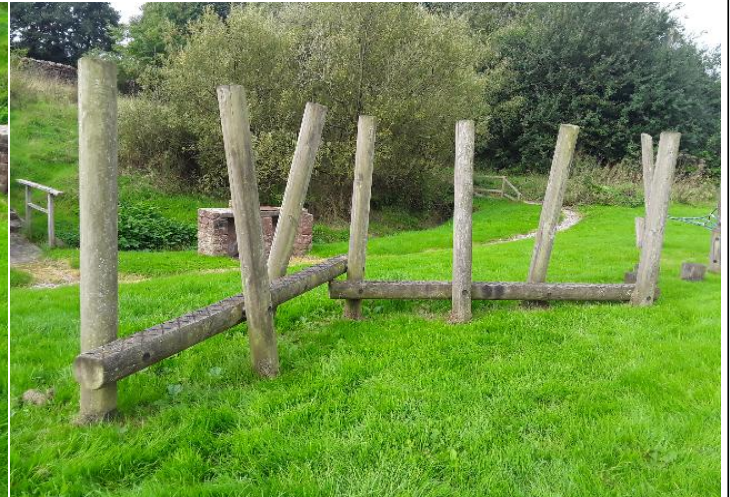
**Item:** Activity Equipment - Intertwine  
**Manufacturer:** Playdale Playgrounds Ltd

**Finding:** The intertwine is in satisfactory condition

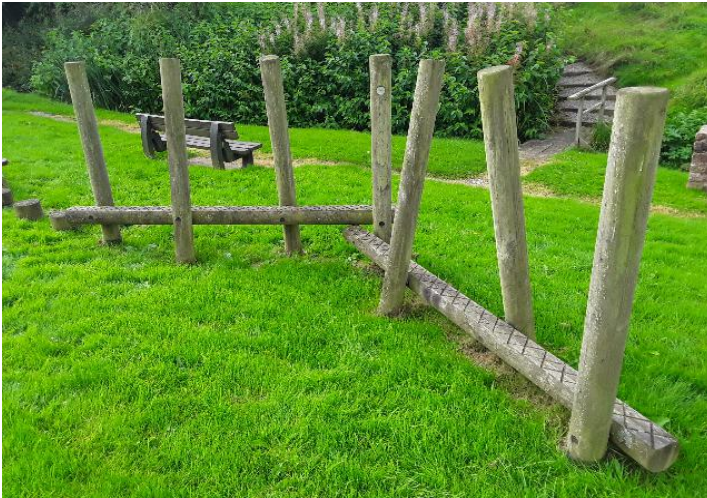
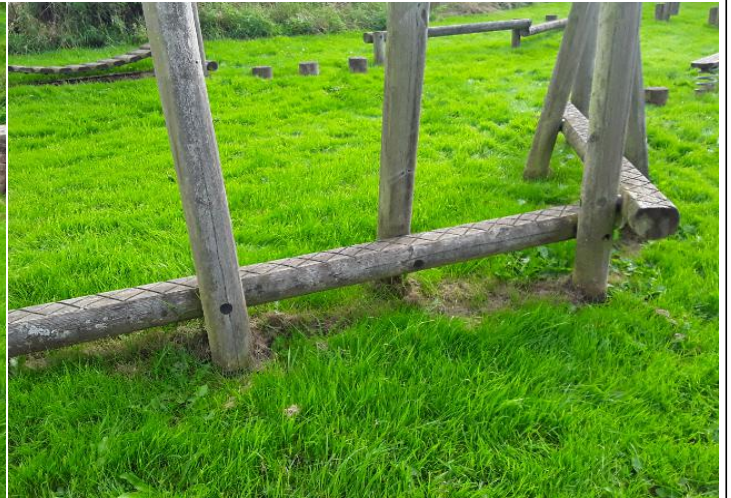
**Item:** Activity Equipment - Intertwine  
**Manufacturer:** Playdale Playgrounds Ltd

There is some evidence of rot in the timber - Monitor use

**Finding:** There is some evidence of rot in the timber

**Action:** Monitor use

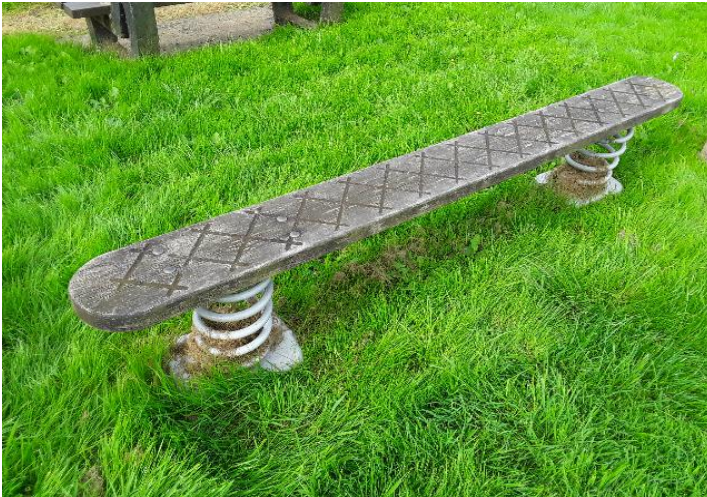
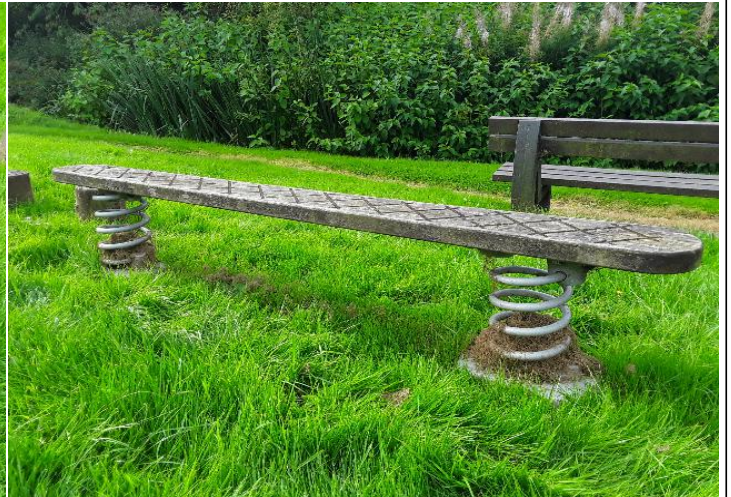
**Item:** Rocking Equipment - Wobble Board  
**Manufacturer:** Playdale Playgrounds Ltd

**Finding:** The wobble board is in satisfactory condition

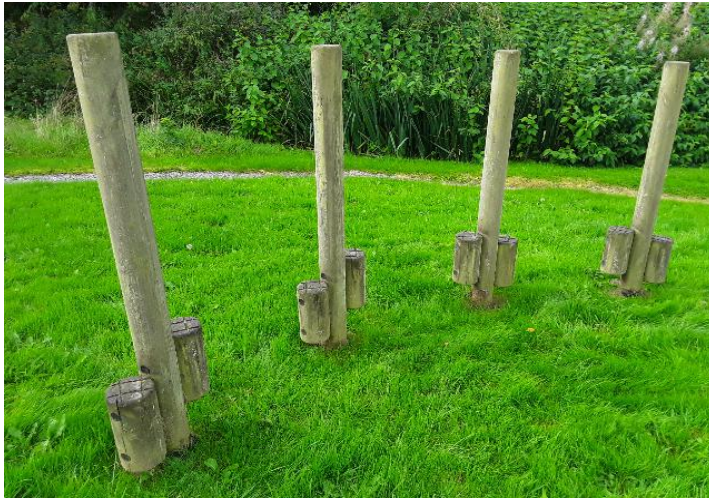
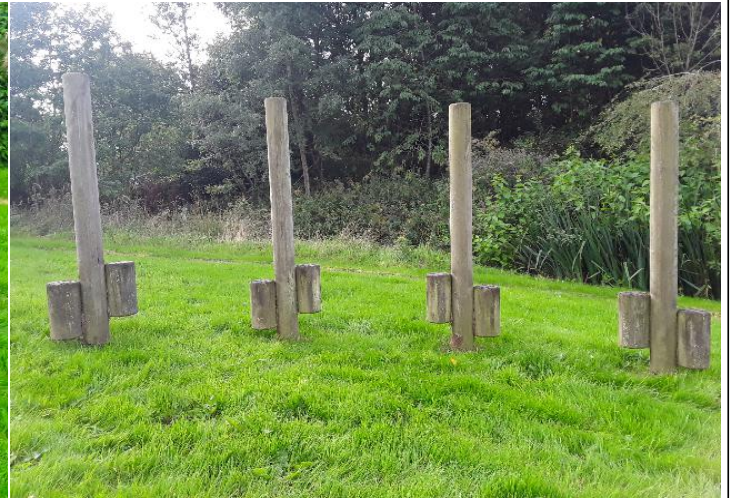
**Item:** Activity Equipment - Stilts  
**Manufacturer:** Playdale Playgrounds Ltd

**Finding:** The stilts are in satisfactory condition

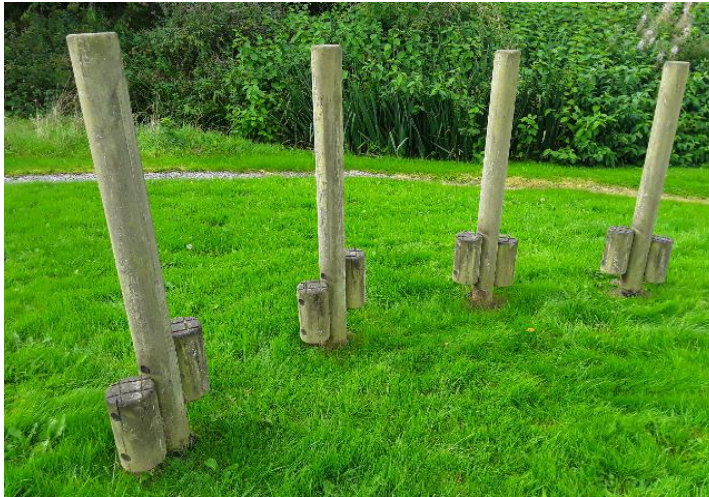
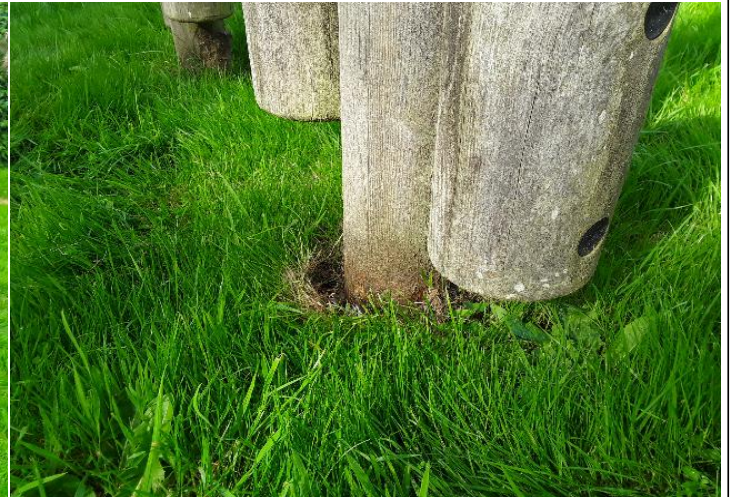
**Item:** Activity Equipment - Stilts  
**Manufacturer:** Playdale Playgrounds Ltd

A pole is showing rot - Monitor for for further deterioration

**Finding:** A pole is showing rot

**Action:** Monitor for for further deterioration

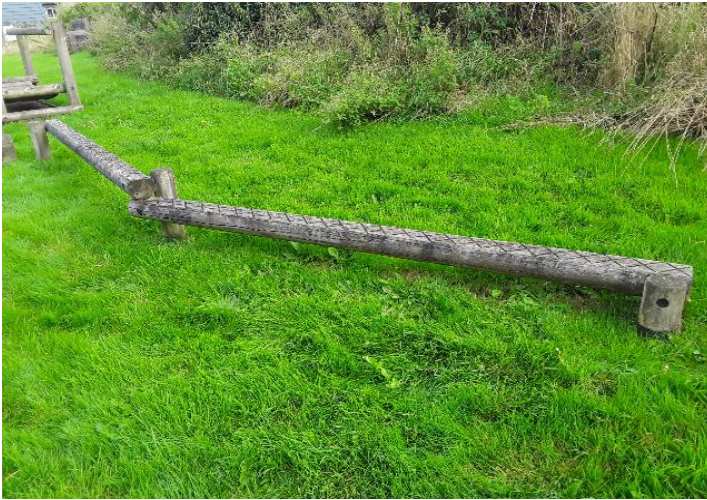
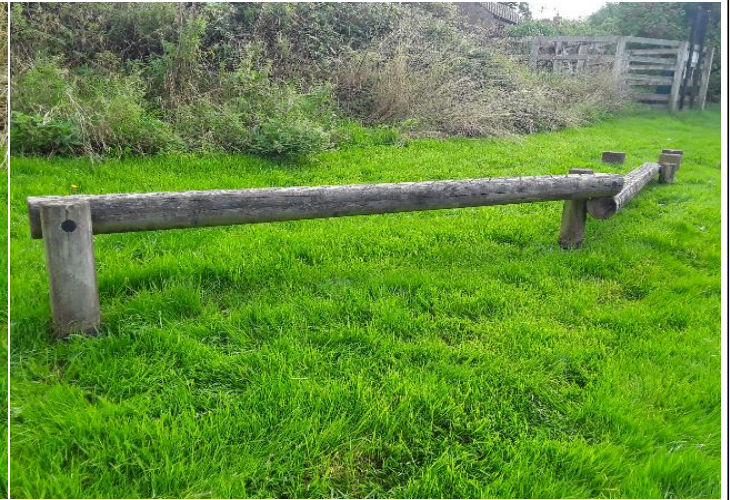
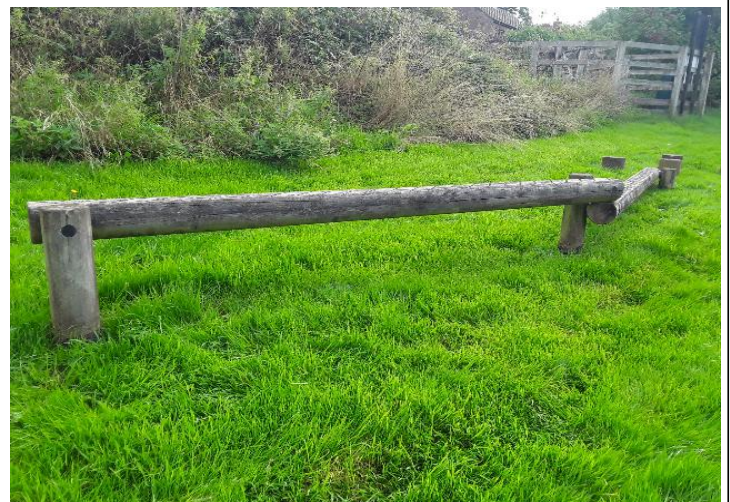
**Item:** Activity Equipment - Balance Beam  
**Manufacturer:** Playdale Playgrounds Ltd

**Finding:** The twin balance beam is in satisfactory condition **Action:** None required

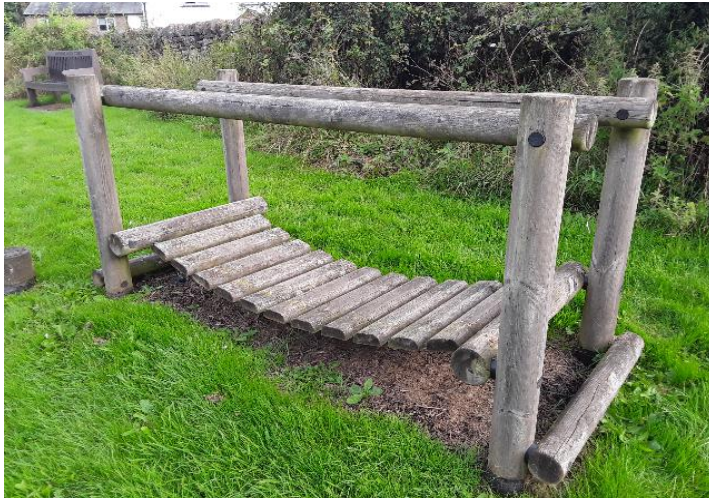
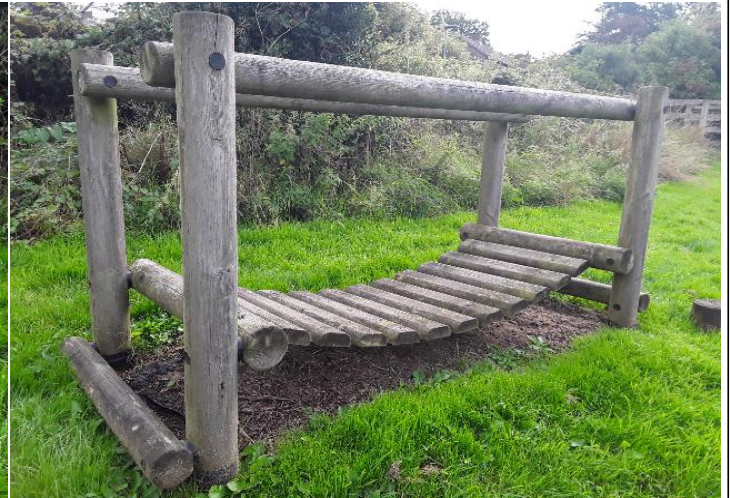
**Item:** Activity Equipment - Bridge  
**Manufacturer:** Playdale Playgrounds Ltd

**Finding:** The mini-suspension bridge is in satisfactory condition

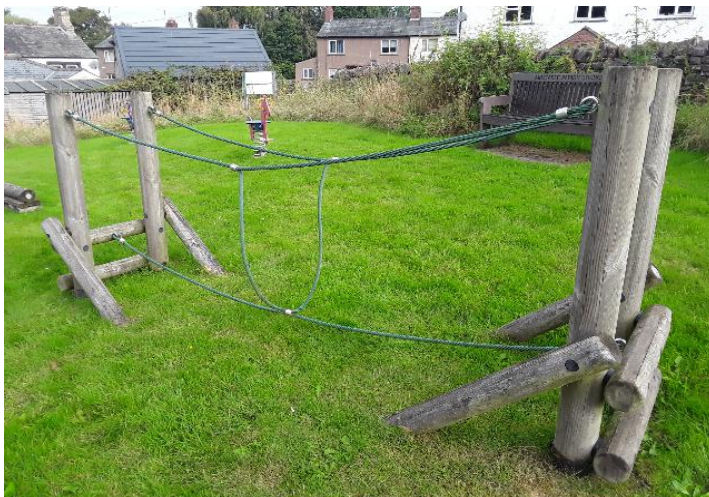
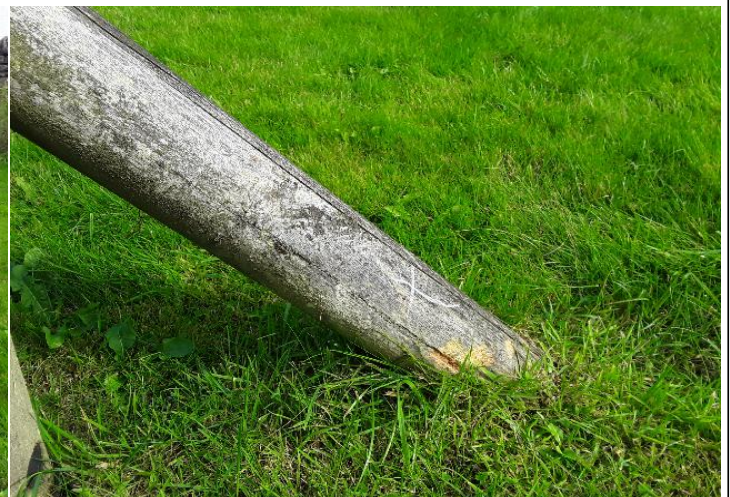
**Item:** Activity Equipment - Burma Bridge  
**Manufacturer:** Playdale Playgrounds Ltd

A strainer pole is rotten - Replace the rotten pole

**Finding:** A strainer pole is rotten

**Action:** Replace the rotten pole

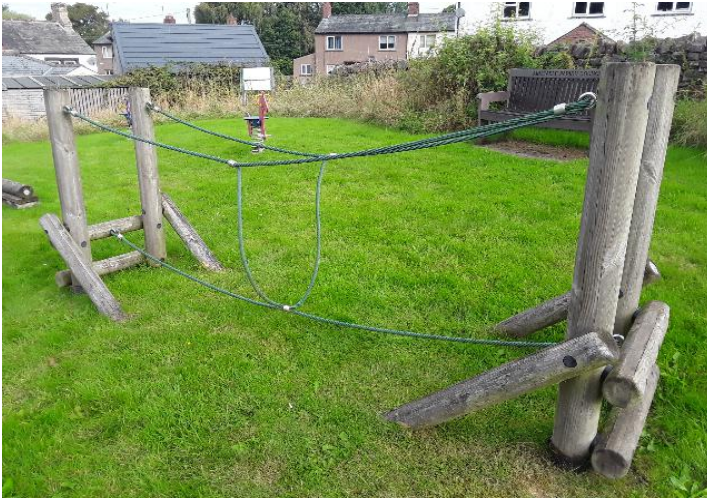
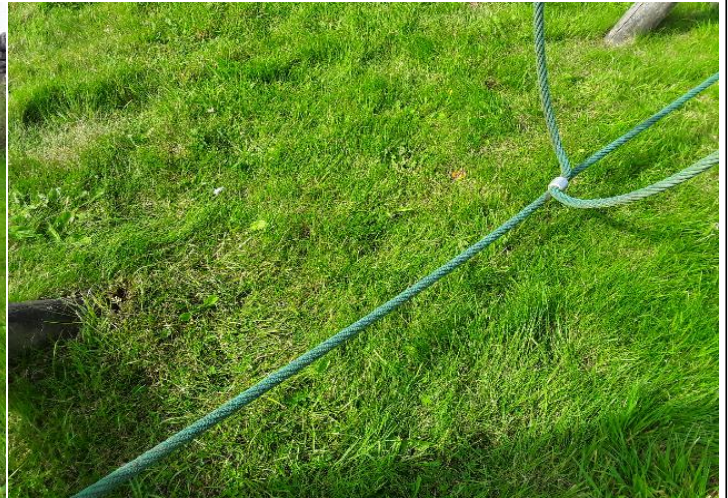
**Item:** Activity Equipment - Burma Bridge  
**Manufacturer:** Playdale Playgrounds Ltd

The bottom rope is showing slight damage, and signs of wear - None required

**Finding:** The bottom rope is showing slight damage, and signs of wear

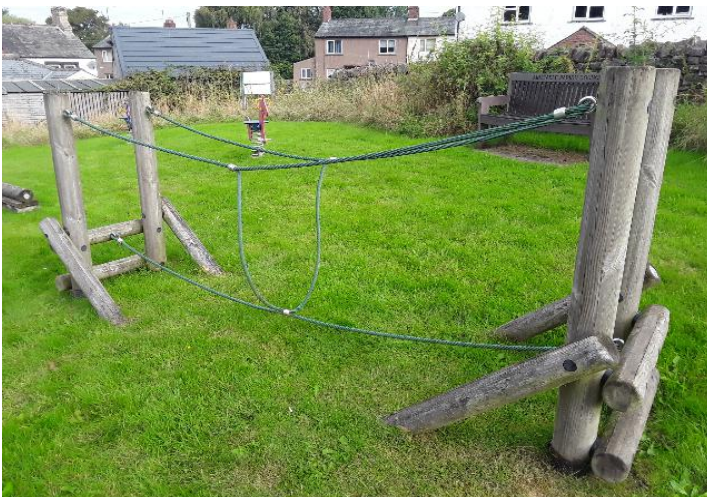
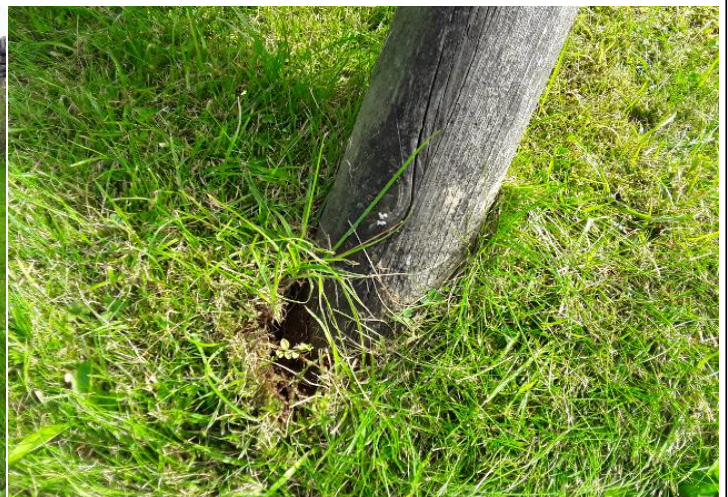
**Item:** Activity Equipment - Burma Bridge  
**Manufacturer:** Playdale Playgrounds Ltd

There is some evidence of rot in the timber - Monitor for further rot

**Finding:** There is some evidence of rot in the timber

**Action:** Monitor for further rot

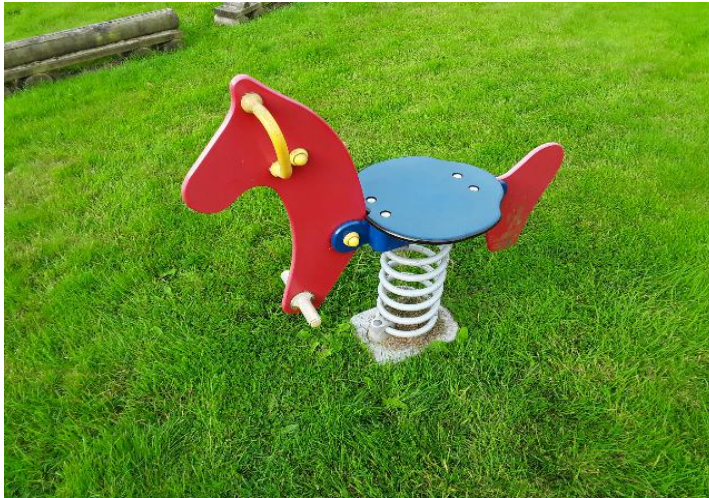
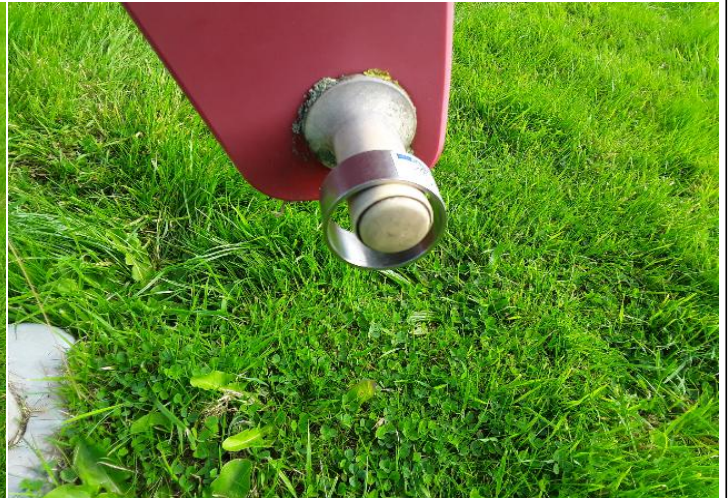
**Item:** Rocking Equipment - Spring Horse  
**Manufacturer:** Ledon

The ends of the footrests fail to meet the dimension requirements of BS EN 1176 - Monitor use

**Finding:** The ends of the footrests fail to meet the dimension requirements of BS EN 1176

**Action:** Monitor use

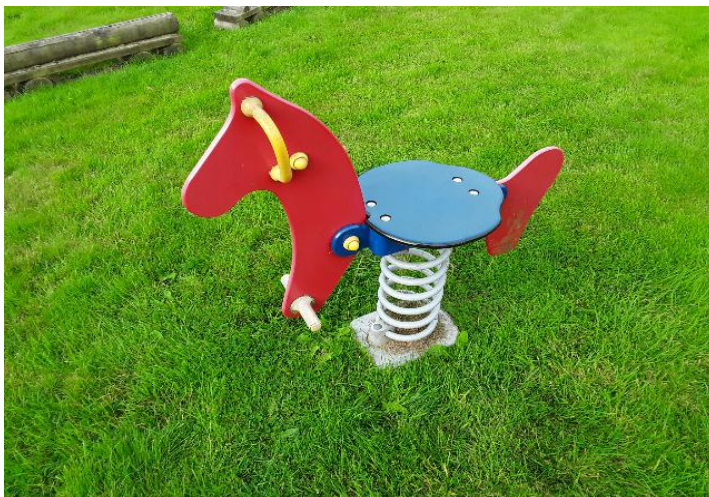
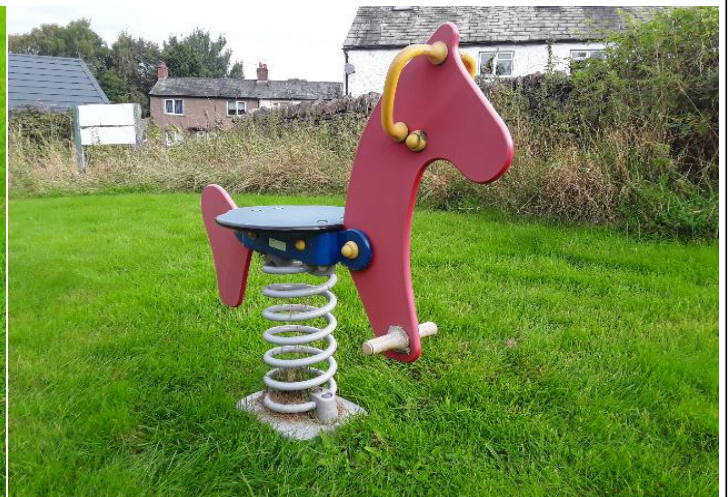
**Item:** Rocking Equipment - Spring Horse  
**Manufacturer:** Ledon

**Finding:** The spring horse is in satisfactory condition

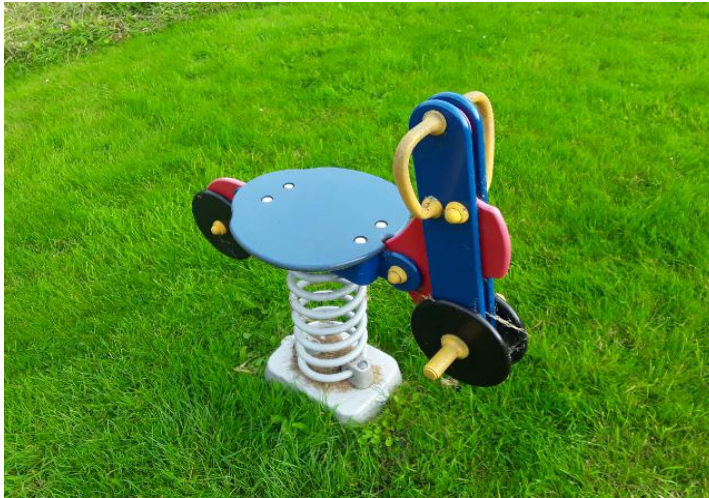
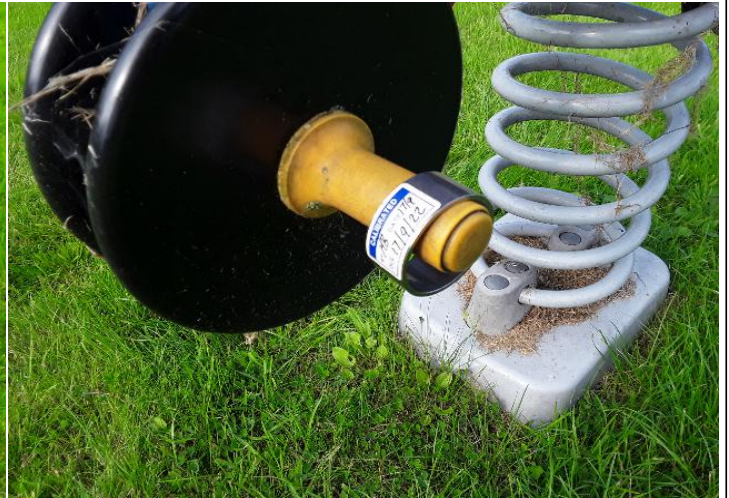
**Item:** Rocking Equipment - Spring Motorbike  
**Manufacturer:** Ledon

The footrests fail dimension requirements - Monitor use

**Finding:** The footrests fail dimension requirements

**Action:** Monitor use

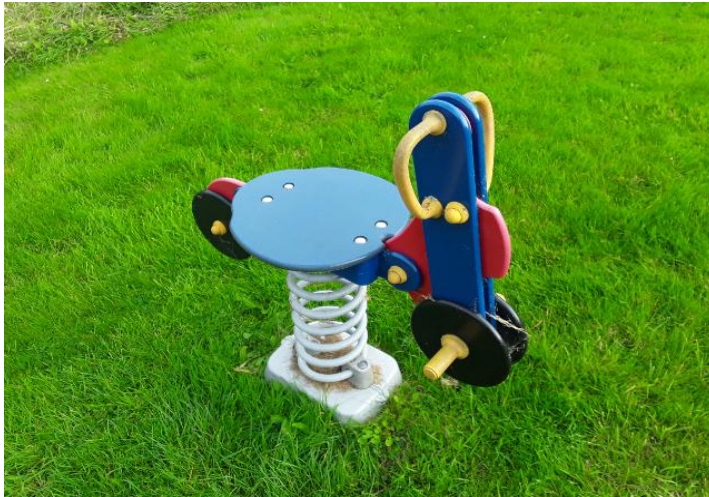
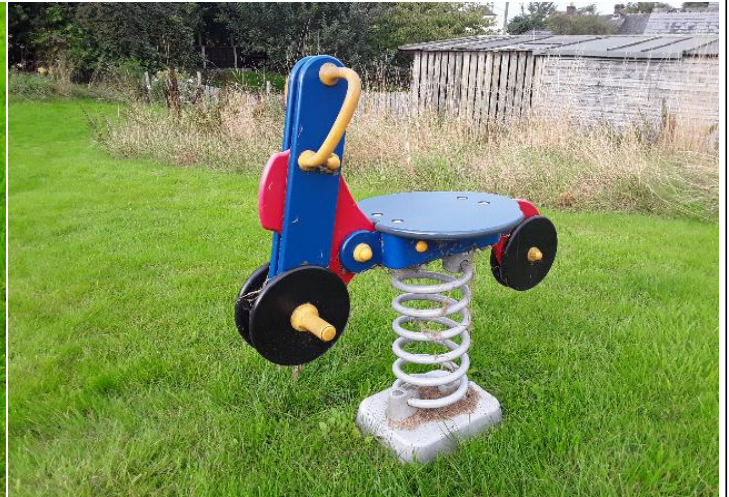
**Item:** Rocking Equipment - Spring Motorbike  
**Manufacturer:** Ledon

**Finding:** The Springer is in satisfactory condition

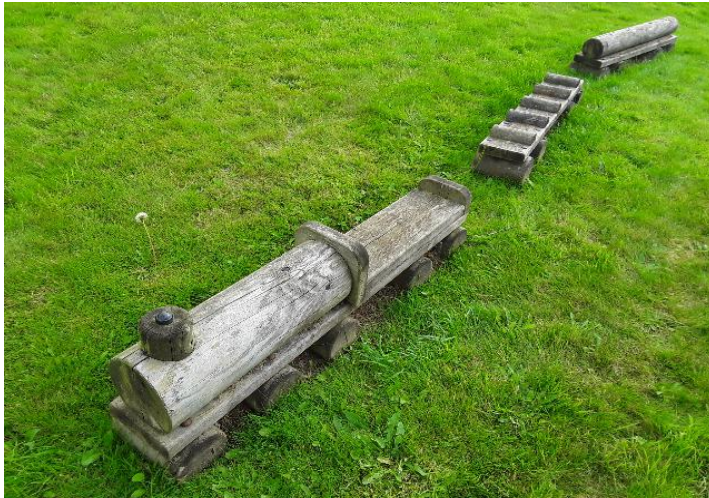
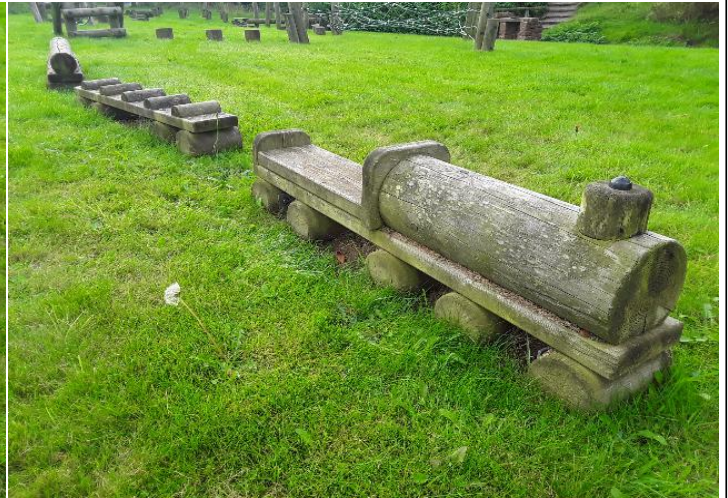
**Item:** Activity Equipment - Train  
**Manufacturer:** Playdale Playgrounds Ltd

**Finding:** The train is in satisfactory condition

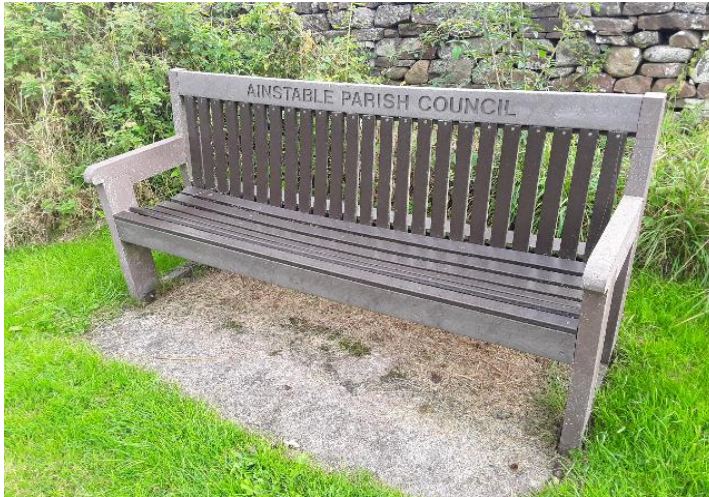
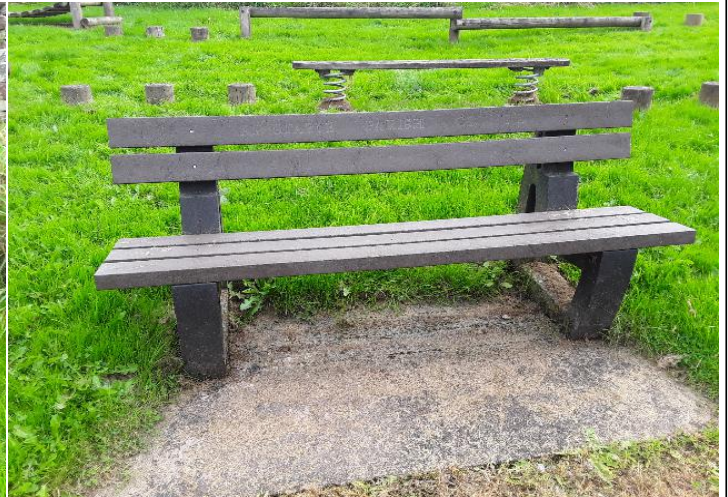
**Item:** Ancillary Items - Seating Area  
**Manufacturer:** Unknown

**Finding:** The seats are in good condition

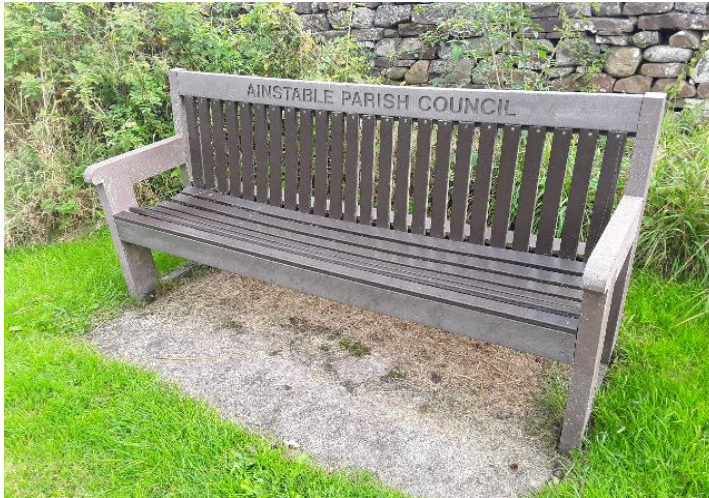
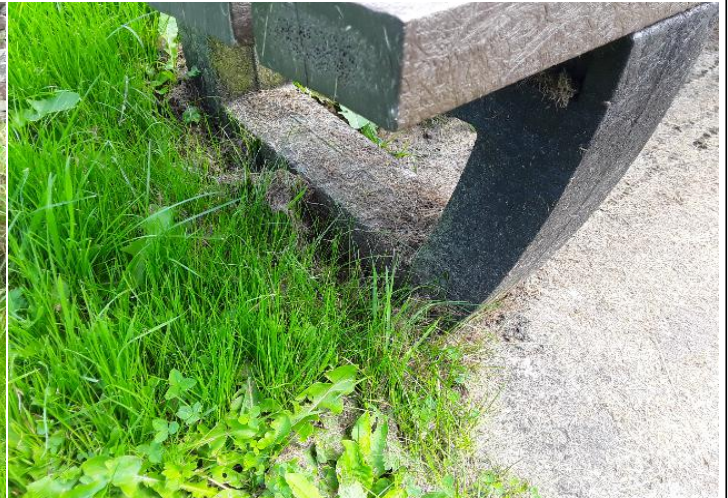
**Item:** Ancillary Items - Seating Area  
**Manufacturer:** Unknown

A seat is slightly loose on its ground fixings - Monitor for further deterioration

**Finding:** A seat is slightly loose on its ground fixings

**Action:** Monitor for further deterioration

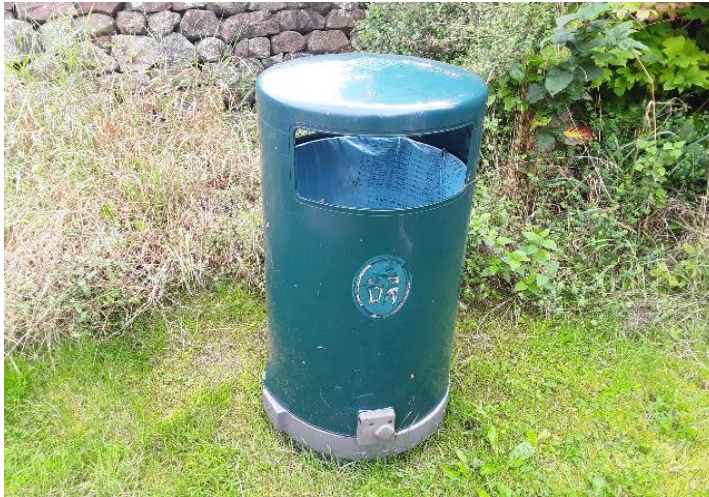
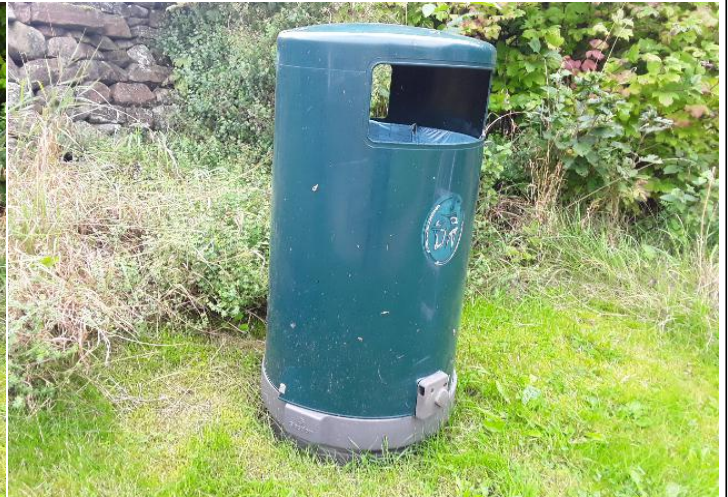
**Item:** Ancillary Items - Litter Bin  
**Manufacturer:** Glasdon

**Finding:** The bin is in satisfactory condition

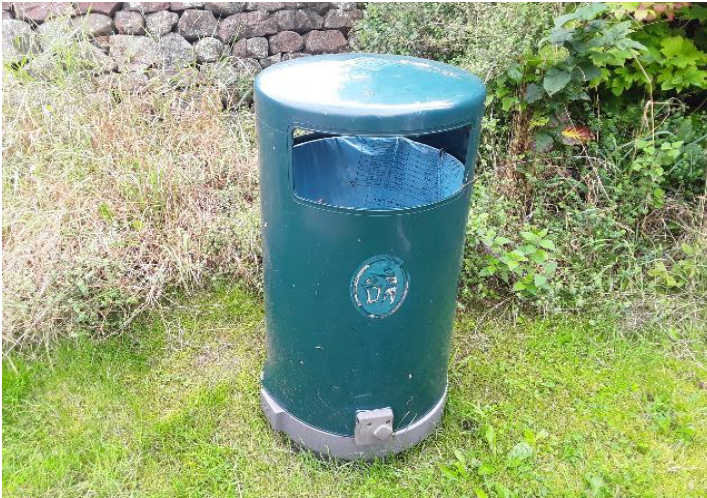
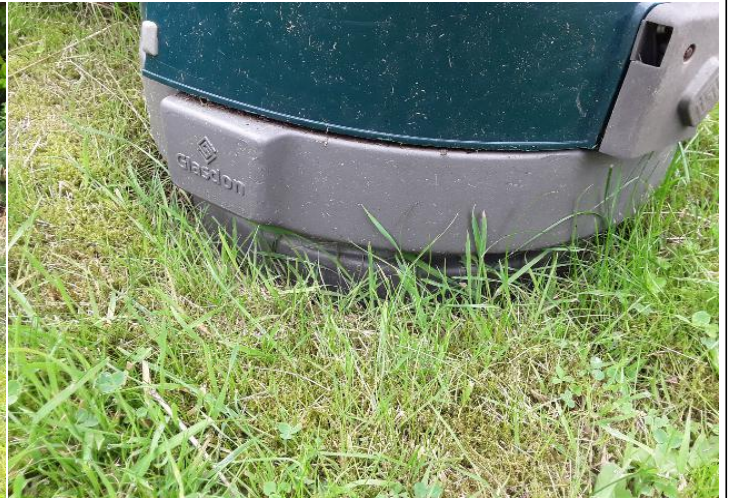
**Item:** Ancillary Items - Litter Bin  
**Manufacturer:** Glasdon

The bin is slightly loose on its ground fixings - Monitor use

**Finding:** The bin is slightly loose on its ground fixings

**Action:** Monitor use
