# Playdale Playgrounds

## Annual Inspection

Ainstable Parish Council

Millennium Green  
Main Street, Ainstable, Cumbria,

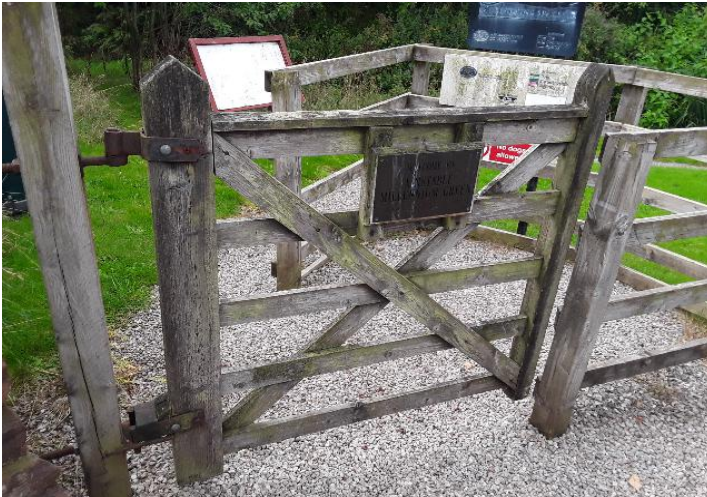
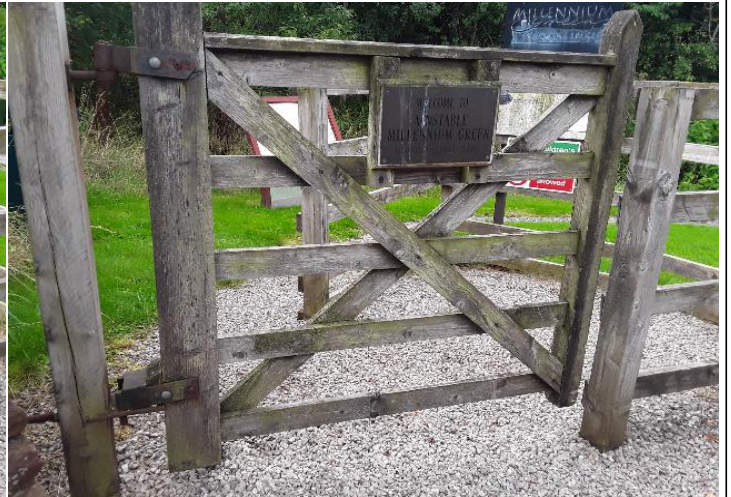
**Item:** Gates - Gate  
**Manufacturer:** Unknown

**Finding:** The gate is in satisfactory condition

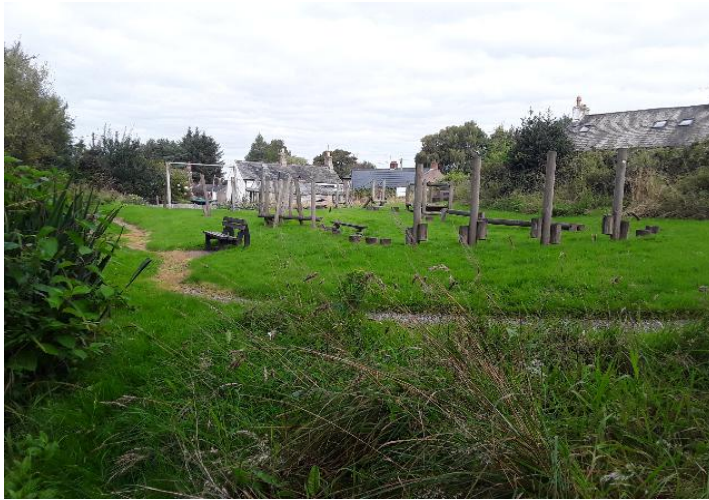
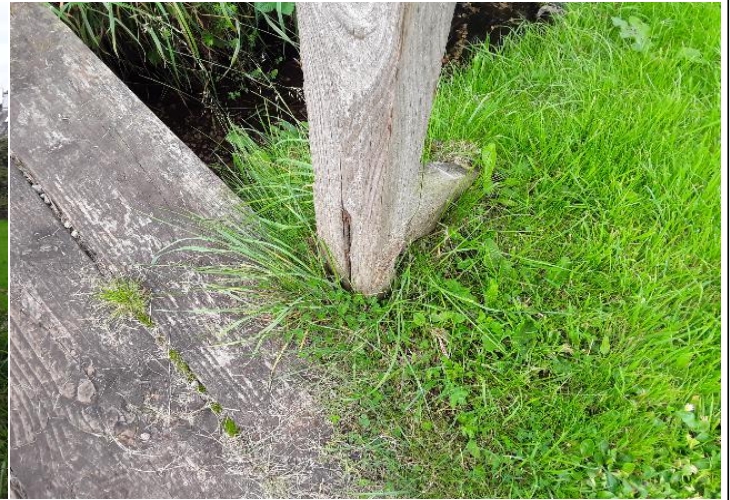
**Item:** Ancillary Items - Site General  
**Manufacturer:** Unknown

A bridge handrail post is loose - Refix the post

**Finding:** A bridge handrail post is loose

**Action:** Refix the post

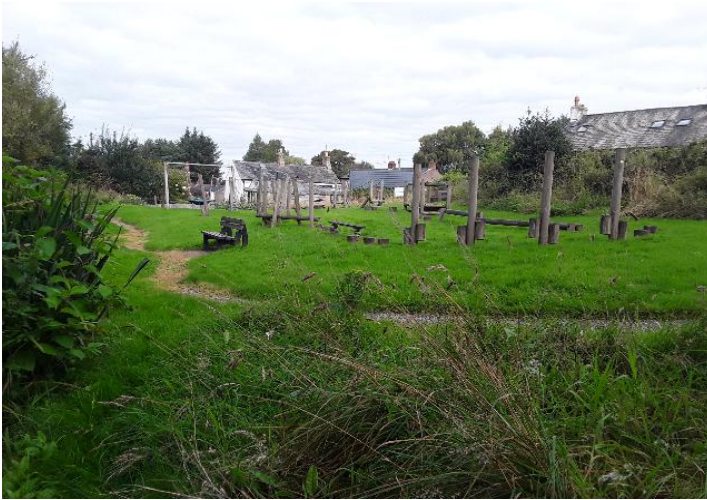
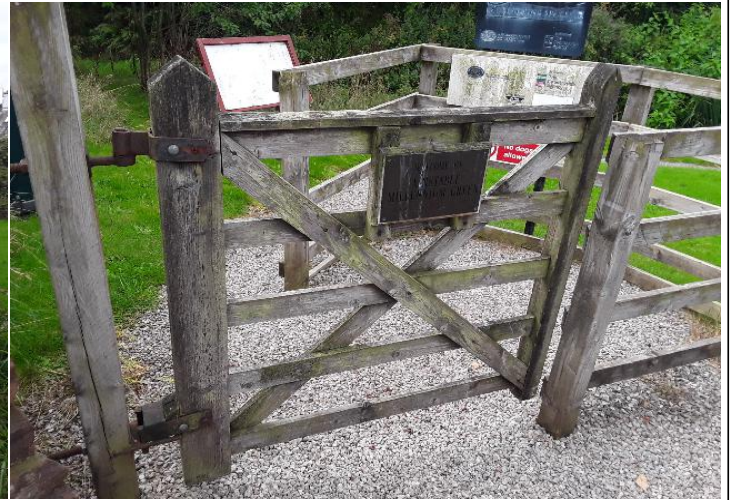
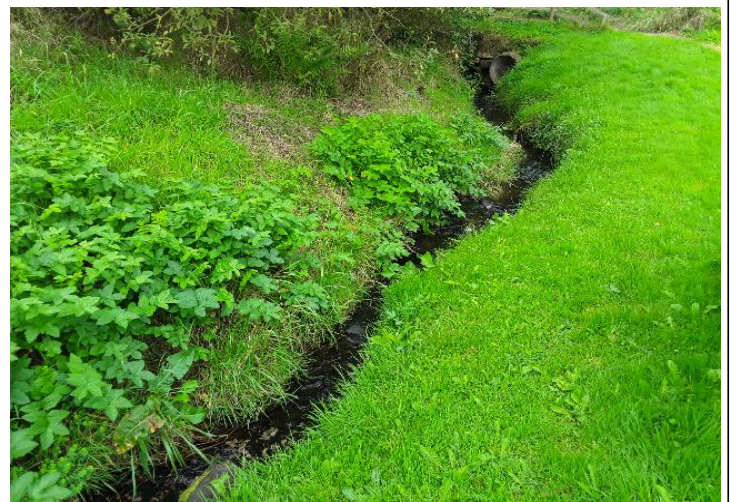
**Item:** Ancillary Items - Site General  
**Manufacturer:** Unknown

It is recommended that information signs with emergency contact details are installed at each entrance/exit point to the playground - Provide in accordance with the recommendations set out in BS EN 1176, also mentioning the beck as a potential hazard

**Finding:** It is recommended that information signs with emergency contact details are installed at each entrance/exit point to the playground

**Action:** Provide in accordance with the recommendations set out in BS EN 1176, also mentioning the beck as a potential hazard

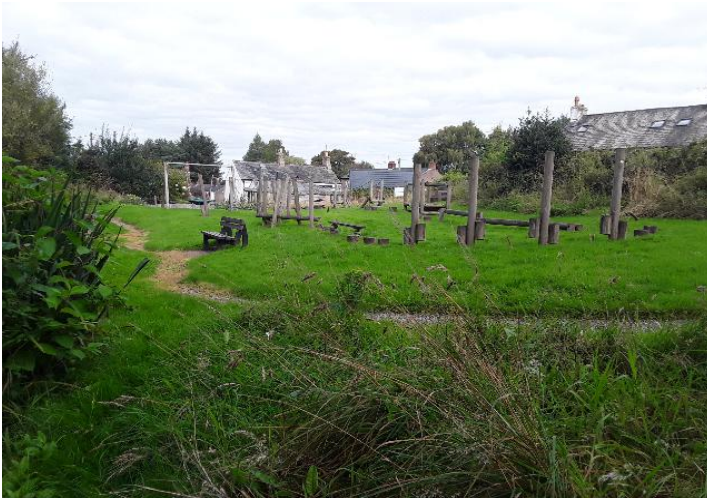
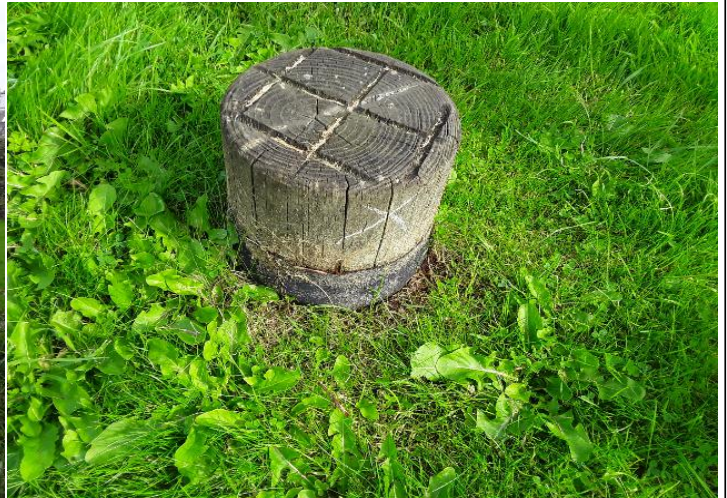
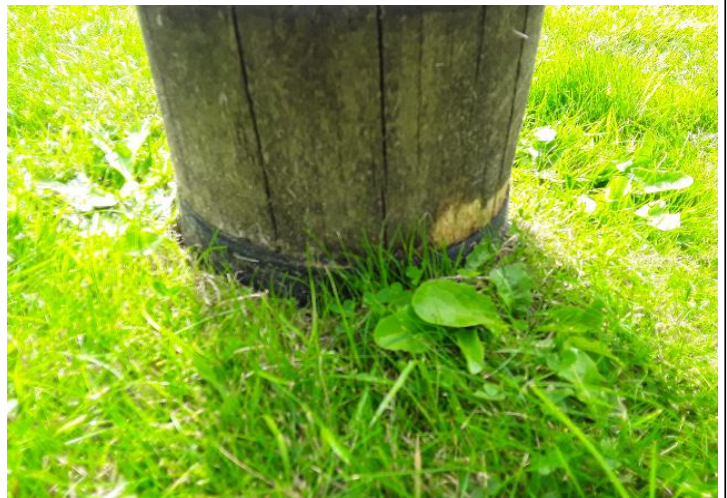
**Item:** Ancillary Items - Site General  
**Manufacturer:** Unknown

The covering on the bottom of the poles may cause rot, due to been damp. Stimmer damage can also lead to rot - Monitor for deterioration of the poles

**Finding:** The covering on the bottom of the poles may cause rot, due to been damp. Stimmer damage can also lead to rot

**Action:** Monitor for deterioration of the poles

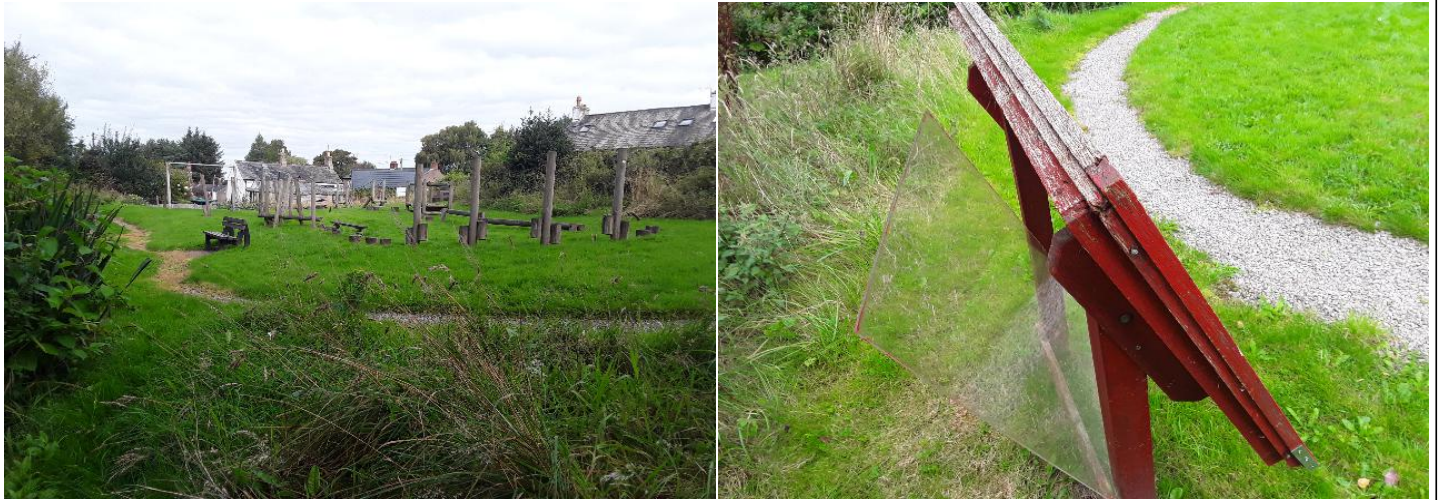
**Item:** Ancillary Items - Site General  
**Manufacturer:** Unknown

An information board is failing - Repair or remove

**Finding:** An information board is failing

**Action:** Repair or remove
