Playdale Playgrounds

Annual Inspection Report For Millennium Green

Date of inspection: 27/07/2019

Main Street, Ainstable, Cumbria

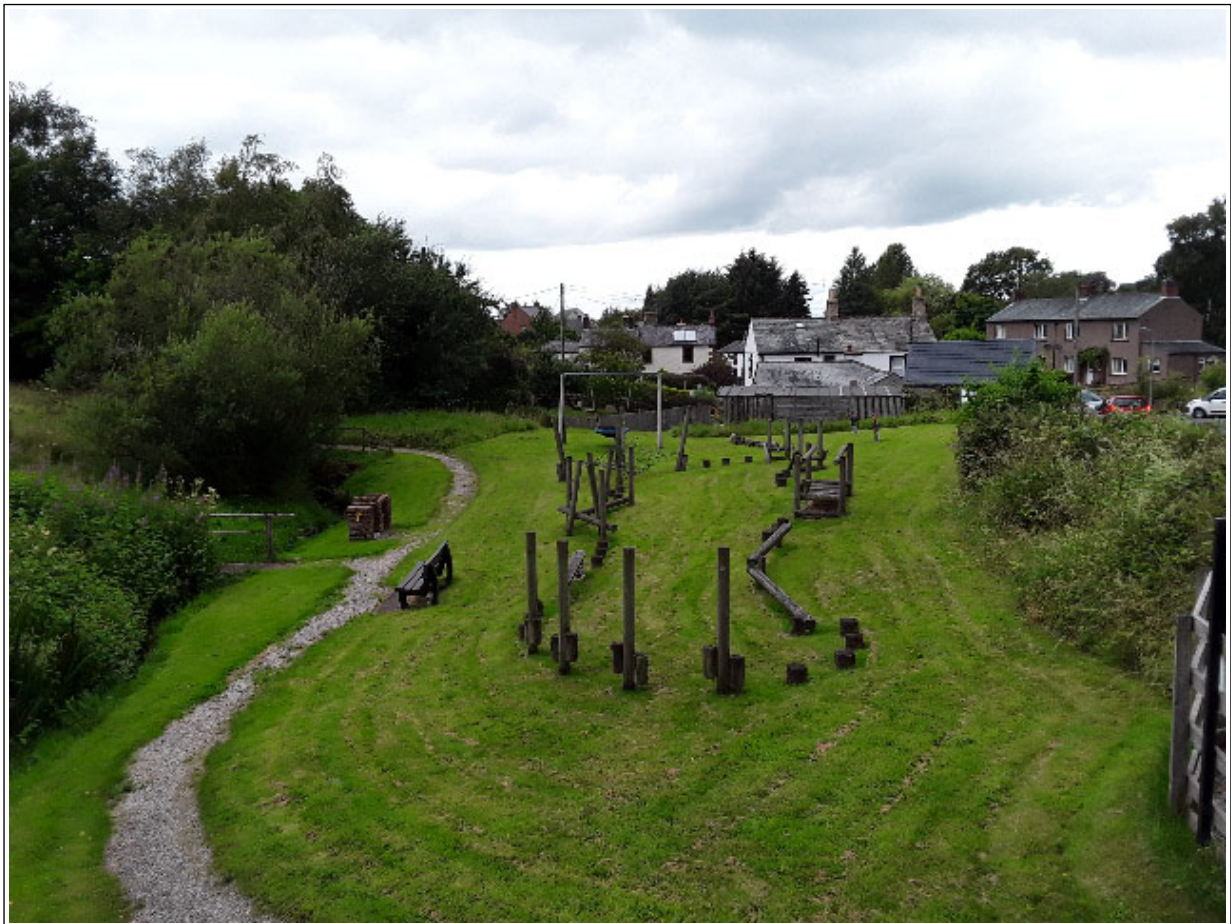
Location: The site is partially overlooked by properties in the local community

Disabled Access: Generally accessible; an area accessible to most.
