# Playdale Playgrounds

## Annual Inspection

Ainstable Parish Council

## Millennium Green

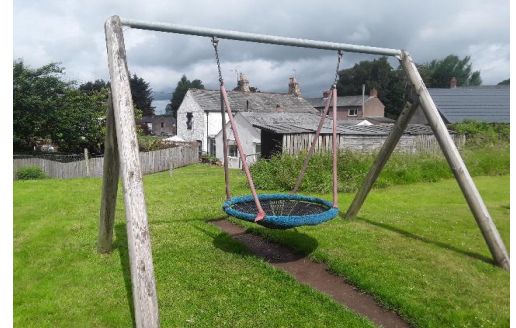
**Item:** Basket Swing - Type 1  
**Manufacturer:** Playdale Playgrounds Ltd  
**Surface Type:** Grass Matrix Tiles  
**Item Quantity:** 1  
**Equipment Compliance:** No  
**Surface Area Compliance:** No

Swings of this design are recommended to have a secondary safety mechanism fitted to prevent collapse of the seat - Consider providing a secondary safety mechanism

The shackles are showing wear - Grease the shackles (Done) and monitor for further deterioration

There is some evidence of rot in a leg - Monitor use

The large chain links are wearing, which may require attention next year - Monitor for any further deterioration

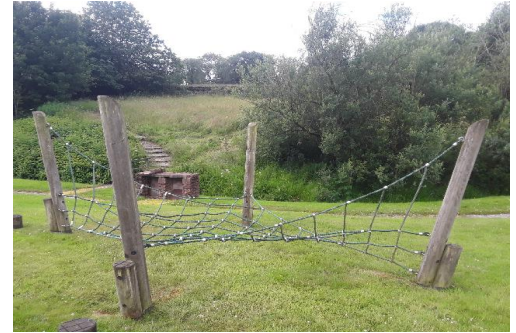
**Item:** Net Climber  
**Manufacturer:** Playdale Playgrounds Ltd  
**Surface Type:** Grass  
**Item Quantity:** 1  
**Equipment Compliance:** Yes  
**Surface Area Compliance:** Yes

The step-up logs are starting to show rot - Monitor use

The net is starting to showing signs of wear and slight damage - Monitor for further deterioration

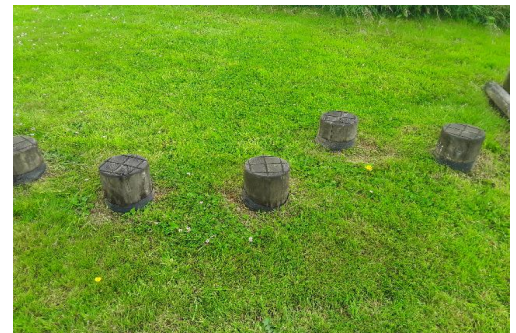
**Item:** Log Walk  
**Manufacturer:** Playdale Playgrounds Ltd  
**Surface Type:** Grass  
**Item Quantity:** 24  
**Equipment Compliance:** Yes  
**Surface Area Compliance:** Yes

3no logs are rotten in the middle - Replace the rotten logs

Some logs are showing slight rot - Monitor for any further deterioration

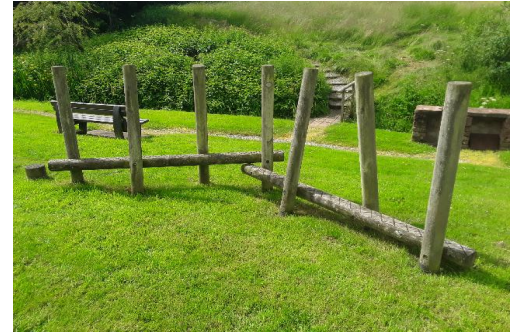
**Item:** Intertwine  
**Manufacturer:** Playdale Playgrounds Ltd  
**Surface Type:** Grass  
**Item Quantity:** 1  
**Equipment Compliance:** Yes  
**Surface Area Compliance:** Yes

There is some evidence of rot in the timber - Monitor use

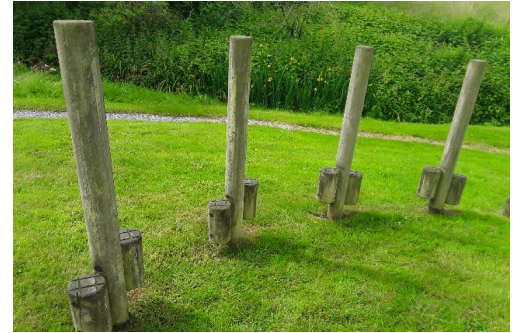
**Item:** Stilts  
**Manufacturer:** Playdale Playgrounds Ltd  
**Surface Type:** Grass  
**Item Quantity:** 4  
**Equipment Compliance:** Yes  
**Surface Area Compliance:** Yes

A stilt is showing rot - Monitor use

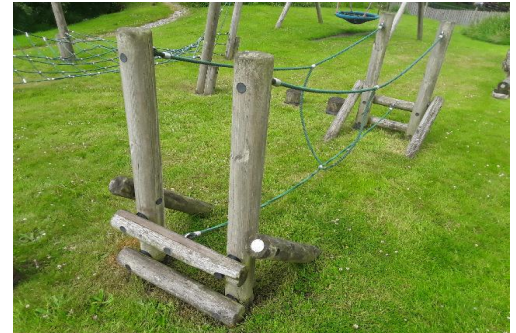
**Item:** Burma Bridge  
**Manufacturer:** Playdale Playgrounds Ltd  
**Surface Type:** Grass  
**Item Quantity:** 1  
**Equipment Compliance:** Yes  
**Surface Area Compliance:** Yes

A strainer pole is rotten - Replace the rotten pole

The bottom rope is showing slight damage, and signs of wear - None required

There is some evidence of rot in the timber - Monitor use

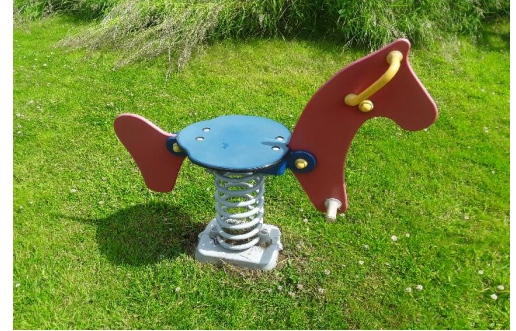
**Item:** Spring Horse  
**Manufacturer:** Ledon  
**Surface Type:** Grass  
**Item Quantity:** 1  
**Equipment Compliance:** No  
**Surface Area Compliance:** Yes

The ends of the footrests fail to meet the dimension requirements of BS EN 1176 - Monitor use

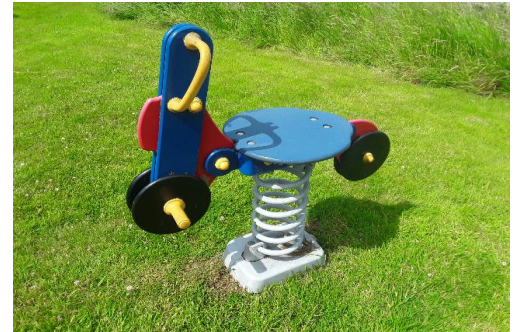
**Item:** Spring Motorbike  
**Manufacturer:** Ledon  
**Surface Type:** Grass  
**Item Quantity:** 1  
**Equipment Compliance:** No  
**Surface Area Compliance:** Yes

The footrests fail dimension requirements - Monitor use

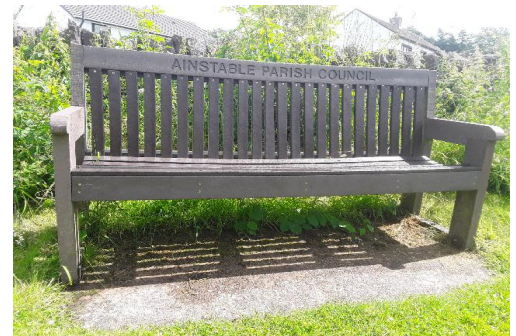
**Item:** Seating Area  
**Manufacturer:** Unknown  
**Surface Type:** Concrete  
**Item Quantity:** 2  
**Equipment Compliance:** N/A  
**Surface Area Compliance:** N/A

A seat is slightly loose on its ground fixings - Monitor for further deterioration

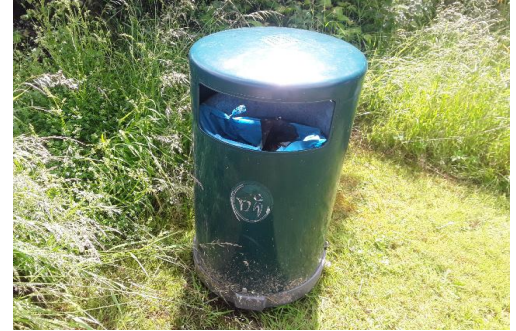
**Item:** Litter Bin  
**Manufacturer:** Unknown  
**Surface Type:** Concrete  
**Item Quantity:** 1  
**Equipment Compliance:** N/A  
**Surface Area Compliance:** N/A

The bin is showing slight damage - Monitor

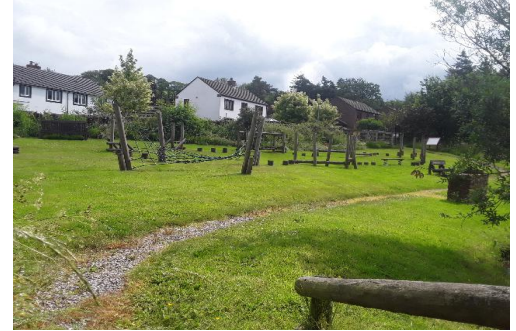
**Item:** Site General  
**Manufacturer:** Unknown  
**Surface Type:** N/A  
**Item Quantity:** 1  
**Equipment Compliance:** N/A  
**Surface Area Compliance:** N/A

It is recommended that information signs with emergency contact details are installed at each entrance/exit point to the playground - Provide in accordance with the recommendations set out in BS EN 1176, also mentioning the beck as a water hazard

Part of the wall is becoming unstable - Repair as required

The covering on the bottom of the poles may cause rot, due to been damp. N.B Stimmer damage can also lead to rot - Monitor for deterioration of the poles

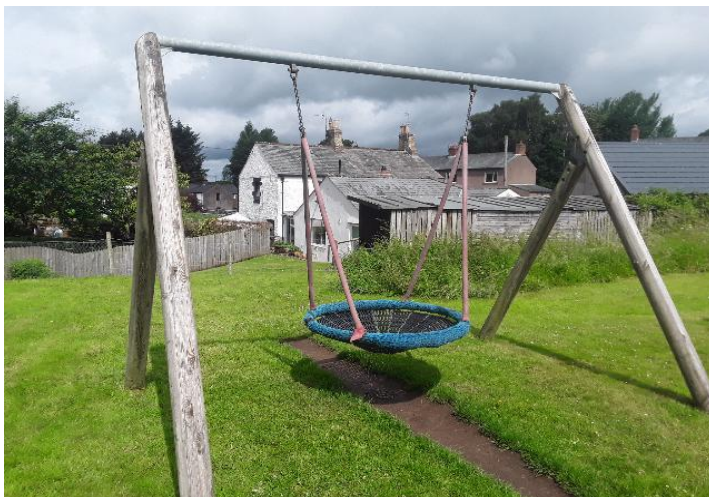
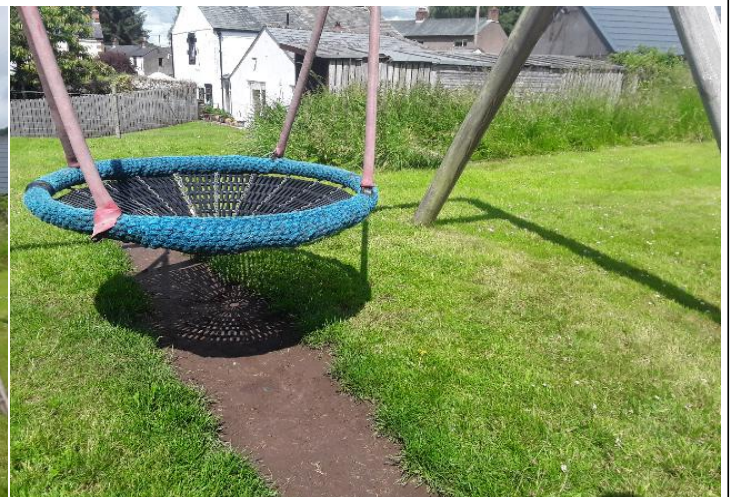
**Item:** Swings - Basket Swing - Type 1  
**Manufacturer:** Playdale Playgrounds Ltd

**Finding:** The grass mats are silted up and the soil is compacted; this may have an effect on the impact absorbing properties of the surface  
**Action:** Consider lifting and relaying the mats or test impact absorbing properties to ensure the correct surface qualities are maintained for the equipment

**i** 8 - Low Risk (Finding 4)

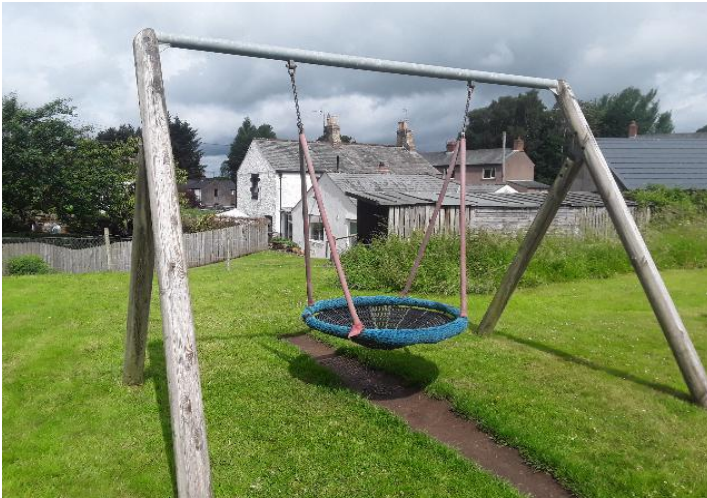
**Item:** Swings - Basket Swing - Type 1  
**Manufacturer:** Playdale Playgrounds Ltd

**Finding:** Fixing Pins have been installed in the impact area **Action:** Remove pins from impact area

**i** 5 - Very Low Risk (Finding 5)

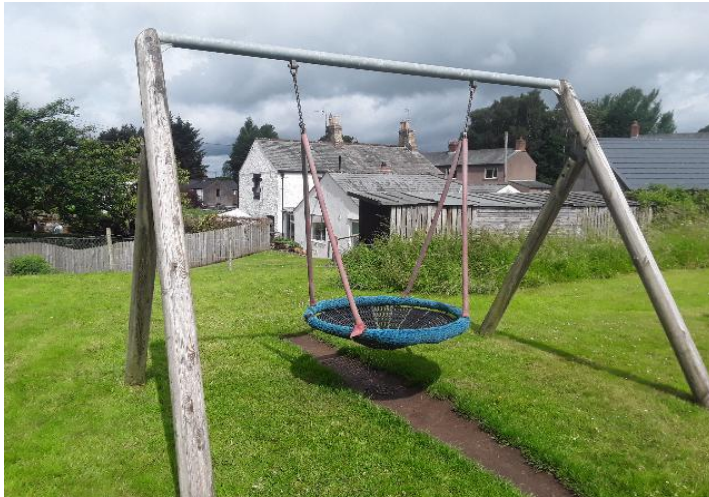
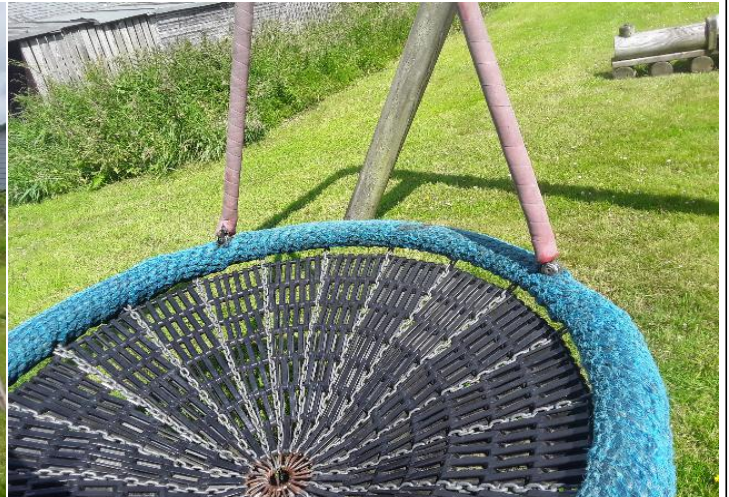
**Item:** Swings - Basket Swing - Type 1  
**Manufacturer:** Playdale Playgrounds Ltd

**Finding:** The seat is starting to show its age

**Action:** Monitor use

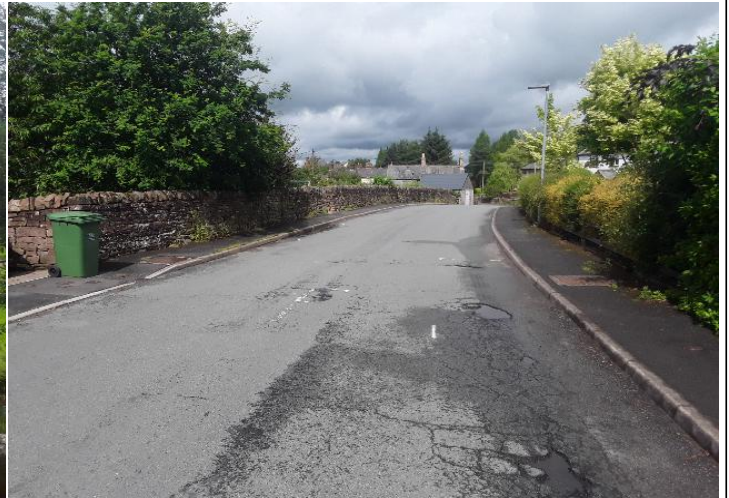
**Item:** Ancillary Items - Site General  
**Manufacturer:** Unknown

**Finding:** The play area entrance is not obvious from the road

**Action:** Consider a warning signage

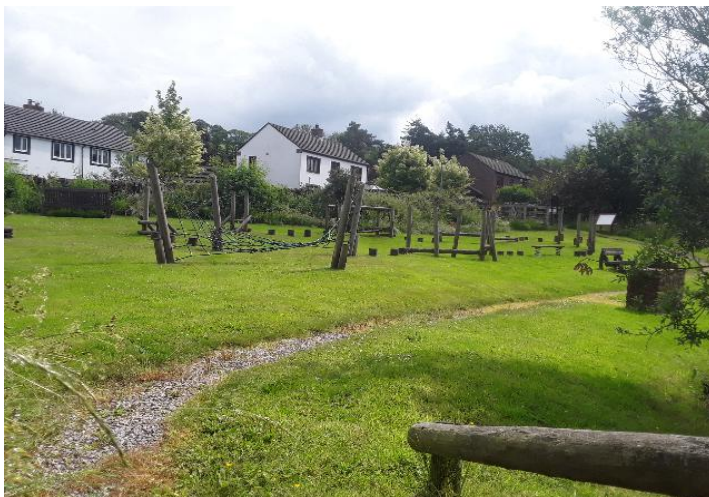
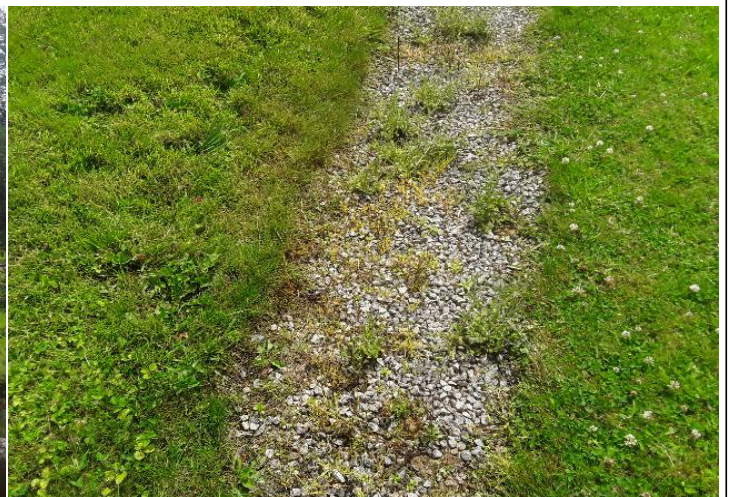
**Item:** Ancillary Items - Site General  
**Manufacturer:** Unknown

**Finding:** The path is becoming over grown

**Action:** Remove the weeds
