# Playdale Playgrounds

## Annual Inspection

Ainstable Parish Council

Millennium Green  
Main Street, Ainstable, Cumbria,

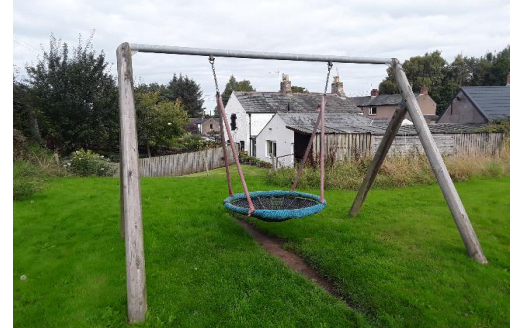
**Item:** Basket Swing - Type 1  
**Manufacturer:** Playdale Playgrounds Ltd  
**Surface Type:** Grass Matrix Tiles  
**Item Quantity:** 1  
**Equipment Compliance:** No  
**Surface Area Compliance:** No

Basket swings are recommended to have a secondary safety mechanism fitted to prevent collapse of the seat - Consider providing a secondary safety mechanism

The exposed chain openings are in excess of 8.6mm - Refit and tape the damaged hose (Done whilst on site)

There is some evidence of rot in a leg - Monitor use

The large chain links are wearing, which may require attention next year - Monitor for any further deterioration and replace as required

The shackles are showing wear - Monitor for further deterioration

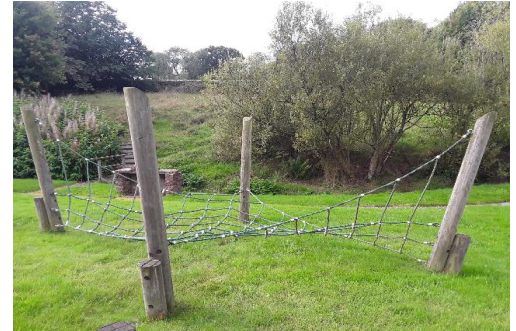
**Item:** Net Climber  
**Manufacturer:** Playdale Playgrounds Ltd  
**Surface Type:** Grass  
**Item Quantity:** 1  
**Equipment Compliance:** Yes  
**Surface Area Compliance:** Yes

The web net is in satisfactory condition - See below

There is rot are starting in places - Monitor for any deterioration

The net is starting to showing signs of wear and slight damage - Monitor for further deterioration

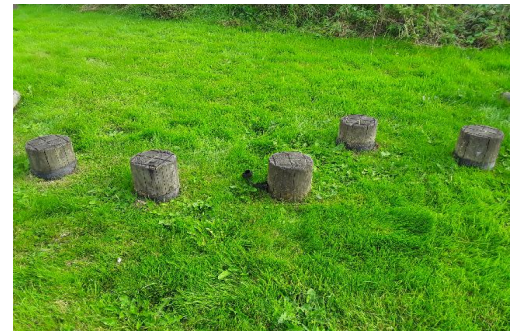
**Item:** Log Walk  
**Manufacturer:** Playdale Playgrounds Ltd  
**Surface Type:** Grass  
**Item Quantity:** 24  
**Equipment Compliance:** Yes  
**Surface Area Compliance:** Yes

6no logs are rotten in the middle - Replace the rotten logs

Some logs are showing rot - Monitor for any further deterioration

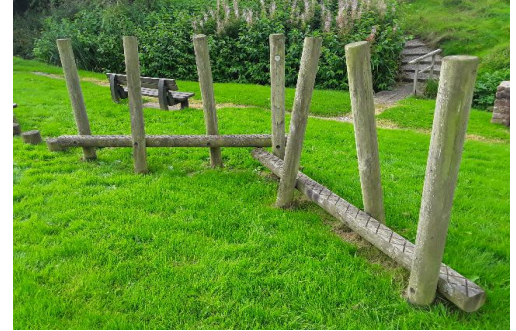
**Item:** Intertwine  
**Manufacturer:** Playdale Playgrounds Ltd  
**Surface Type:** Grass  
**Item Quantity:** 1  
**Equipment Compliance:** Yes  
**Surface Area Compliance:** Yes

The intertwine is in satisfactory condition - See below

There is some evidence of rot in the timber - Monitor use

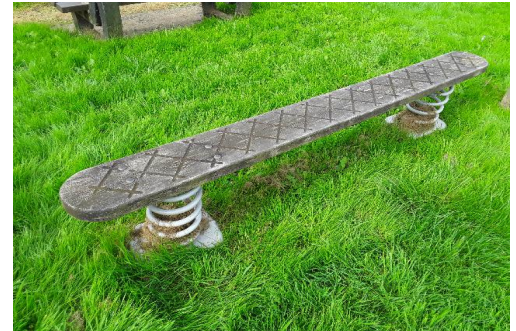
**Item:** Wobble Board  
**Manufacturer:** Playdale Playgrounds Ltd  
**Surface Type:** Grass  
**Item Quantity:** 1  
**Equipment Compliance:** Yes  
**Surface Area Compliance:** Yes

The wobble board is in satisfactory condition - None required

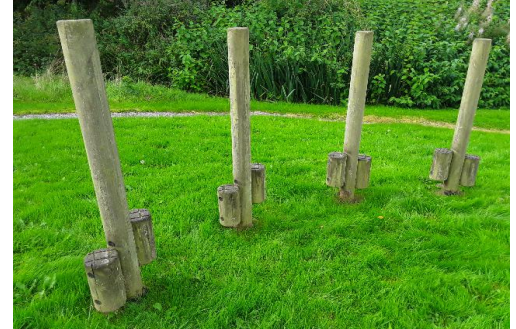
**Item:** Stilts  
**Manufacturer:** Playdale Playgrounds Ltd  
**Surface Type:** Grass  
**Item Quantity:** 4  
**Equipment Compliance:** Yes  
**Surface Area Compliance:** Yes

The stilts are in satisfactory condition - See below

A pole is showing rot - Monitor for for further deterioration

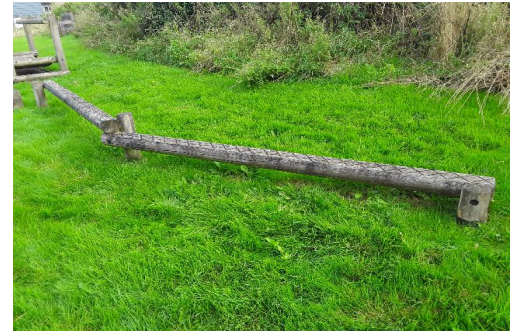
**Item:** Balance Beam  
**Manufacturer:** Playdale Playgrounds Ltd  
**Surface Type:** Grass  
**Item Quantity:** 2  
**Equipment Compliance:** Yes  
**Surface Area Compliance:** Yes

The twin balance beam is in satisfactory condition - None required

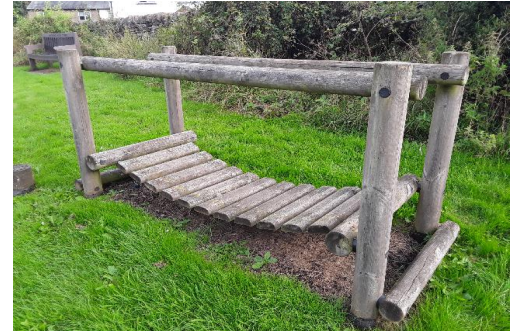
**Item:** Bridge  
**Manufacturer:** Playdale Playgrounds Ltd  
**Surface Type:** Grass  
**Item Quantity:** 1  
**Equipment Compliance:** Yes  
**Surface Area Compliance:** Yes

The mini-suspension bridge is in satisfactory condition - None required

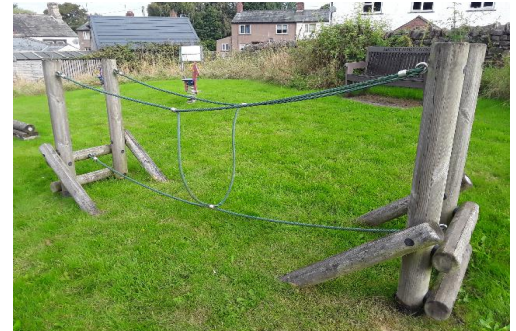
**Item:** Burma Bridge  
**Manufacturer:** Playdale Playgrounds Ltd  
**Surface Type:** Grass  
**Item Quantity:** 1  
**Equipment Compliance:** Yes  
**Surface Area Compliance:** Yes

A strainer pole is rotten - Replace the rotten pole

The bottom rope is showing slight damage, and signs of wear - None required

There is some evidence of rot in the timber - Monitor for further rot

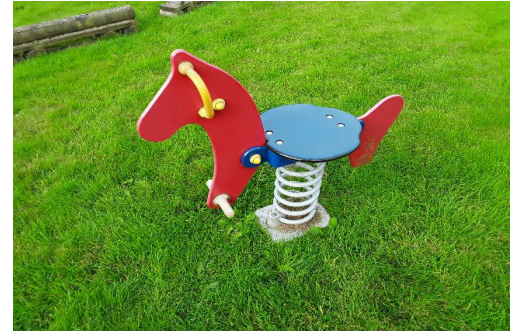
**Item:** Spring Horse  
**Manufacturer:** Ledon  
**Surface Type:** Grass  
**Item Quantity:** 1  
**Equipment Compliance:** No  
**Surface Area Compliance:** Yes

The ends of the footrests fail to meet the dimension requirements of BS EN 1176 - Monitor use

The spring horse is in satisfactory condition - None required

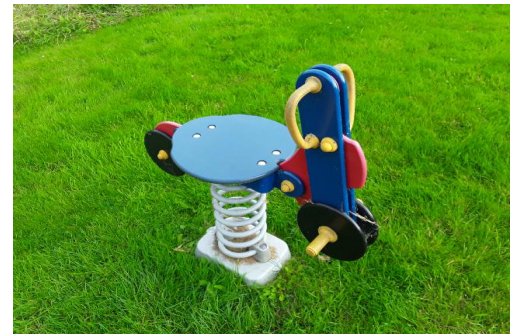
**Item:** Spring Motorbike  
**Manufacturer:** Ledon  
**Surface Type:** Grass  
**Item Quantity:** 1  
**Equipment Compliance:** No  
**Surface Area Compliance:** Yes

The footrests fail dimension requirements - Monitor use

The Springer is in satisfactory condition - None required

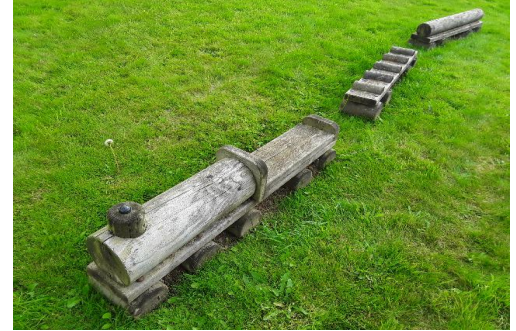
**Item:** Train  
**Manufacturer:** Playdale Playgrounds Ltd  
**Surface Type:** Grass  
**Item Quantity:** 1  
**Equipment Compliance:** Yes  
**Surface Area Compliance:** Yes

The train is in satisfactory condition - None required

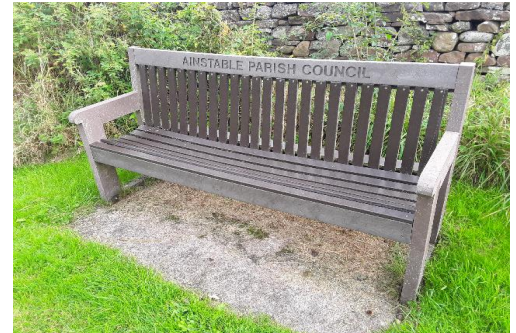
**Item:** Seating Area  
**Manufacturer:** Unknown  
**Surface Type:** Concrete  
**Item Quantity:** 2  
**Equipment Compliance:** N/A  
**Surface Area Compliance:** N/A

The seats are in good condition - See below

A seat is slightly loose on its ground fixings - Monitor for further deterioration

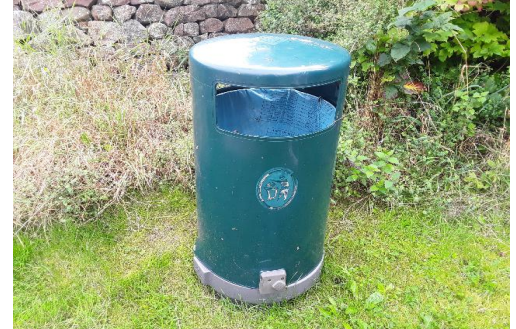
**Item:** Litter Bin  
**Manufacturer:** Glasdon  
**Surface Type:** Concrete  
**Item Quantity:** 1  
**Equipment Compliance:** N/A  
**Surface Area Compliance:** N/A

The bin is in satisfactory condition - See below

The bin is slightly loose on its ground fixings - Monitor use

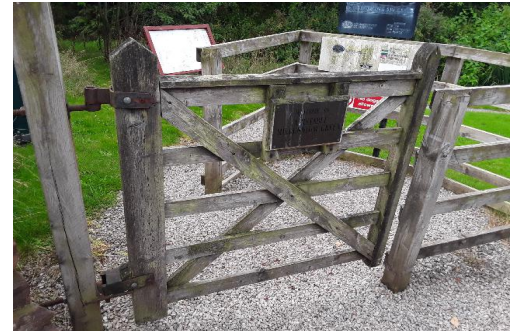
**Item:** Gate  
**Manufacturer:** Unknown  
**Surface Type:** Crushed Stone  
**Item Quantity:** 1  
**Equipment Compliance:** N/A  
**Surface Area Compliance:** N/A

The gate is in satisfactory condition - See below

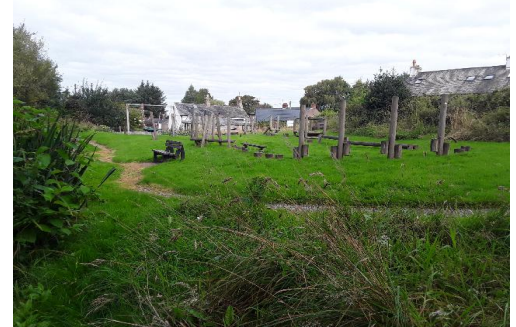
**Item:** Site General  
**Manufacturer:** Unknown  
**Surface Type:** N/A  
**Item Quantity:** 1  
**Equipment Compliance:** N/A  
**Surface Area Compliance:** N/A

A bridge handrail post is loose - Refix the post

It is recommended that information signs with emergency contact details are installed at each entrance/exit point to the playground - Provide in accordance with the recommendations set out in BS EN 1176, also mentioning the beck as a potential hazard

The covering on the bottom of the poles may cause rot, due to been damp. Stimmer damage can also lead to rot - Monitor for deterioration of the poles

An information board is failing - Repair or remove

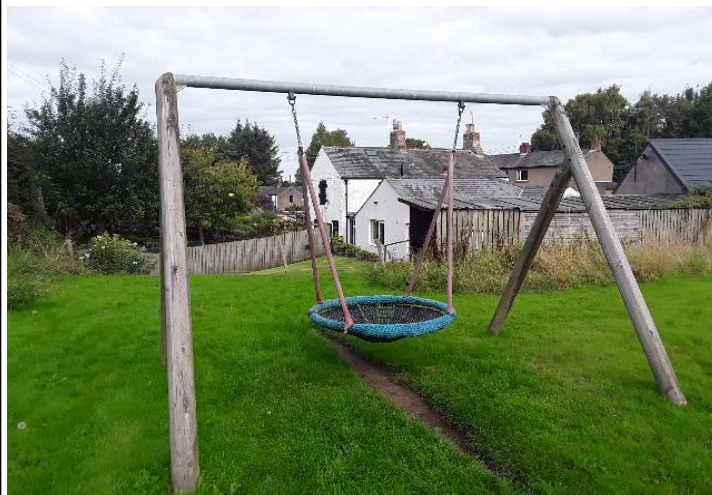
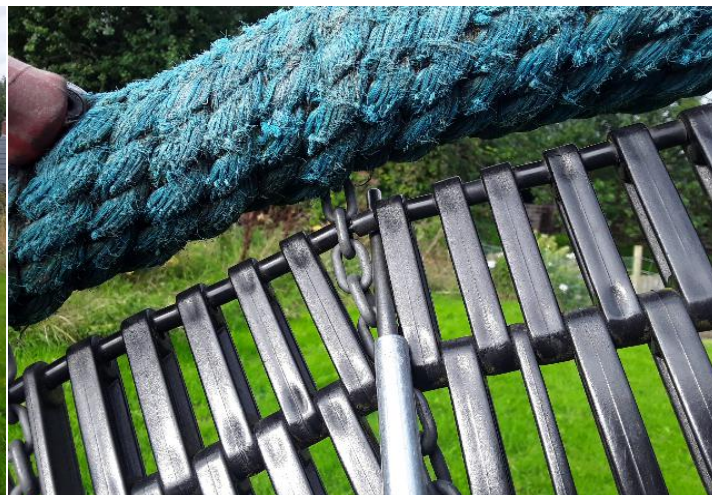
**Finding:** The openings between the slots in the Basket Seat **Action:** Monitor Use form finger entrapments; whilst the swing is in motion

**i** 6 - Low Risk (Finding 3)

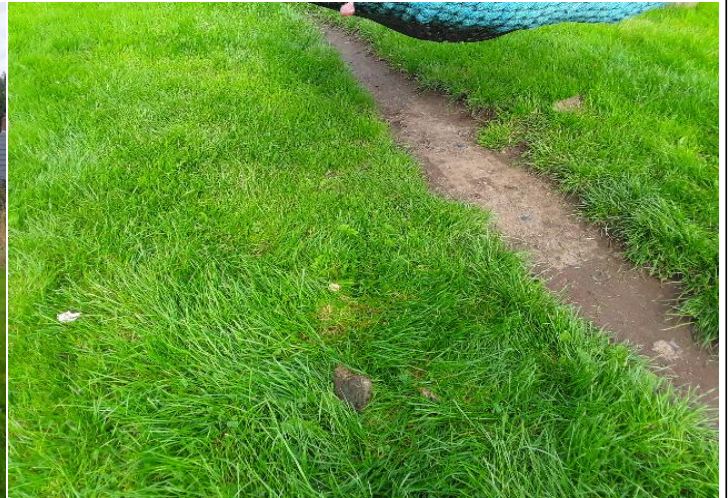
**Finding:** The grass mats are silted up and the soil is compacted; this may have an effect on the impact absorbing properties of the surface

**Action:** Consider lifting and relaying the mats or test impact absorbing properties to ensure the correct surface qualities are maintained for the equipment

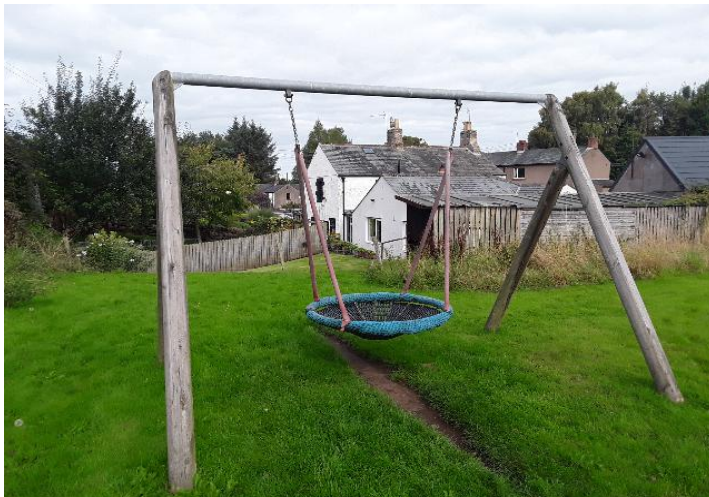
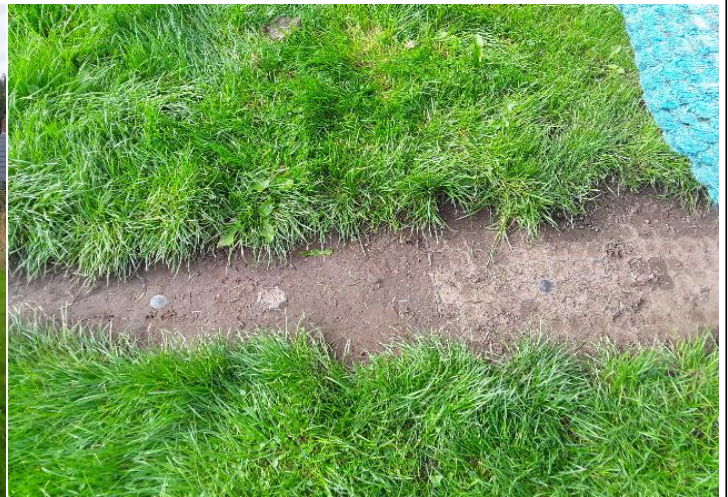
**Finding:** Fixing Pins have been installed in the impact area

**Action:** Remove pins from impact area

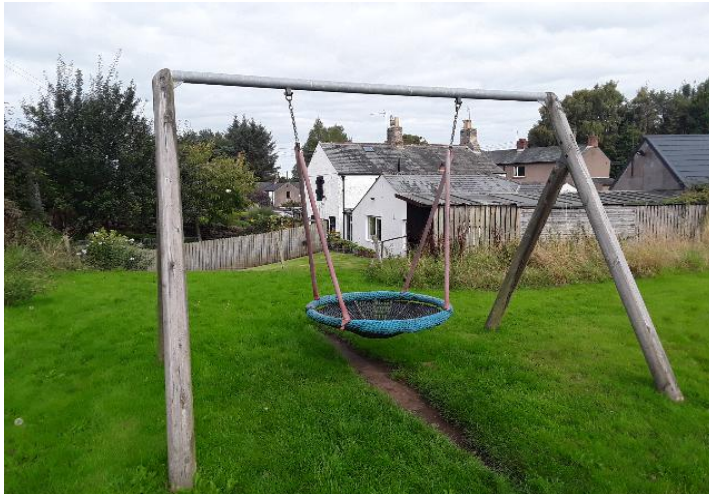
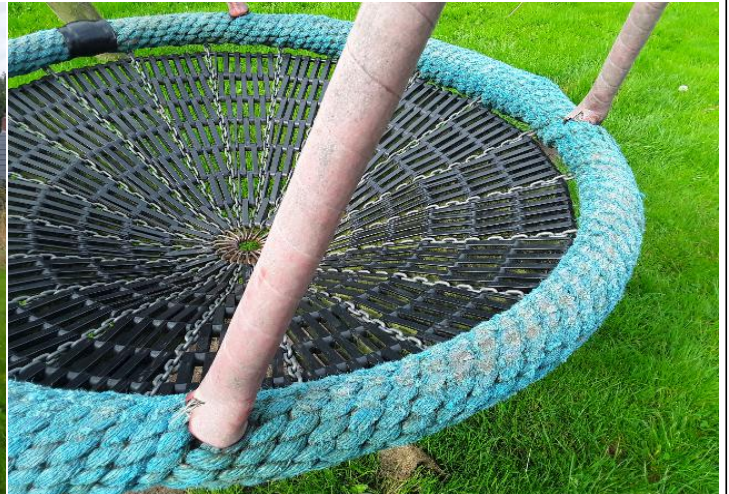
**Finding:** The seat is starting to show its age

**Action:** Monitor use

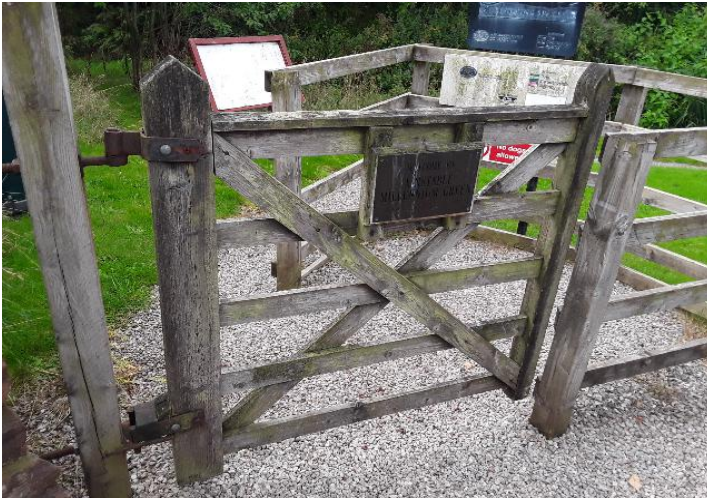
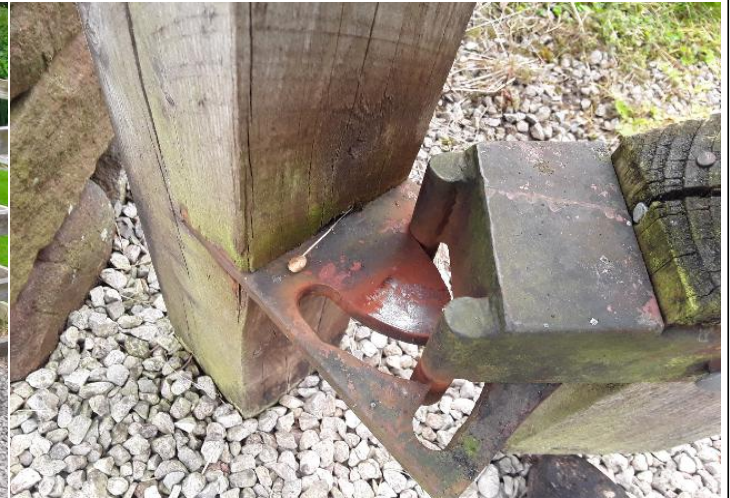
**Finding:** The hinge is squeaking

**Action:** Grease the hinge (Dine)

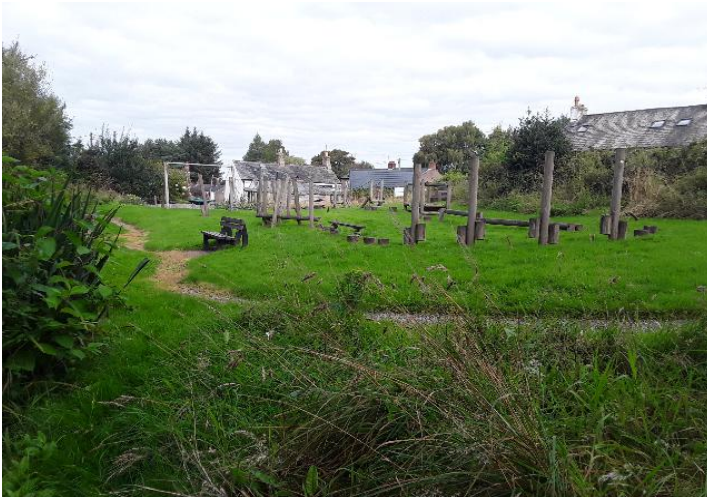
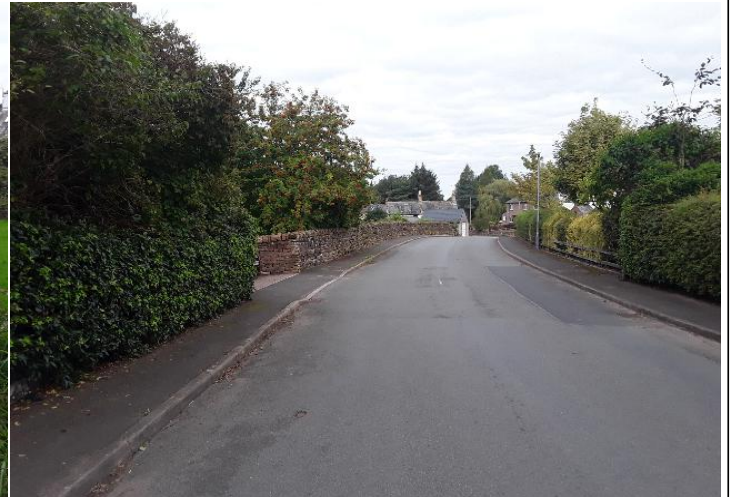
**Finding:** The play area entrance is not obvious from the road

**Action:** Consider a warning sign

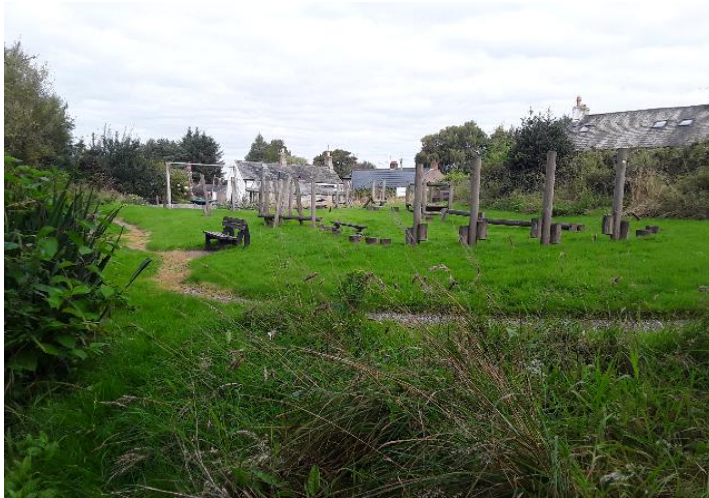
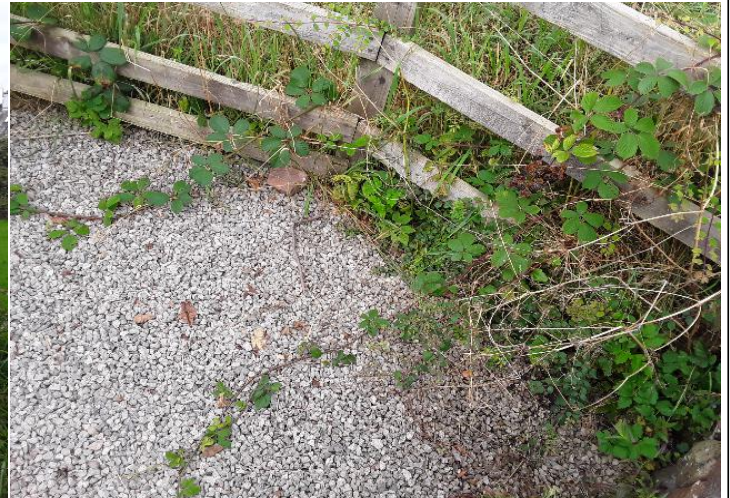
**Finding:** Brambles are encroaching into the entrance way

**Action:** Cut back the brambles

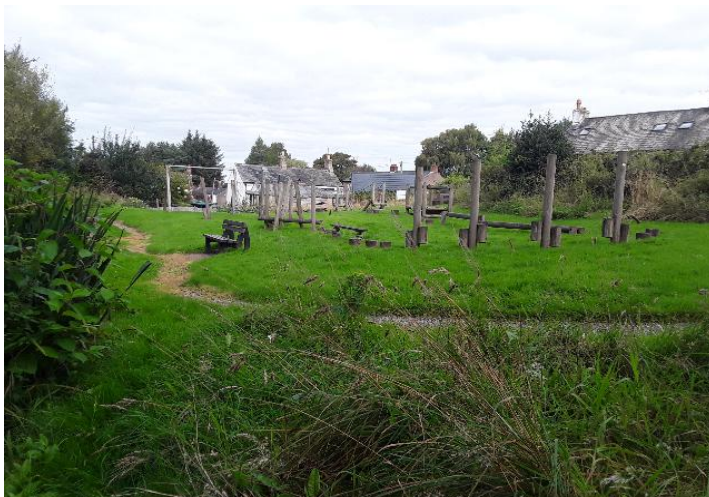
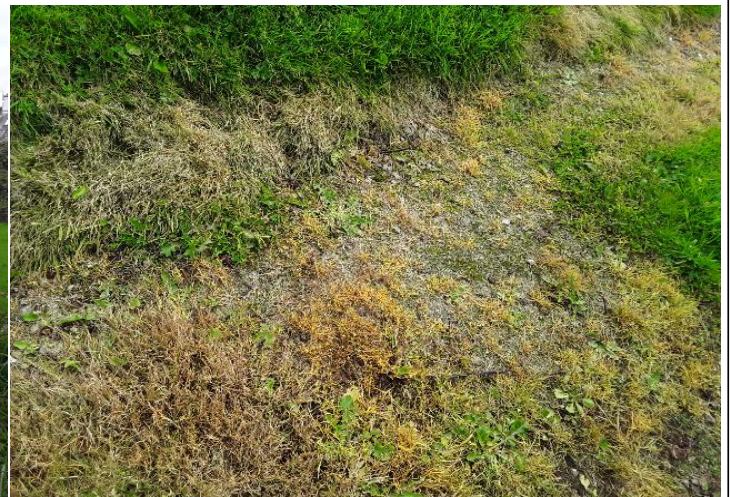
**Finding:** The path is becoming overgrown

**Action:** Remove the weeds
